FACILITY RESERVE STUDY

GOLETA VALLEY COMMUNITY CENTER

5679, 5681, 5689 and 5717 Hollister Avenue
Goleta, California 93117

EMG Project #: 92184.10R-002.052
Date of Report: September 1, 2010
On-site Date: March 21, and 22, 2010

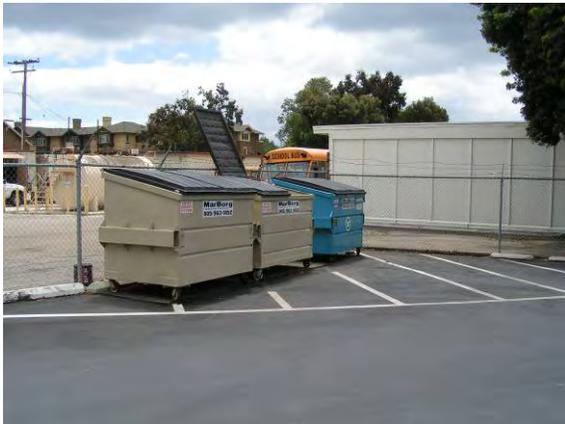
Dumpsters are located in the parking area and are placed on the asphalt paving. The dumpsters are not enclosed.

Photo #9:	Dumpsters
-----------	-----------

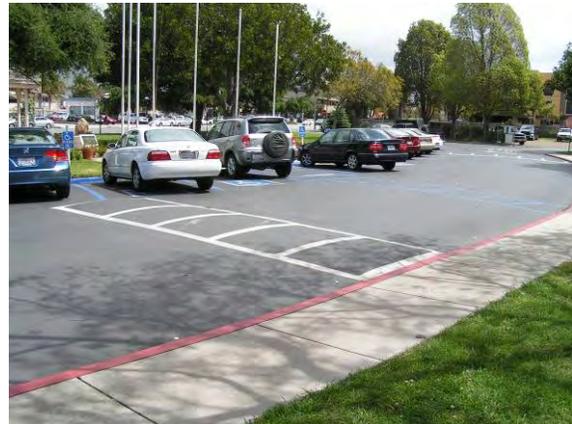
Photo #10:	Disabled parking front lot
------------	----------------------------

3.2	37575	ADA Strobe Fire Alarm	15	15	0	3	EA	\$500.00	\$1,500	\$1,500														\$1,500						\$3,000
3.2	37390	ADA - Install signage indicating Van Accessible Parking, pole mounted	0	0	0	2	Sign	\$106.36	\$213	\$213																				\$213

3.2	37391	ADA, paint van-accessible space with signage	5	0	5	2	EA	\$220.00	\$440					\$440					\$440					\$440						\$1,320
3.2	37574	ADA, Wrap drain pipes below accessible lavatory	0	0	0	2	EA	\$65.00	\$130	\$130																				\$130

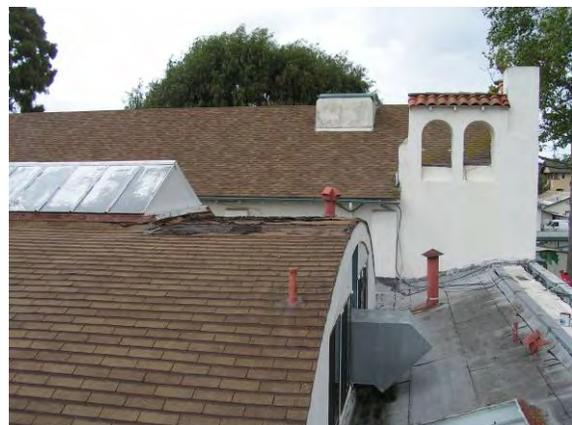
Photo #12:	Roofs at dining hall and assembly room of main building. Deteriorated roofing membrane near skylight
------------	--

6.3	37788	Repair roof at Dining Hall skylight	0	0	0	1	Each	\$1,500.00	\$1,500	\$1,500																				\$1,500
6.3	37786	Main building roofing, BUR. replace	20	15	5	12	SQ	\$812.58	\$9,751					\$9,751																\$9,751

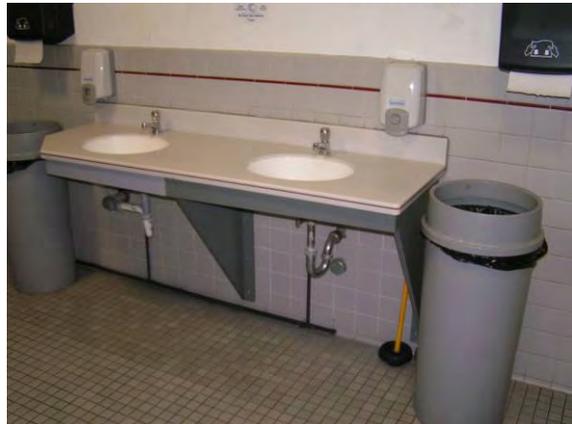
Photo #22: Missing pipe protection at main building restroom
