FACILITY RESERVE STUDY

CITY OF GOLETA

AMTRAK BUILDING

EMG Project #: 92184.10R-006.052
Date of Report: August 31, 2010
On site Date: August 9, 2010

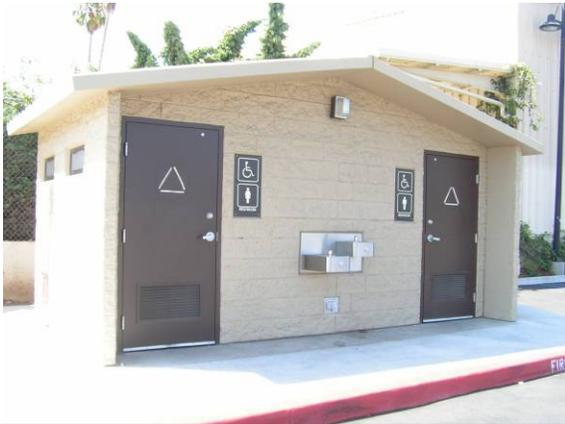
Photo #1: Front elevation.

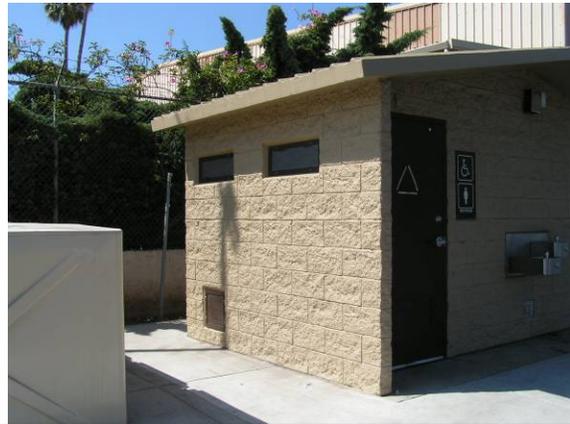
Photo #2: Left side elevation.

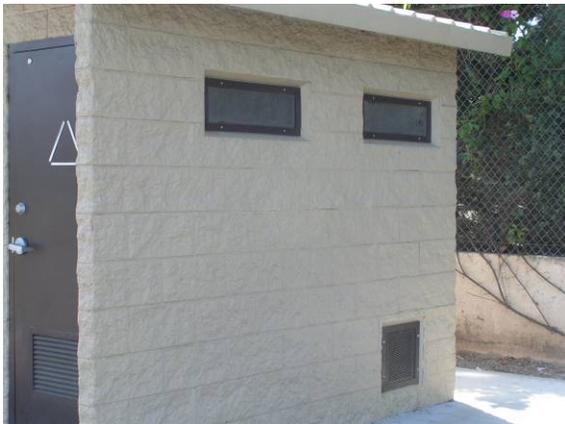
Photo #3: Right side elevation.

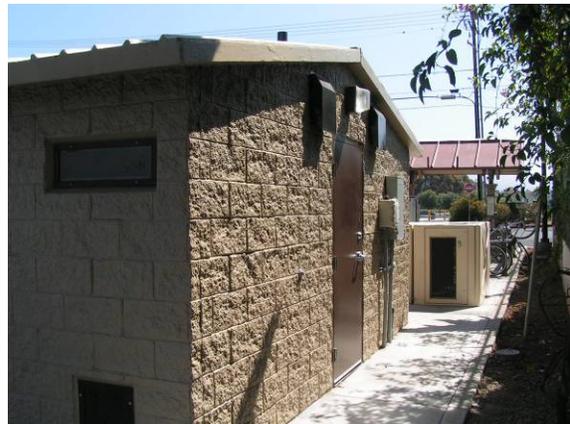
Photo #4: Rear elevation.

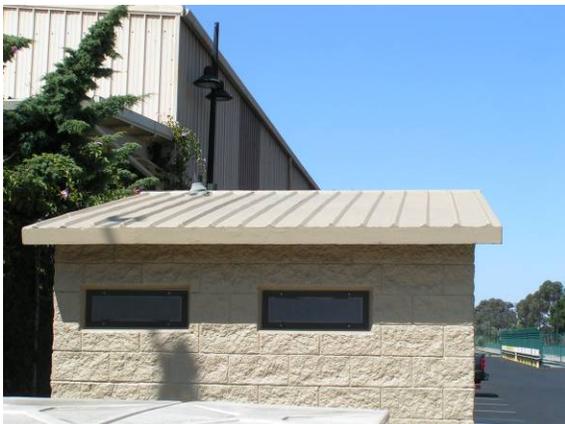
- The roof waterproofing coating is in good condition. Based on its estimated Remaining Useful Life (RUL), the roof coating will require replacement during the assessment period. According to the POC the City is not responsible for the maintenance of the roof waterproofing.
- There is no evidence of active roof leaks.
- There is no evidence of roof deck deterioration. The roof substrate should be inspected during any future roof repair or replacement work.
- There is no evidence of fire retardant treated plywood (FRT).
- Roof drainage appears to be adequate.

Photo #5: Roof overview.

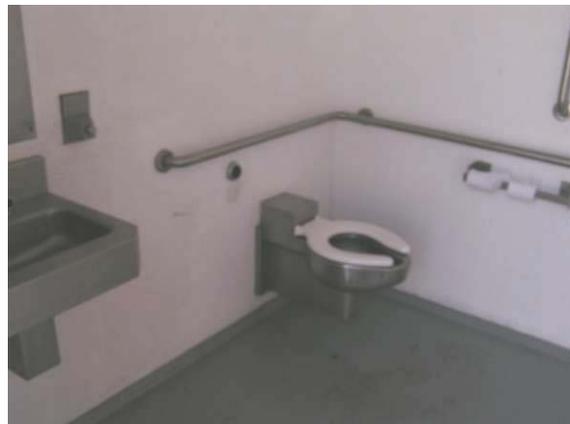
- Accessibility signage at restroom doors is missing.

Photo #6: Interior of restroom.

Report Section	Location	Description	ID	Cost Description	Quantity	Unit	Unit Cost	Subtotal	Deficiency Repair Estimate *
3.2	Restroom		50904	Wall mounted ADA compliant signage	2	EA	\$51.31	\$103	\$103
Immediate Repairs Total									\$103
* Location Factor (1.0) included in totals.

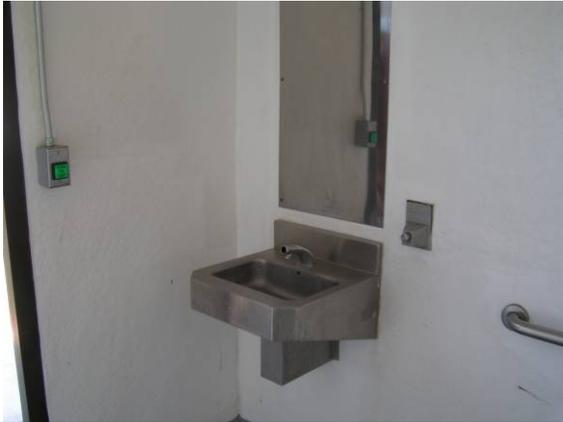
- The lavatory faucets were not operable because of missing valve actuator buttons. The cost to replace the missing buttons is relatively insignificant and the work can be performed as part of the property management’s routine maintenance program. The cost of this work is not included in the cost tables.
- With the exception of the above, the plumbing system appears to be well maintained and in good condition. The water pressure appears to be adequate. The plumbing systems will require routine maintenance during the assessment period.

Photo #7: Lavatory and mirror.

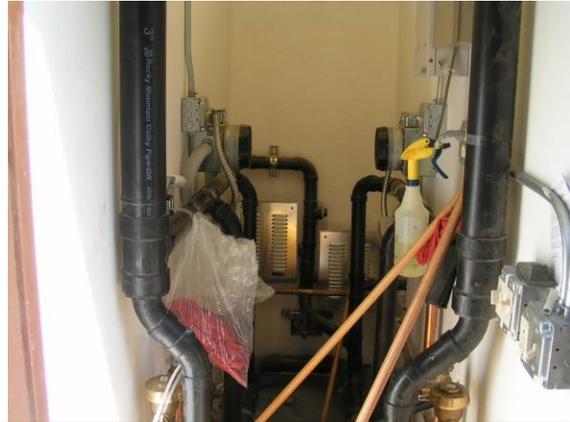
Photo #8: Mechanical room between restrooms.

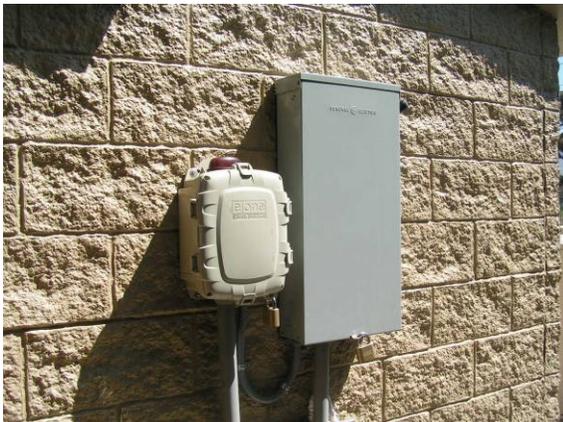
Photo #9: Sewage system control box and electrical panel enclosure.

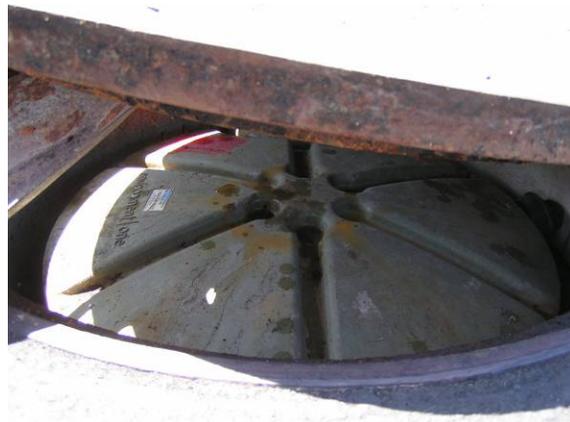
Photo #10: Sewage holding tank in driveway.

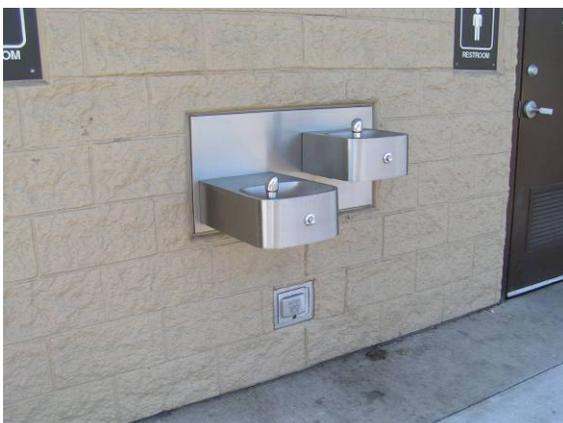
Photo #11: Drinking fountains.

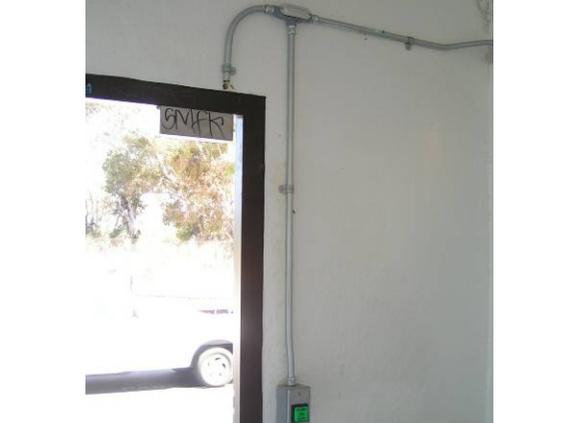
Photo #12: Door access control wiring. Tampered wiring located above the door frame.
