# FACILITY RESERVE STUDY

## HISTORIC TRAIN DEPOT

300 North Los Carneros Road

**EMG Project #:** 92184.10R-004.052  
**Date of Report:** September 1, 2010  
**On-Site Date:** April 28 and May 24, 2010

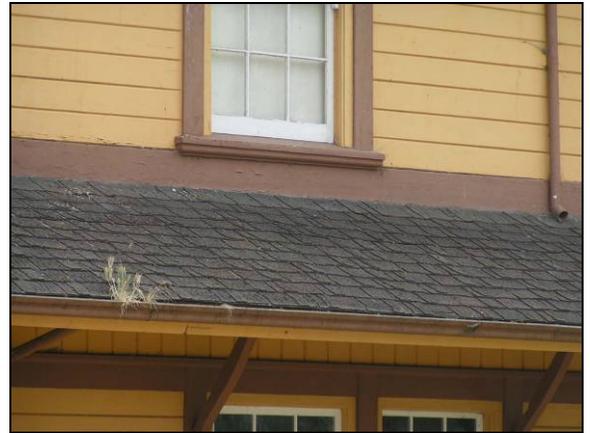
- The roof finishes are 28 years old. Information regarding roof warranties or bonds were requested but are not available.
- The fields of the roofs are in fair to poor condition. The shingles show signs of general deterioration. Based on the estimated Remaining Useful Life (RUL) and current condition, the roof shingles will require replacement during the assessment period. The cost of this work is included in the **Replacement Reserves Cost Estimate**.

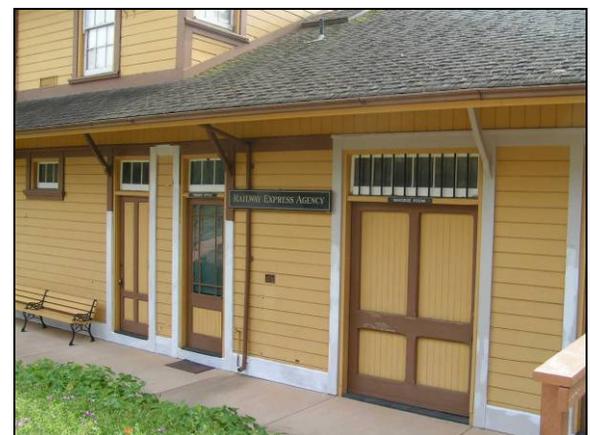
- There is significant evidence of exterior wood trim deterioration due to woodpecker activity. A local, licensed pest control contractor must be retained to treat the property as required to eliminate the birds. A regular program to prevent return of the birds should be instituted.

- The wood siding and trim is in fair to poor condition. There are significant areas of wood pecker-damaged wood trim, isolated areas of deteriorated and weathered painted finishes and siding throughout the exterior of the building. The damaged materials must be patched, repaired or replaced. The cost of this work is included in the **Replacement Reserves Cost Estimate**. In addition to these repairs, the exterior walls will require painting over the assessment period. The cost of this work is included in the **Replacement Reserves Cost Estimate**.

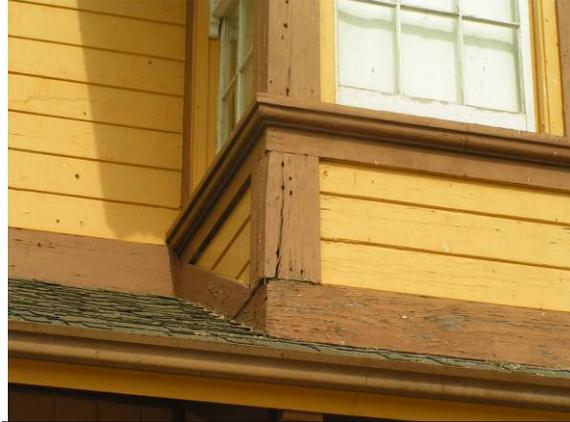
Photo #8:	Woodpecker damage
-----------	-------------------

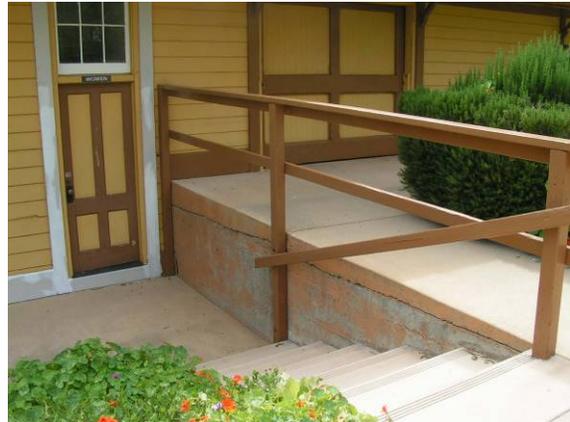
Photo #10:	Stair missing handrails
------------	-------------------------

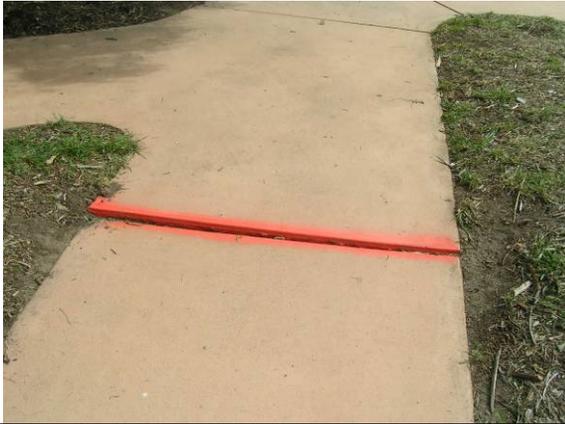
Photo #13:	Uplifted sidewalk
------------	-------------------

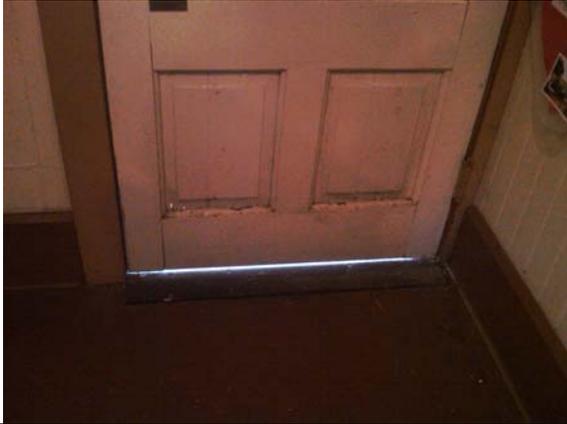
Photo #25:	Air gap under threshold
------------	-------------------------

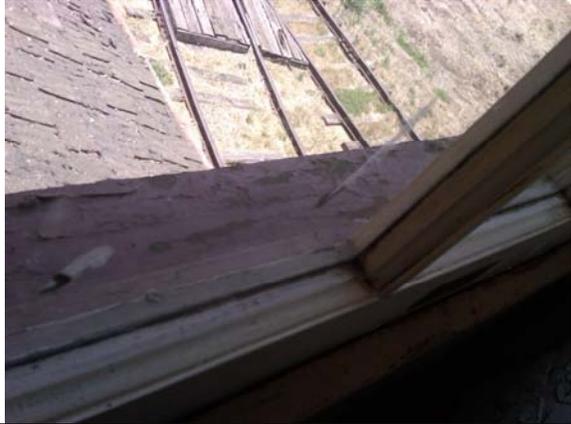
Photo #26:	Peeling paint at upper floor window sill
------------	--

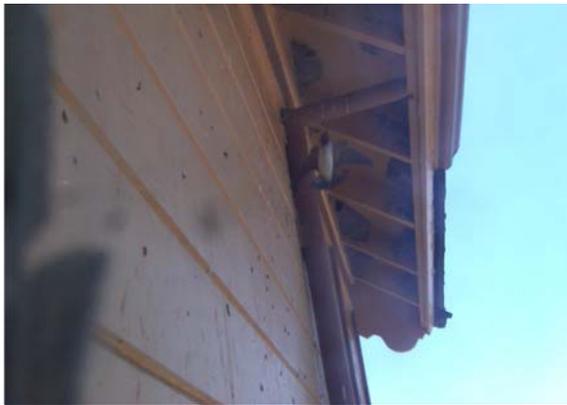
Photo #27:	Bird nests at eaves
------------	---------------------

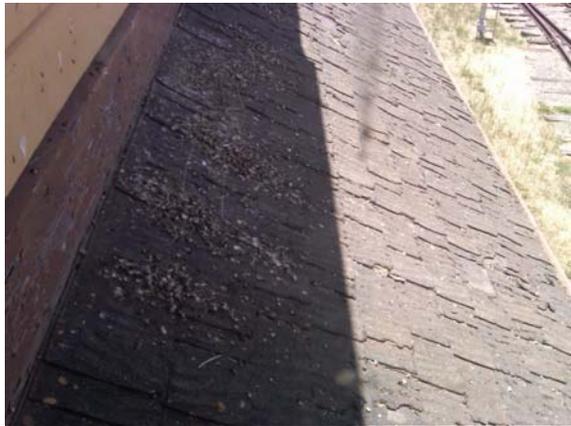
Photo #28:	Bird droppings below eave
------------	---------------------------
