FACILITY RESERVE STUDY

STOW GROVE PARK

580 La Patera Lane
Goleta, California 93117

EMG Project #: 92184.10R-005.052
Date of Report: September 7, 2010
On-Site Date: August 9, 2010

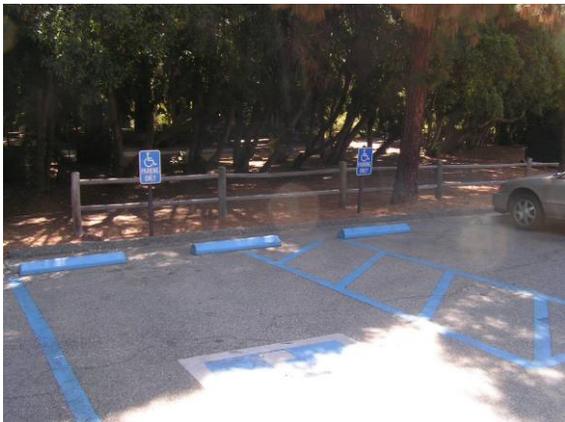
Based on a physical count, parking is provided for 100 cars. All of the parking stalls are located in an open lot. There are two handicapped-accessible parking stalls, neither of which is van accessible.

Photo #3: Accessible parking spaces

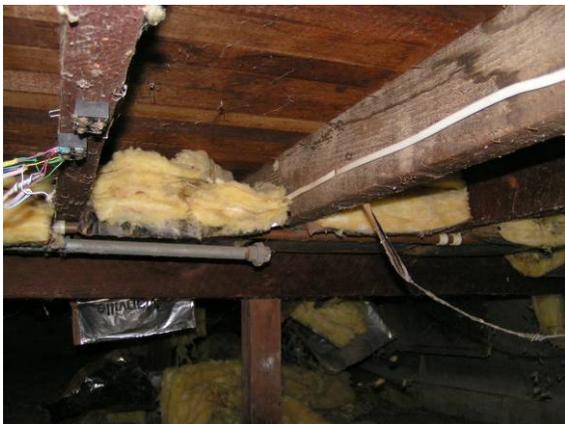
It was reported that the underfloor crawl space of the Caretaker's Residence is infested with rodents nesting in the fiberglass batt insulation. A pest control contractor should be retained to assess the situation and recommend a treatment program. Ongoing pest control is considered routine maintenance and is not included in the cost tables. Damaged and soiled insulation must be replaced. Removal and clean-up should be performed by a pest control contractor due to the potentially hazardous conditions. See Section 6.2 for further discussion.

Photo #11: Caretaker's Residence – Crawl space showing missing insulation

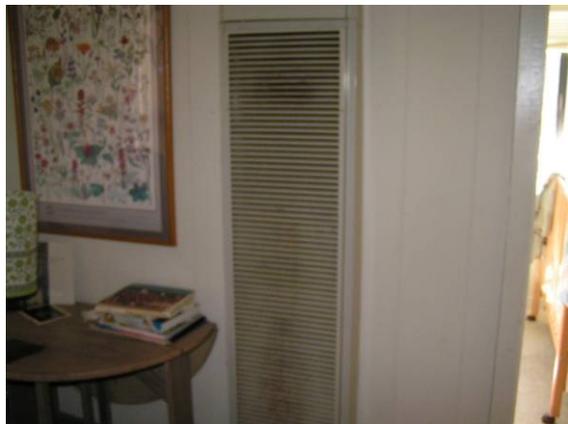
- The wall heater appears to be in good condition. Based on its estimated Remaining Useful Life (RUL), the space heaters will require replacement later during the assessment period. The cost of replacement is included in the Replacement Reserves.

Photo #18: Caretaker's Residence – Wall heater

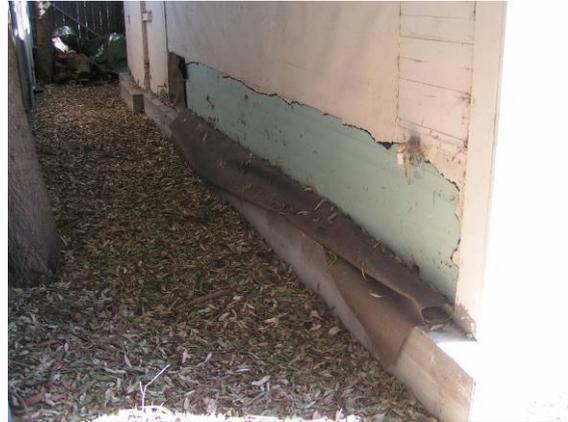
- Drainage at the rear of the storage shed is directed toward the building and water infiltration into the building was reported. Damage to the exterior wall finish is evident and appears to be the result of moisture from the poor drainage. A concrete headwall has been constructed at the base of the rear wall of the building. The wall was reportedly constructed to divert drainage flow and prevent water from entering the building. The grade around the building should be adjusted to keep water from reaching the building in order to prevent future water infiltration into the building and damage to the wall structure and finishes. The cost of adjusting the grade around the building is included in the **Immediate Repairs**.
- Otherwise, the storm water system appears to provide adequate runoff capacity. There is no evidence of major ponding or erosion.

Photo #26: Storage Shed – Damaged wall at rear due to drainage issue

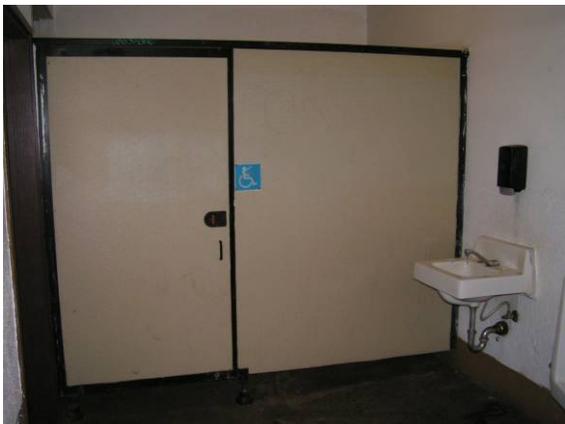
Photo #35: Restroom Building – Accessible toilet stall partitions and lavatory without pipe wrap

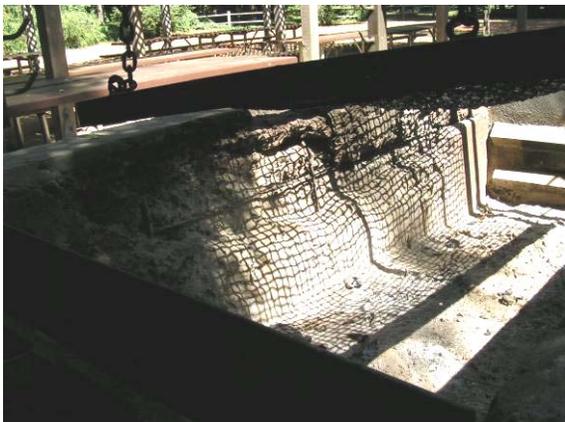
Photo #41: Deteriorated concrete at bar-b-que
