FACILITY RESERVE STUDY

RANCHO LA PATERA AND STOW HOUSE

EMG Project #: 92184.10R-003.052
Date of Report: September 1, 2010
On-site Date: April 27, 2010

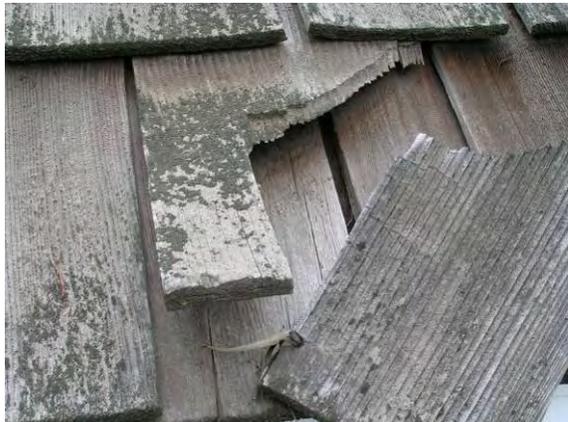
Photo #16: Damaged roof shingle – Stow House

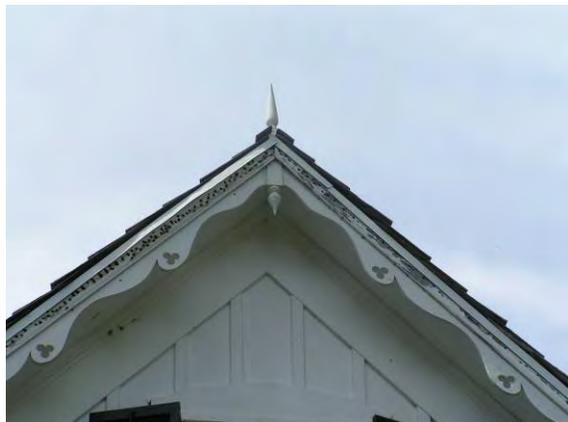
Photo #18: Woodpecker damage to wood trim – Stow House

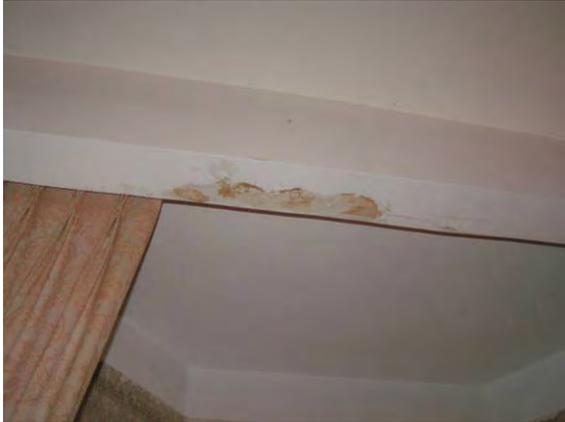
There is visible evidence of isolated areas of moisture intrusion at the first floor living room bay window ceiling beam and at the second floor ceilings in the Stow House. The area of staining totals approximately 20 square feet of ceiling area.

The moisture appears to be the result of window and roof leaks. Although the presence of mold was not apparent, the possibility of mold growth as a result of the moisture intrusion is possible. The presence of mold in exterior and interior environments is normal and unavoidable. Exposure to mold or mold producing materials can be hazardous and should be avoided. The presence of mold does not necessarily constitute an exposure. This assessment does not constitute a comprehensive mold survey of the Project, and any conclusions are based solely on conditions readily observable in accessed areas.

Photo #25: Water damage at living bay window beam – Stow House

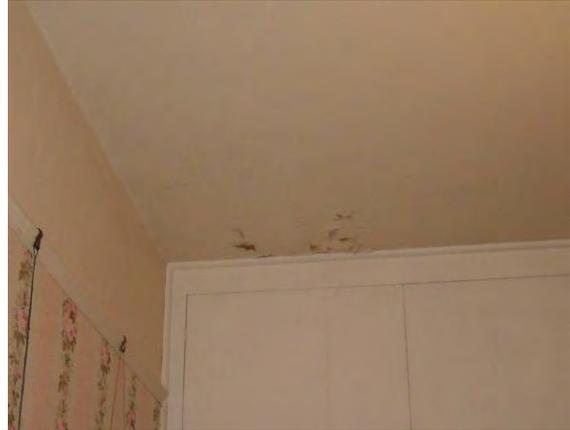
Photo #26: Water damage at second floor bedroom ceiling – Stow House

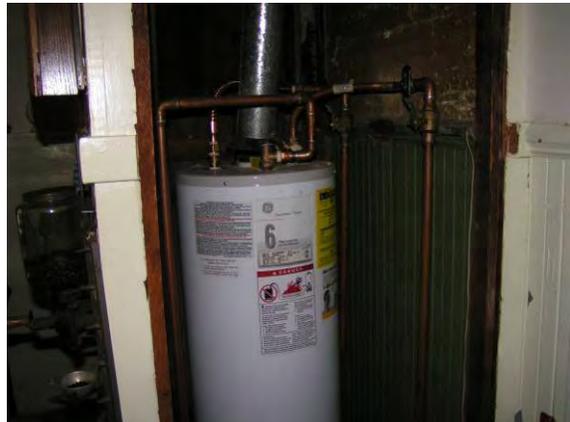
Photo #28: Water heater – Stow House; note absence of seismic restraint

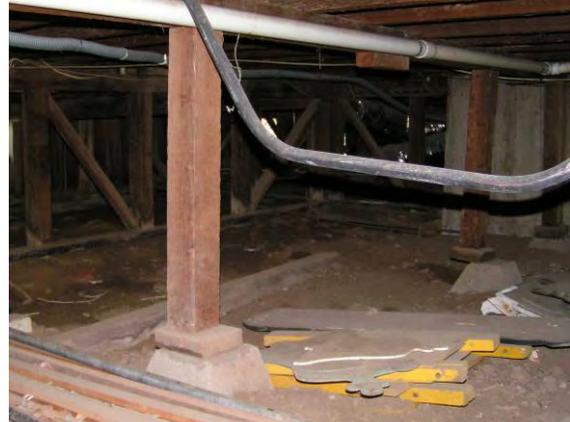
- At the Stow House it appears that framing to foundation connections are inadequate and there is wood to earth contact at the interior cripple walls. Some of the foundation posts have shifted and are not completely bearing on their footings. In addition, according to the staff moisture is evident in the attic of the Stow House. An architect or engineer must be retained to analyze the existing conditions, provide recommendations and, if necessary, estimate the scope and cost of any required repairs. See Sections 6.1 and 6.3 for discussion and costs.
- At the Stow House there is significant evidence of exterior wood trim deterioration due to wood pecker activity at the Stow House. A local, licensed pest control contractor should be retained to treat the property as required to eliminate the threat. See section 6.4 for discussion and costs.

Photo #30: Crawl space posts displaced at footing – Stow House

| Report Section | ID | Cost Description | Quantity | Unit | Unit Cost | Subtotal | Deficiency Repair Estimate * |
|---|---|--|---|---|---|---|---|
| 6.1 | 37838 | Correct foundation anchorage | 1 | Each | \$15,000.00 | \$15,000 | \$16,830 |

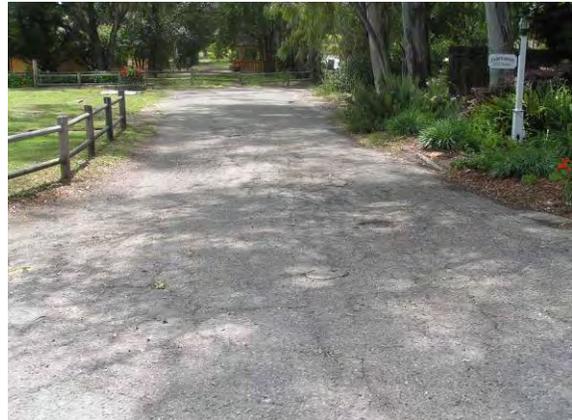
Photo #76: Service drive pavement condition

| Report Section | ID | Cost Description | Lifespan (EUL) | Observed Age (EAge) | Remaining Life (RUL) | Quantity | Unit | Unit Cost | Subtotal | 2011 | 2012 | 2013 | 2014 | 2015 | 2016 | 2017 | 2018 | 2019 | 2020 | 2021 | 2022 | 2023 | 2024 | 2025 | 2026 | 2027 | 2028 | 2029 | 2030 | Deficiency Repair Estimate |
|--|---|---|---|---|---|---|---|---|---|---|---|---|---|---|---|---|---|---|---|---|---|---|---|---|---|---|---|---|---|---|
| 5.2 | 38278 | Repair and Seal Coat asphalt | 5 | 4 | 1 | 3.6 | 10000 SF | \$7,642.00 | \$27,511 | | \$27,511 | | | | | \$27,511 | | | \$27,511 | | | | | | \$27,511 | | | | | \$110,045 |

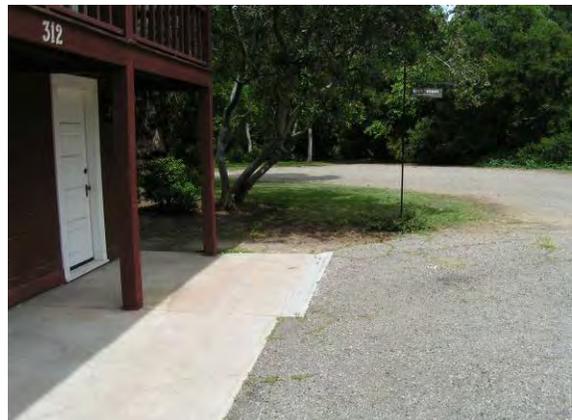
Photo #78: Area of flooding in front of Bunk House

| Report Section | ID | Cost Description | Quantity | Unit | Unit Cost | Subtotal | Deficiency Repair Estimate * |
|---|---|--|---|---|---|---|---|
| 5.3 | 37756 | Civil Engineer Drainage study | 1 | EA | \$2,500.00 | \$2,500 | \$2,805 |
| 5.3 | 37837 | Drainage correction allowance | 1 | Each | \$5,000.00 | \$5,000 | \$5,610 |
