FACILITY RESERVE STUDY

CITY OF GOLETA

GOLETA LIBRARY

EMG Project #: 92184.10R-001.052
Date of Report: September 1, 2010
On-site Date: April 20, 2010

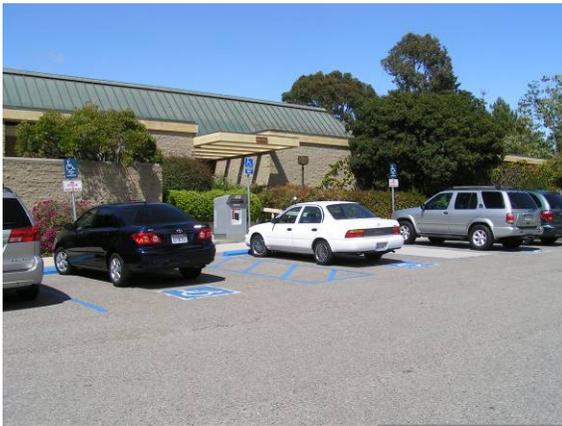
- Adequate number of designated parking stalls and signage for vans are not provided. In addition, the existing grade cross slope at the parking spaces appeared to have a slope of greater than 2%. It is likely that a measured ADA Study will recommend that the asphalt parking spaces be replaced with concrete paved spaces with a curb at the uphill side. At this time the costs for this work are not included in the cost tables.

Photo #17: Accessible parking spaces

3.2	37291	ADA, paint van-accessible space with signage	5	0	5	1	EA	\$220.00	\$220						\$220				\$220					\$220					\$660	
3.2	37290	ADA - Install signage indicating Van Accessible Parking, pole mounted	0	0	0	1	Sign	\$106.36	\$106	\$106																			\$106

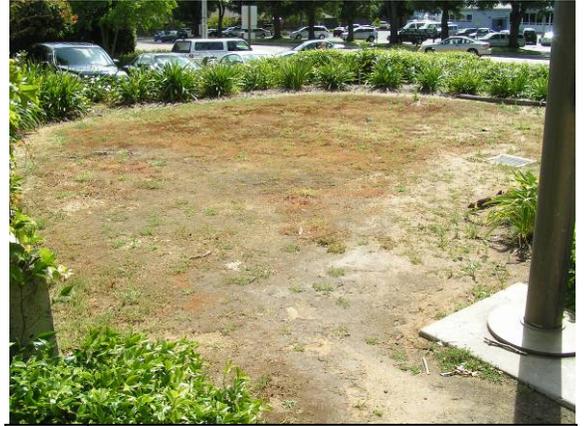
Photo #20: Lawn area at front of building in poor condition

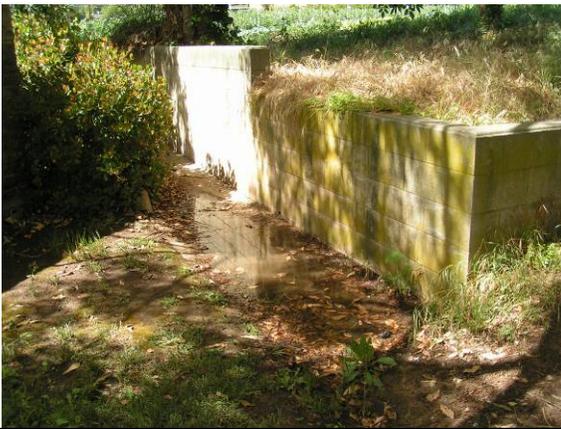
Photo #21: Debris in swale at northeast corner of property

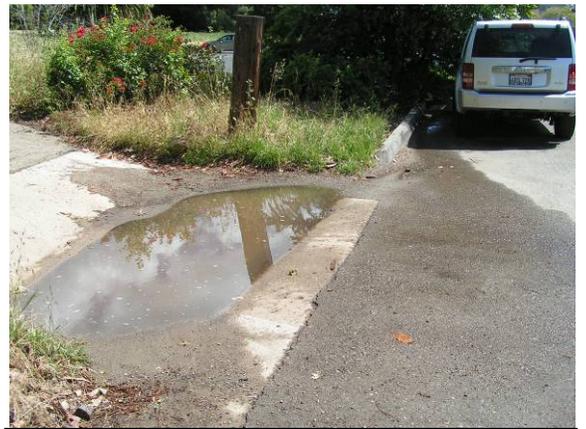
Photo #22: Ponding at swale at access drive to at rear of parking lot

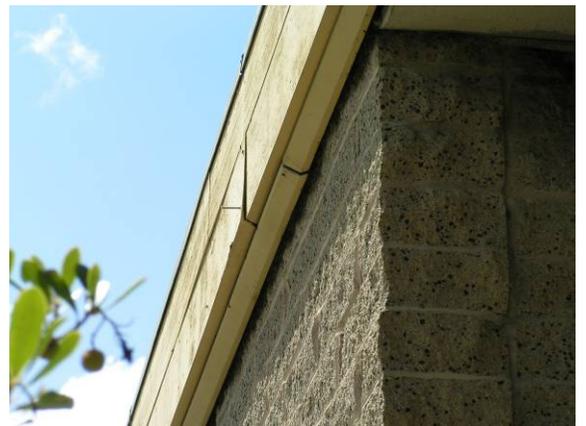
- The painted wood fascia is in fair condition. Isolated areas are warped and pulling away from the building. Based on the estimated Remaining Useful Life (RUL) and current condition, the fascia boards will require partial replacement and painting during the next few years. The cost of this work is included in the **Replacement Reserves**.

Photo #24: Wood fascia

6.4	37254	Paint existing stucco one coat, spray,medium prep work	5	0	5	2400	SF	\$1.41	\$3,384					\$3,384					\$3,384					\$3,384					\$10,152	
6.4	37277	Wood fascia replacement	25	24	1	100	LF	\$12.85	\$1,285		\$1,285																		\$1,285

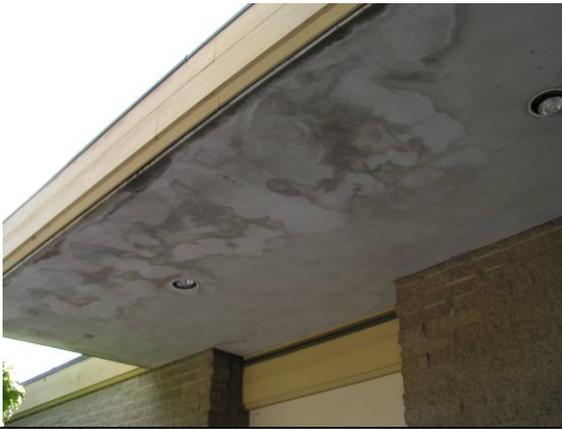
- The stucco soffits are in fair condition. There are isolated areas of water damage. These areas must be repaired by removal and replacement of the damaged stucco. The cost of this work is included in the Immediate Repairs Cost Estimate. The remaining areas of stucco will require painting during the next few years. The cost of this work is included in the **Replacement Reserves**.

Photo #25: Stucco soffit water damage

6.4	37292	Recaulk expansion and control joints up to 1/2" wide	10	9	1	160	LF	\$13.16	\$2,106		\$2,106									\$2,106									\$4,211	
6.4	37256	Replace stucco and lath	25	25	0	3	CSF	\$724.70	\$2,174	\$2,174																			\$2,174

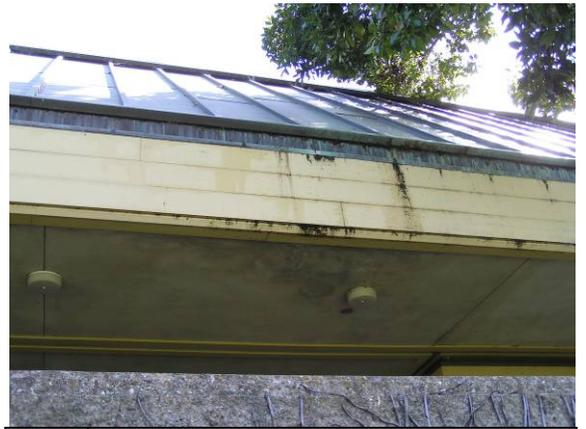
Photo #26: Water damage at fascia and soffit due to clogged drains and gutters

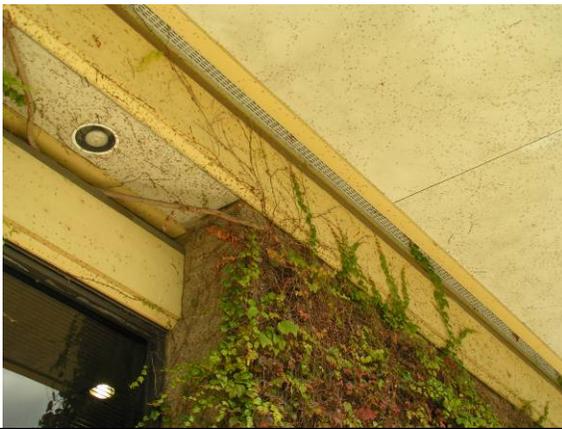
Photo #27: Vines growing onto fascia and soffit

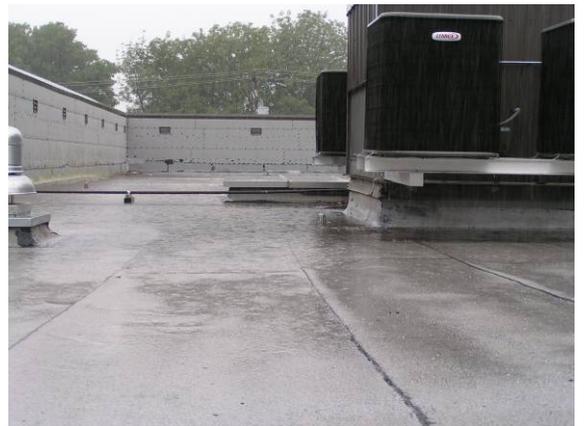
Photo #46: Water ponding at roof

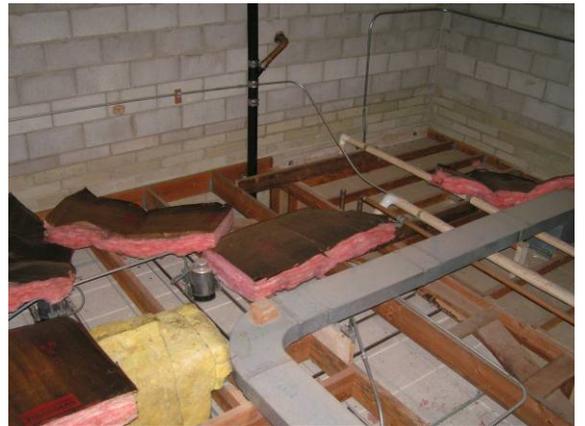
Photo #48: Fallen insulation batts in attic

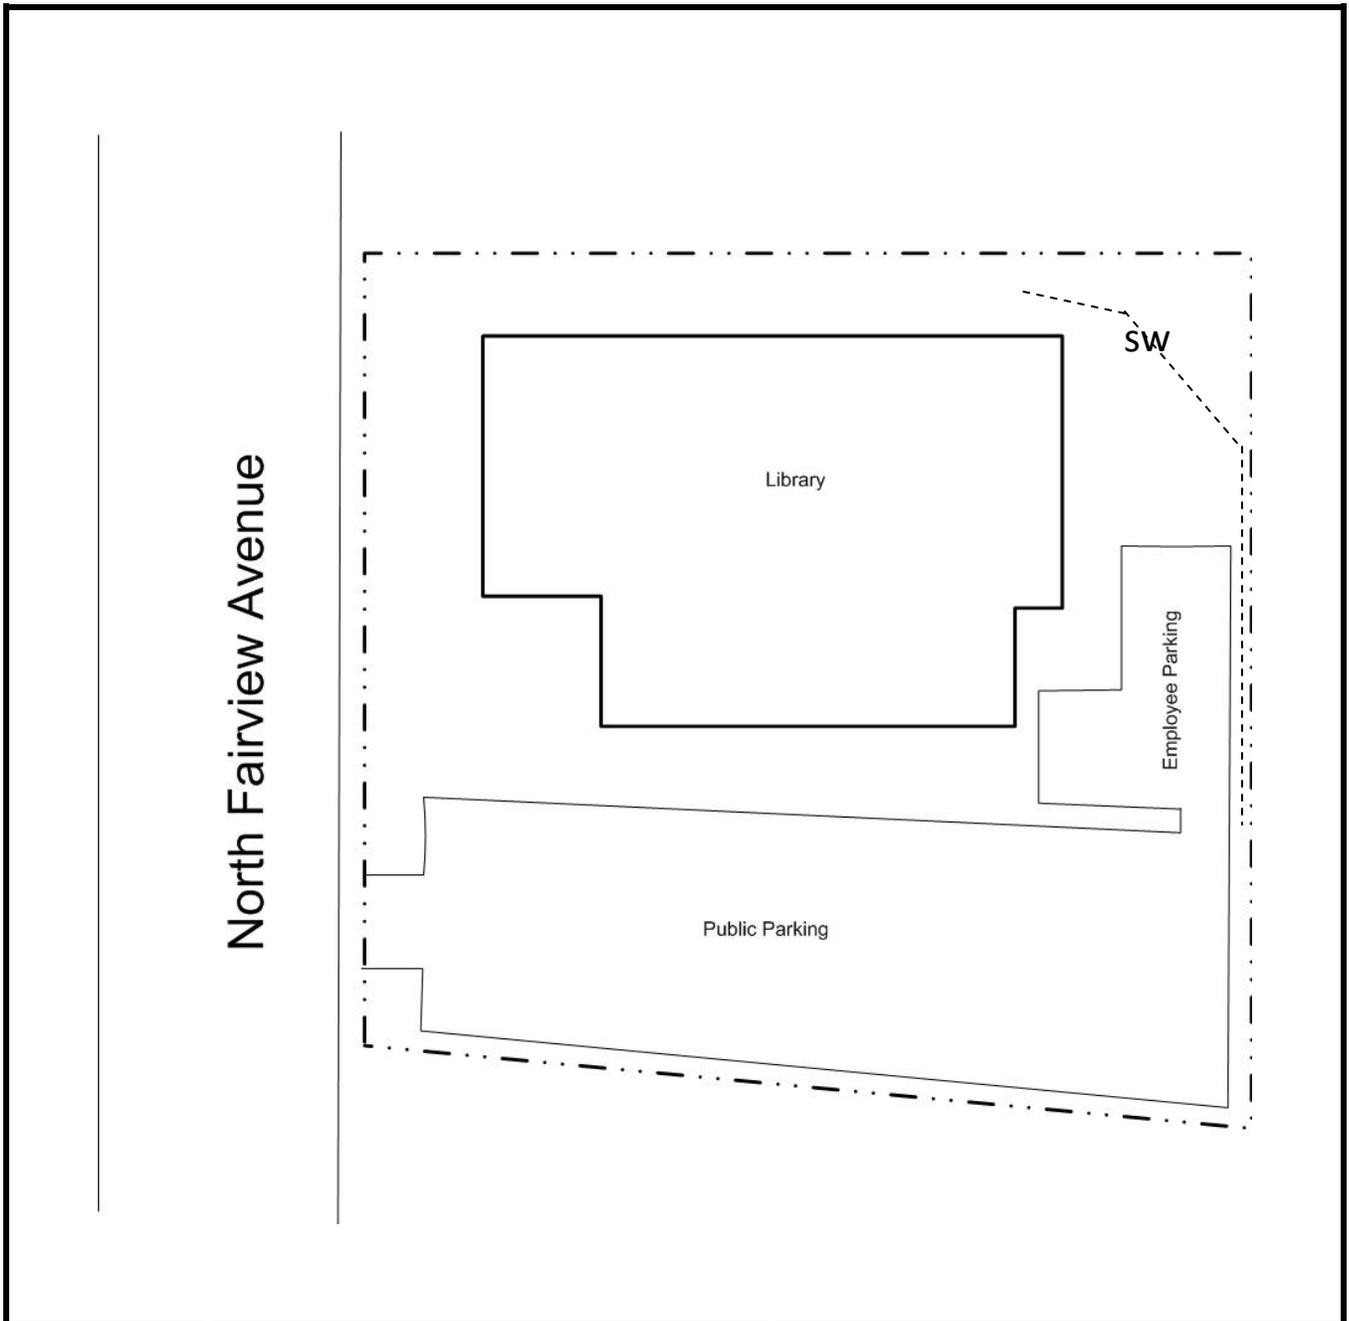
Field Sketch

<p><u>Key:</u> SW – Concrete swale needing cleaning</p>	<p><u>Project Number:</u> 92184.10R-001.052</p>
	<p style="text-align: center;">
