# Goleta Community Center

City of Goleta  
City Council  
2 May 2017

Phase 1  
Historic Resource Evaluation (HRE)

Phase 2  
Potential Impact Study

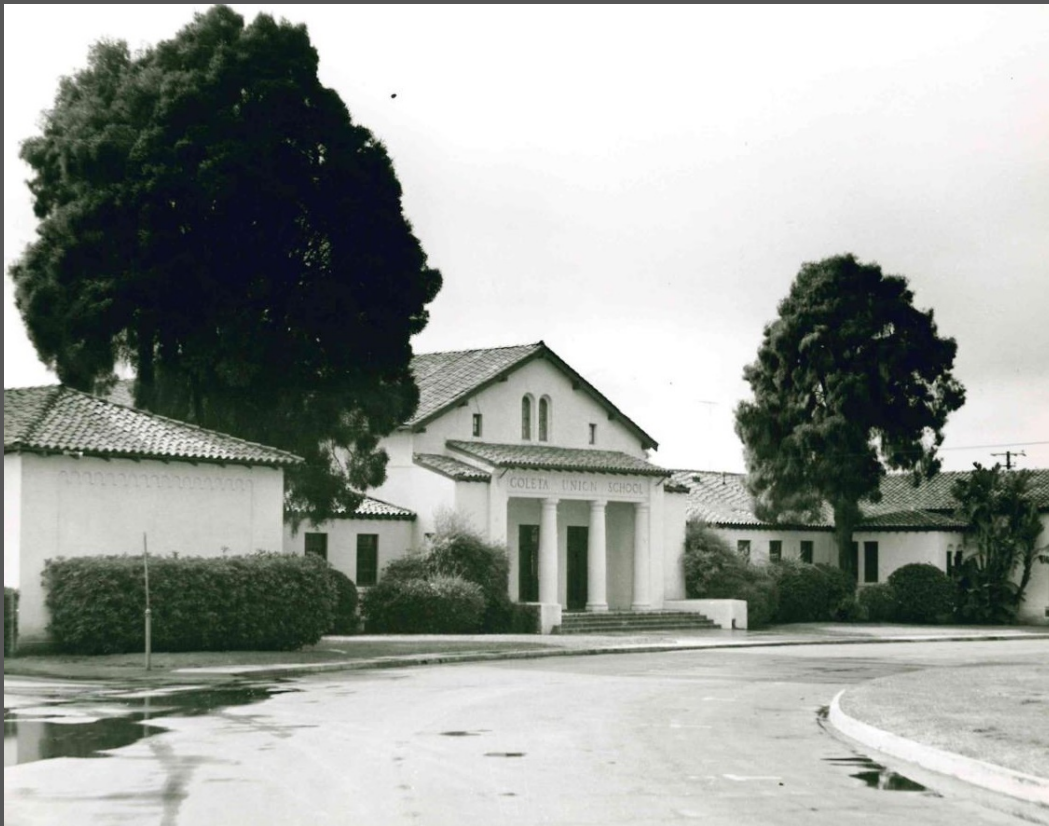
**Criterion C/3 (Architecture):** Potentially also eligible as a work of Louis N. Crawford and as an example of Mediterranean Revival architecture, but key features of the design have been removed

- Removal of red-tile roof, one of the open patios, and original wood windows at east and west façade impact design integrity
- May be eligible under Criterion C/3 if missing or altered features are restored, particularly the red-tile roof
- Retains enough integrity for Criterion A/1, association with development of Goleta and its education system

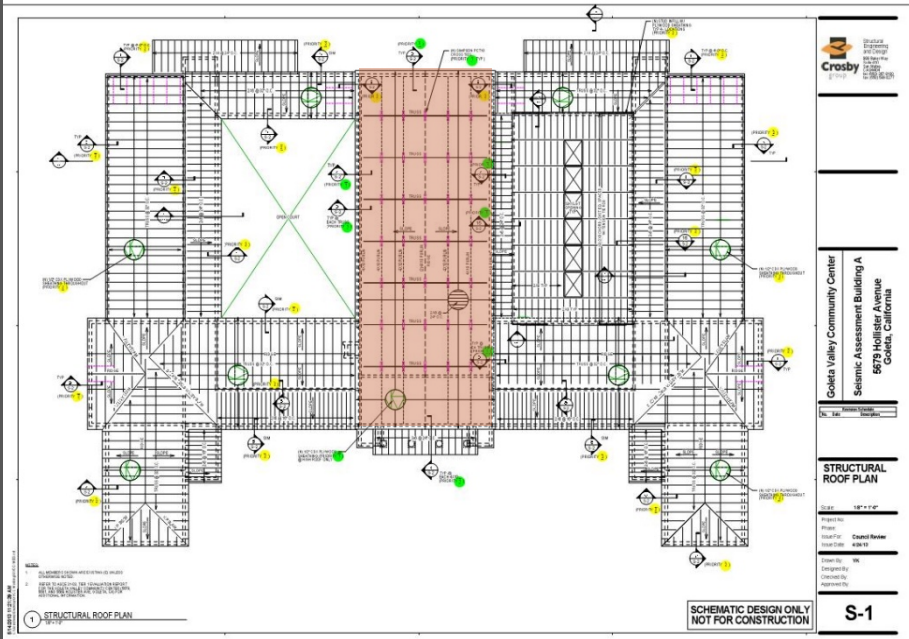
# Seismic Deficiencies

## Priority 1 (Auditorium Only)

- Strengthen existing roof diaphragm
- Strengthen connection of roof framing to exterior walls

## Priority 2 (Included w/ Scenario 2)

- Strengthen remaining roof diaphragms
- Strengthen remaining roof framing to wall connections
- Barrel-vault cripple walls lack sheathing and connections to concrete walls below

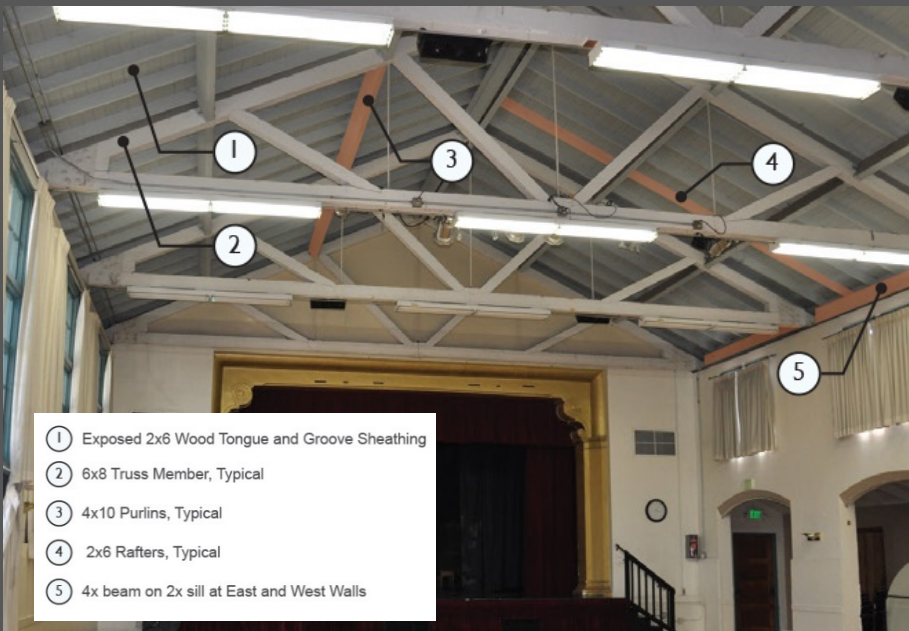
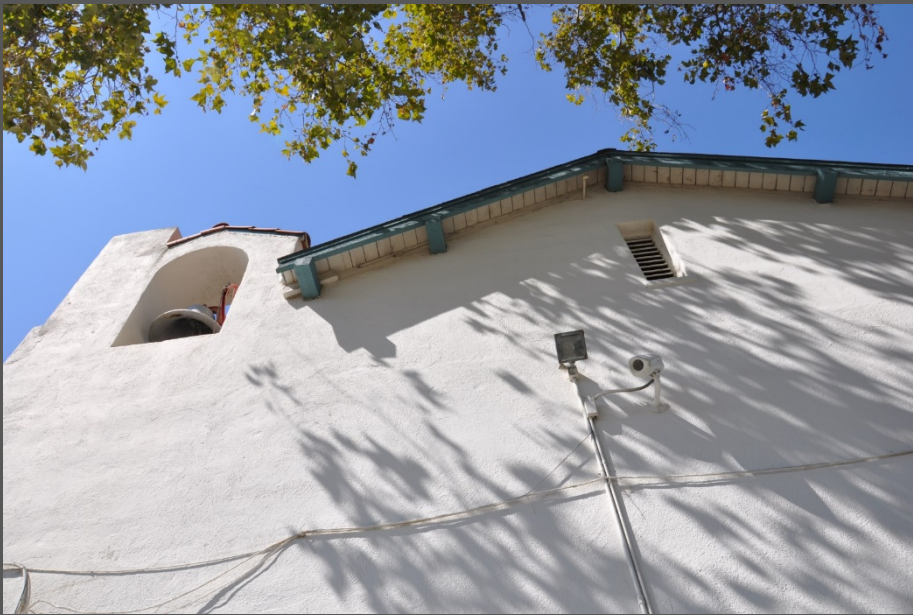
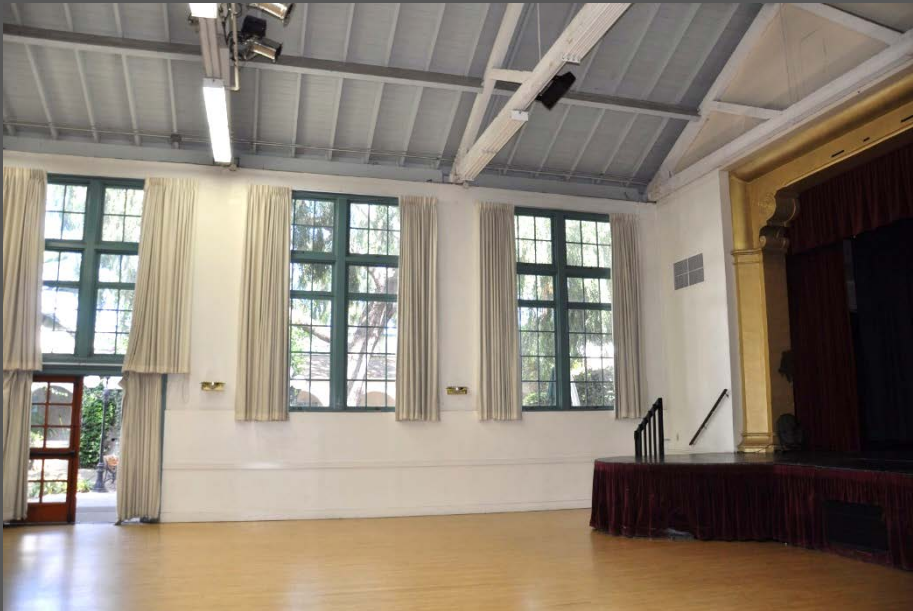
## Strengthen Existing Roof Diaphragm at Auditorium

- New plywood sheathing over existing non-compliant sheathing

- Exposed interior ceiling
- Overhanging eaves with exposed wood rafters

- Install new plywood from above to avoid exposed wood ceiling
- Nailing should be consistent w/ spacing of existing structural members to avoid 'shiners'
- Coordinate roof edge details to minimize thickness of roof edge

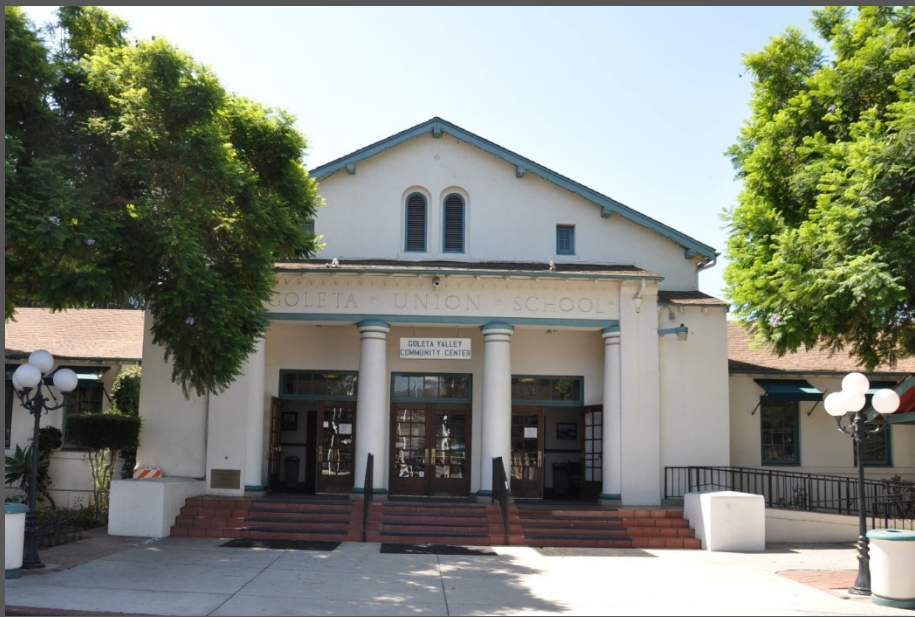
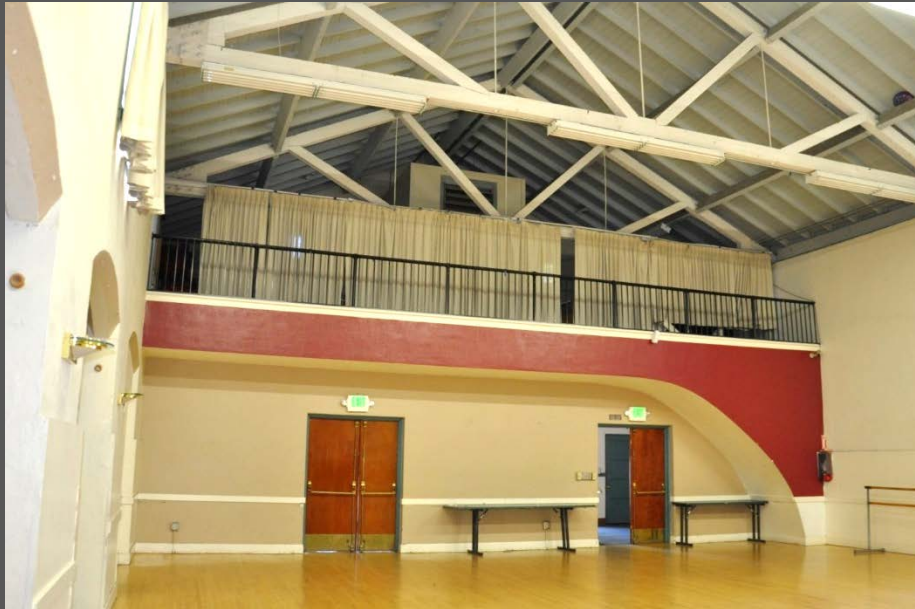
## Strengthen Connection of Roof Framing to Exterior Walls at Auditorium

- New through-wall connections and blocking at gable walls
- New connections of trusses, beams, and rafters to walls

- Visibility of connectors
- Removal, salvage and reinstallation of beams to install connectors

- Approach supplements and avoids removing historic fabric
- New elements should be finished to match adjacent surfaces
