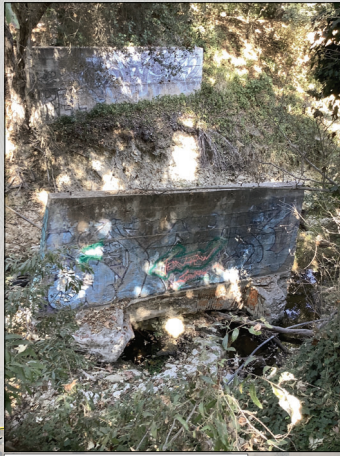
Abandoned bridge abutment in channel bed

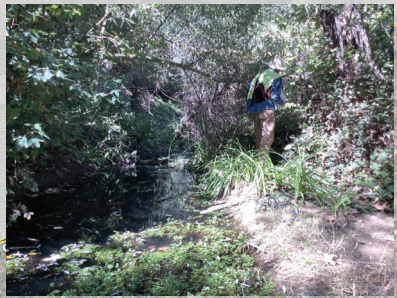
Natural channel with riparian corridor upstream of bridge culvert

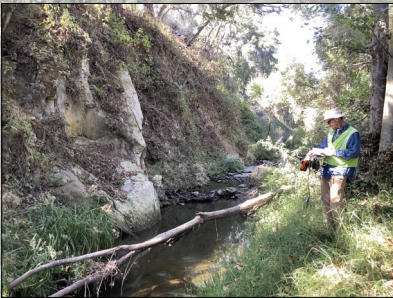
Bedrock outcrop and streamwood

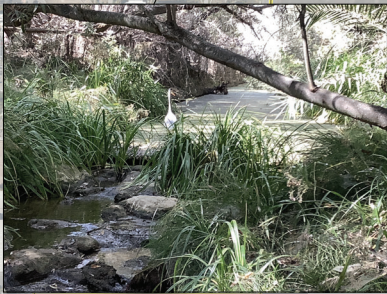
Naturalized channel in foreground, egret mid-distance, engineered channel in background

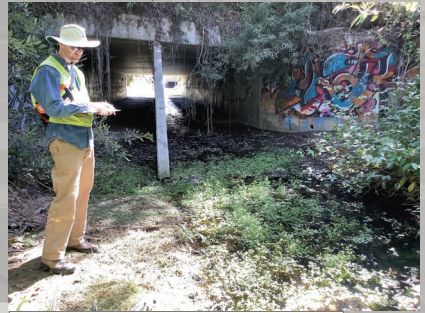
Bridge culvert connecting to downstream concrete channel

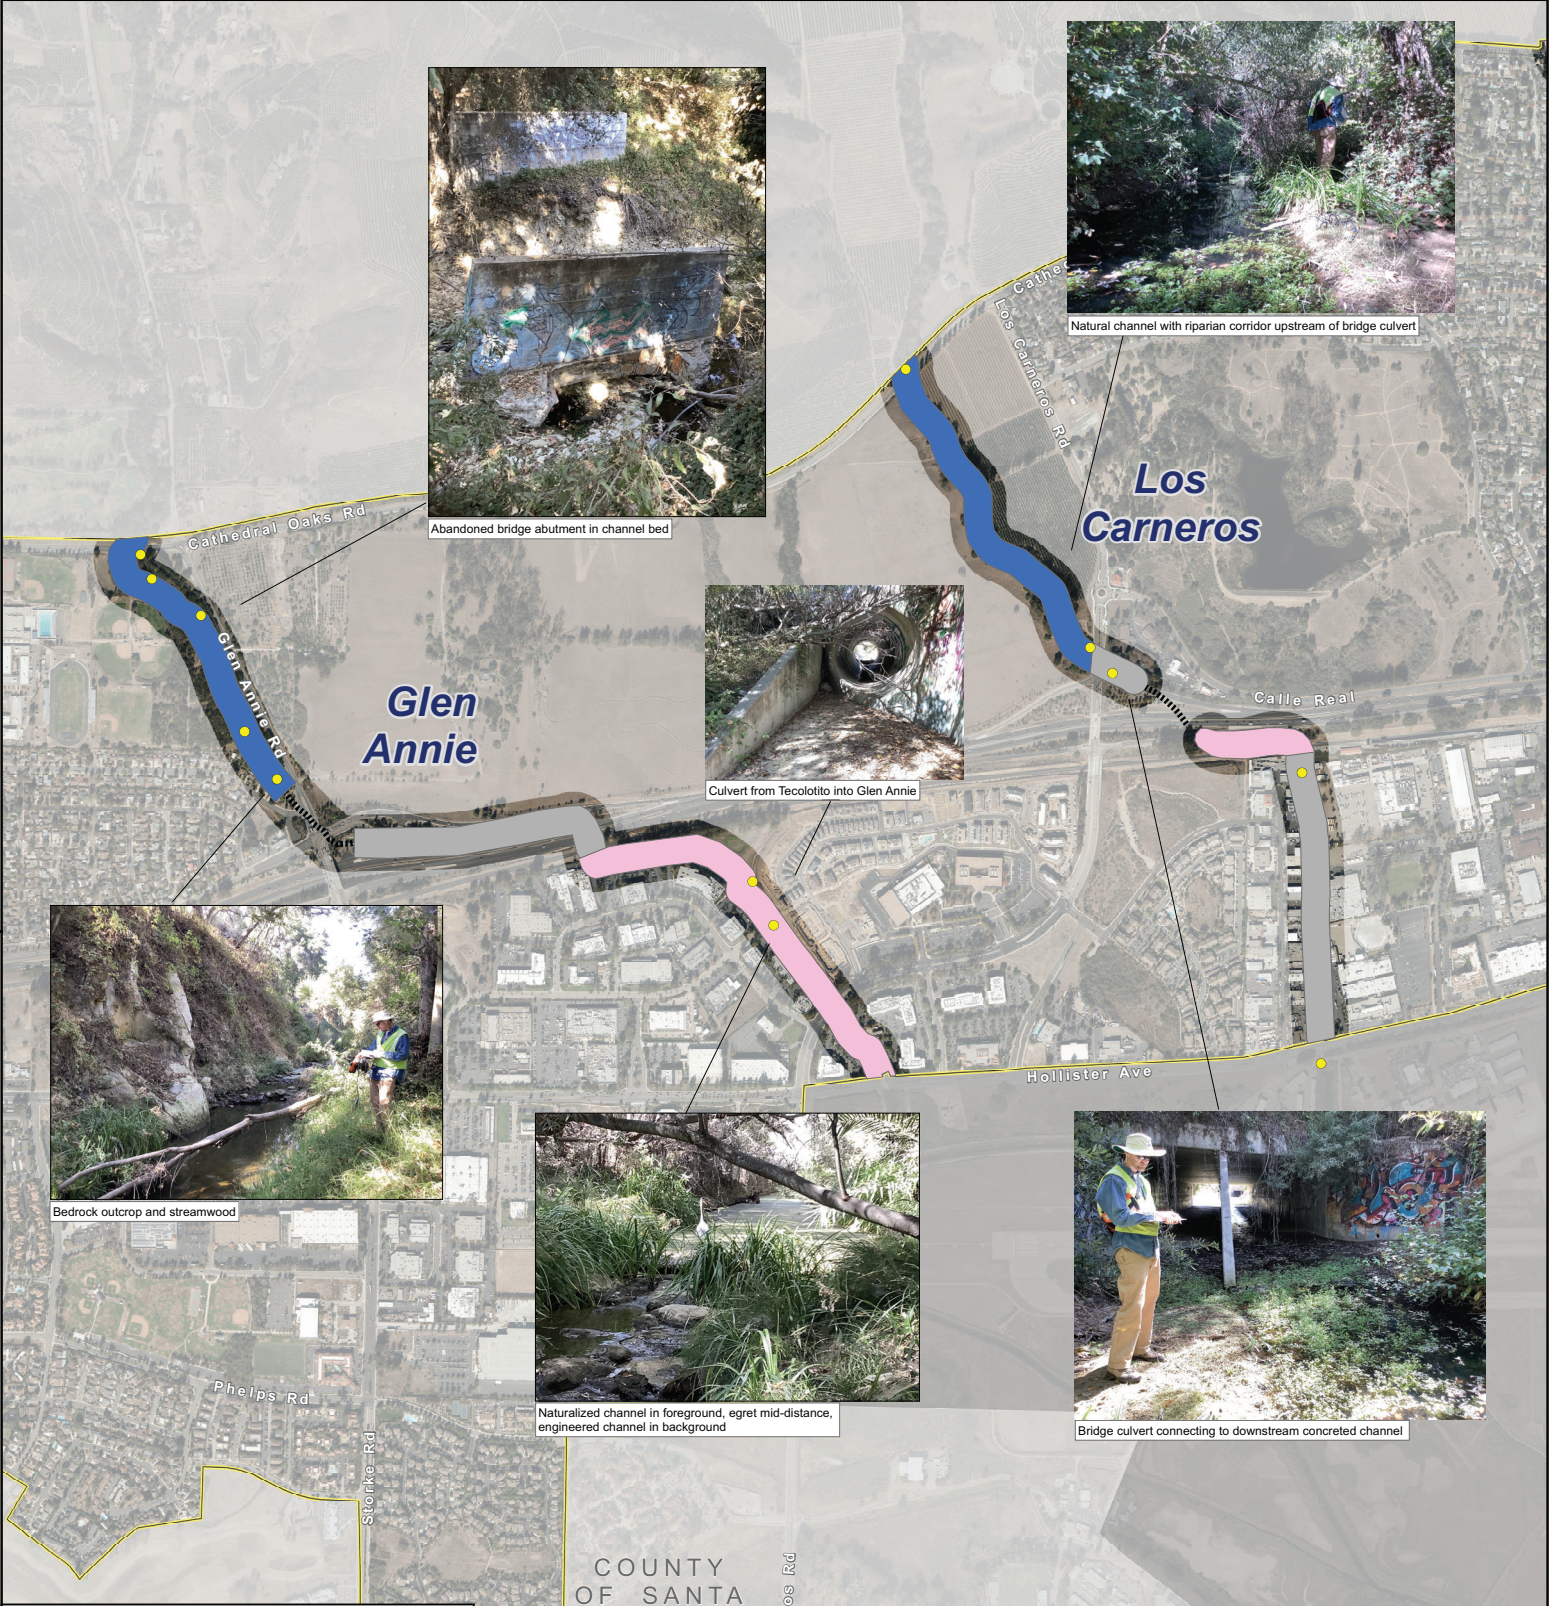
Notes:
Qualitative classifications were made based on point observations along each channel, review of local reports, and aerial photograph interpretation.

Channels that appear to be in approximately the same alignment as original topographic maps are classified as "Natural alignment". These channels were subdivided into reaches that generally show more or less evidence of geomorphic impacts. Impacts include fish passage impediments, bank erosion, high sedimentation, and/or channel confinement (incision, fence revetment or bank protection structures).
