Arborist Report

Project: Patterson Place Apartments

Project # 2037-01-CU20

Date: February 8, 2021

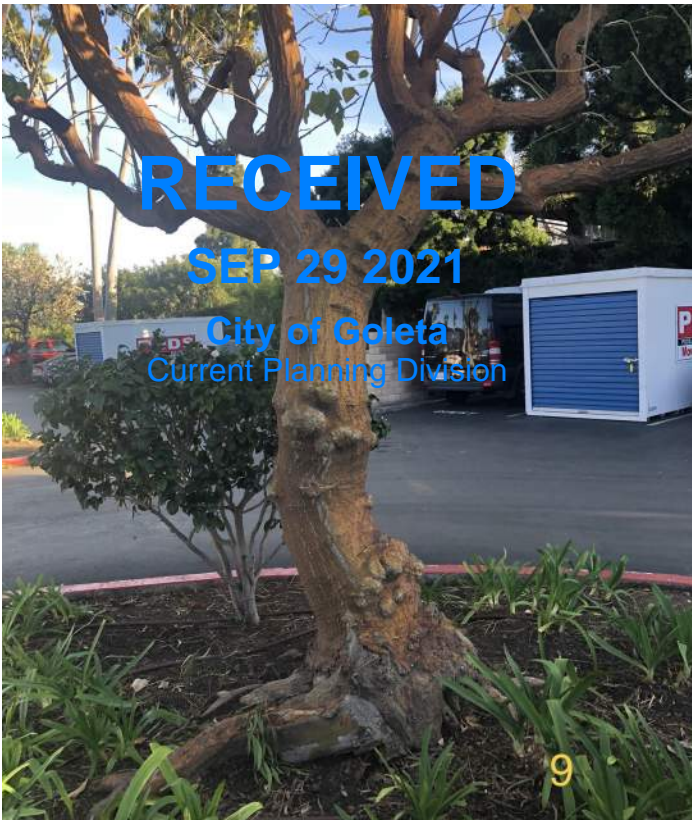
South African coral tree in the parking lot showing signs of root pruning and decay around the root collar.

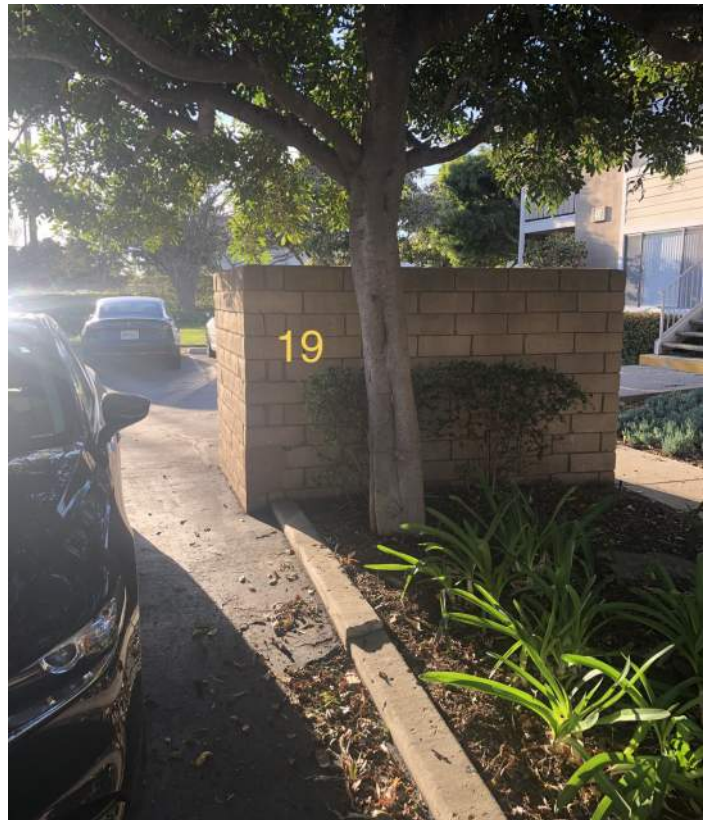
Typical example of AC pavement upheaval and curb damage from underground surface roots.

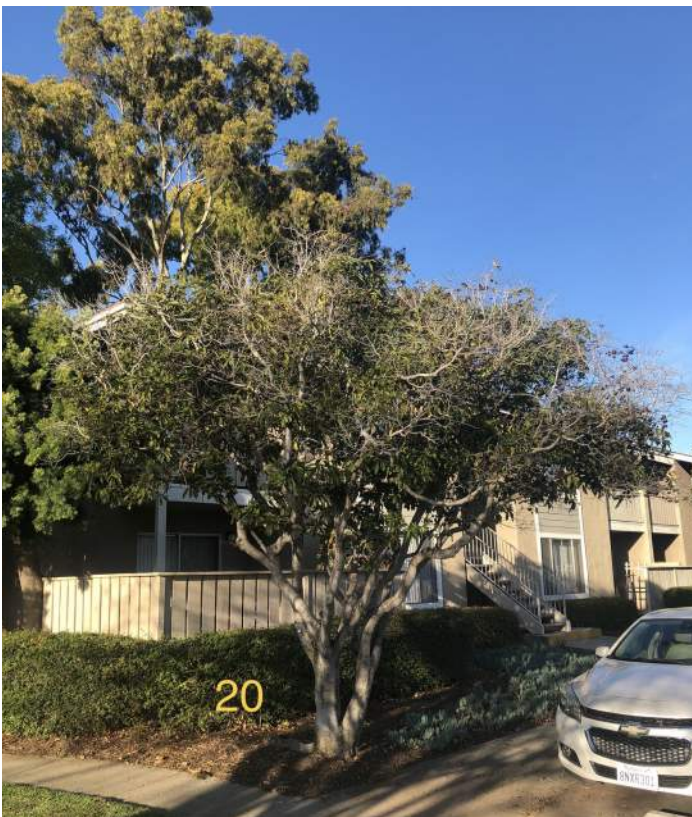
Typical example of the declining Victorian box trees observed. The crown is thinning and dying back from the tips of the branches towards the center of the crown.

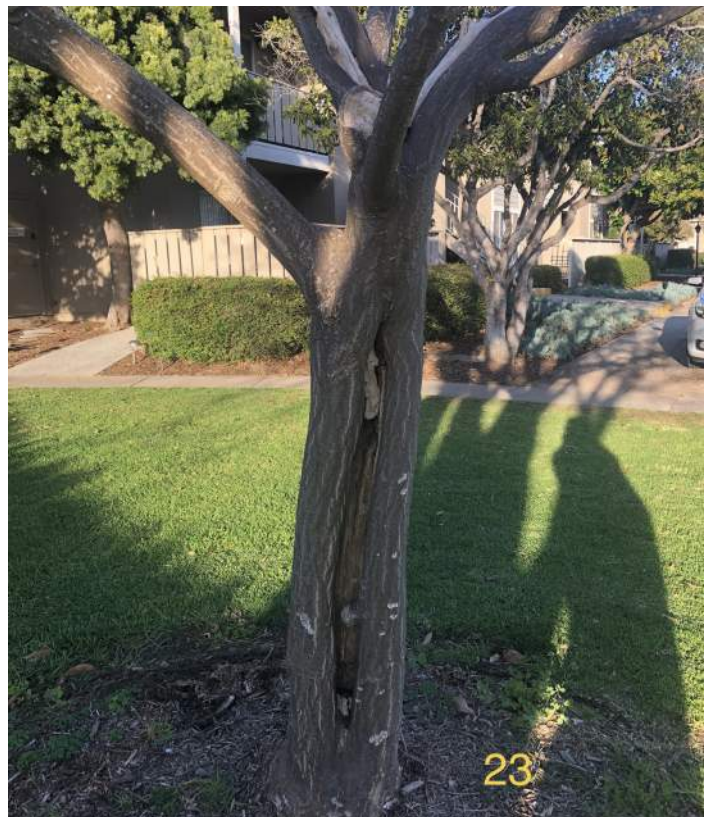
Observations: Many specimens were observed with visible decay in the main stem and other leaders. Like the South African coral trees, this species has a moderate-weak branching structure, that leaves it susceptible to failure if other structural defects are present.

Exposed heartwood and visible decay is common among the naked coral trees observed onsite.

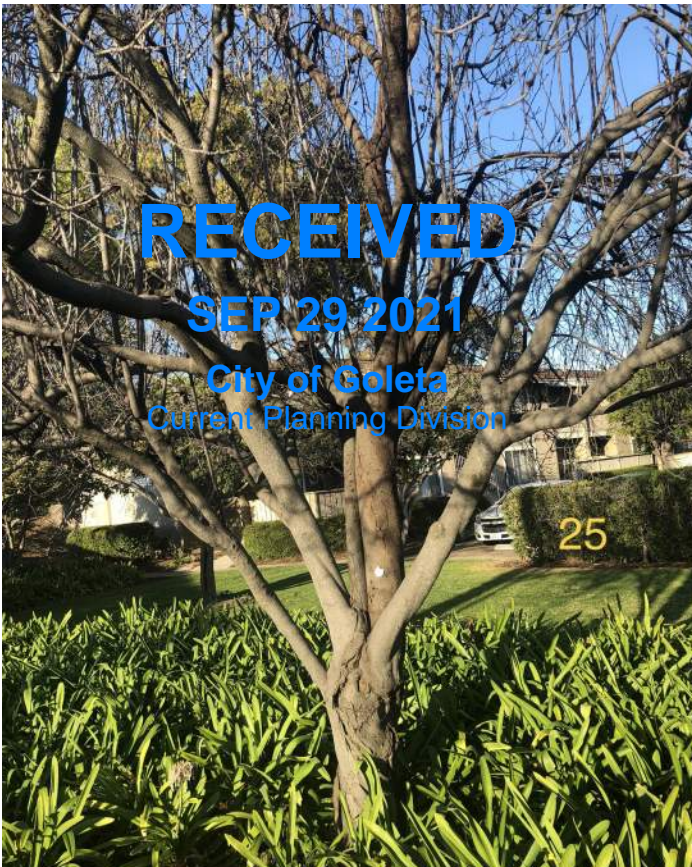
Purple-leaf plum #25 shows visible decay in the tagged leader and moderate dieback in the crown. This specimen is declining and should be removed.

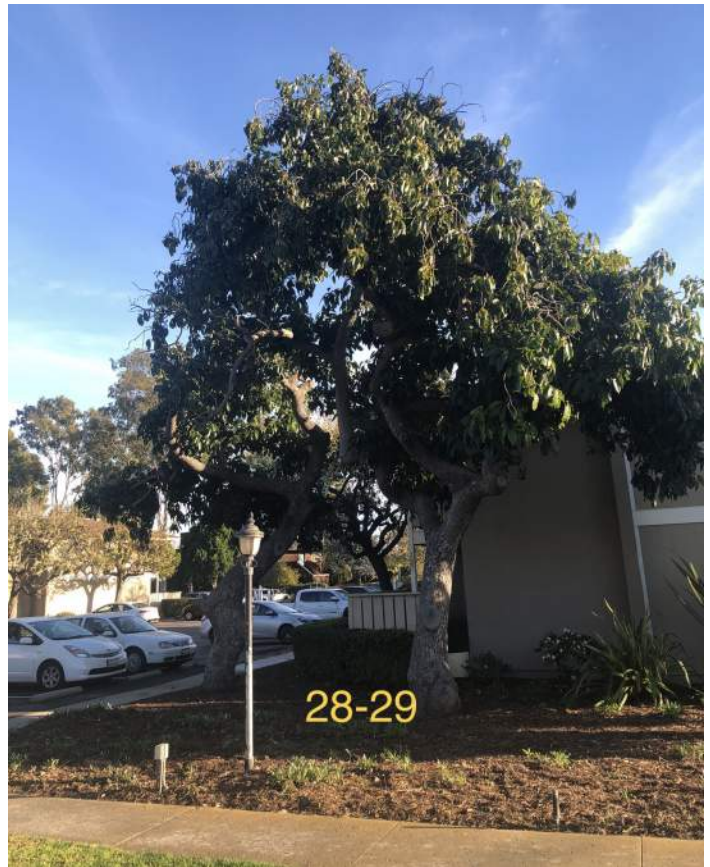
Observations: There are three mature avocado trees located onsite. Although there is no evidence of root rot from the soil surface, it is a common problem for these trees in California and may explain the trees lack of vigor. Trees 28 and 29 appear to be at least 50 years old, which is

well past their expected commercial production lifespan of 35-40 years. Tree 58 is in moderate condition and may be younger than the others.

These are 2 of the 3 avocado trees onsite. They show signs of stress, which is likely attributed to extensive pruning and lack of water. Removal is not necessary at this time, but they should be monitored for signs of decline.

Recommendations: Consider the replacement of trees 28 and 29 with a more suitable species. Continue to monitor trees 28 as 1 matures.

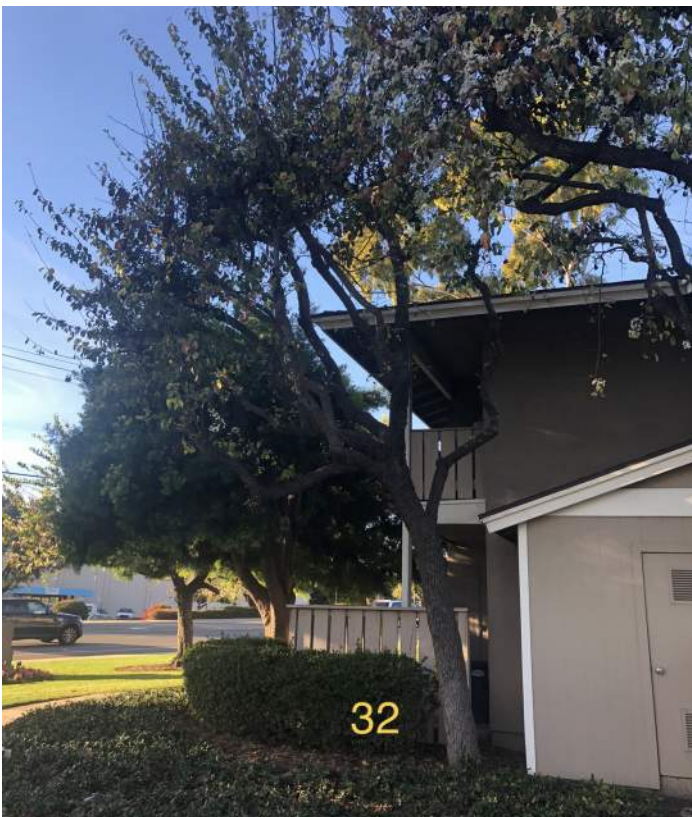
This is a typical example of the many evergreen pears that are planted too close to structures. These specimens should be considered for replacement further from the structures they are currently crowding.

Recommendations: Consider removal of the specimens located within 48" of structures and continue to monitor the remaining specimens. Consider the establishment of a replacement plan to replace these specimens with a more suitable species. The remaining specimens should be pruned on a regular schedule to maintain their size and shape and mitigate premature failure of new attachments during storm events. Each winter, blighted shoots should be removed with sterile tools and a dormant treatment for fire blight should be applied. Reduce the use of high nitrogen fertilizer near the evergreen pears to limit new growth in the spring that is easily infected. As trees are removed, consider replacement with *Pyrus calleryana* 'Capitol,' a columnar pear that is known to be resistant to fire blight and has a crown with a more suitable shape for this dense site.

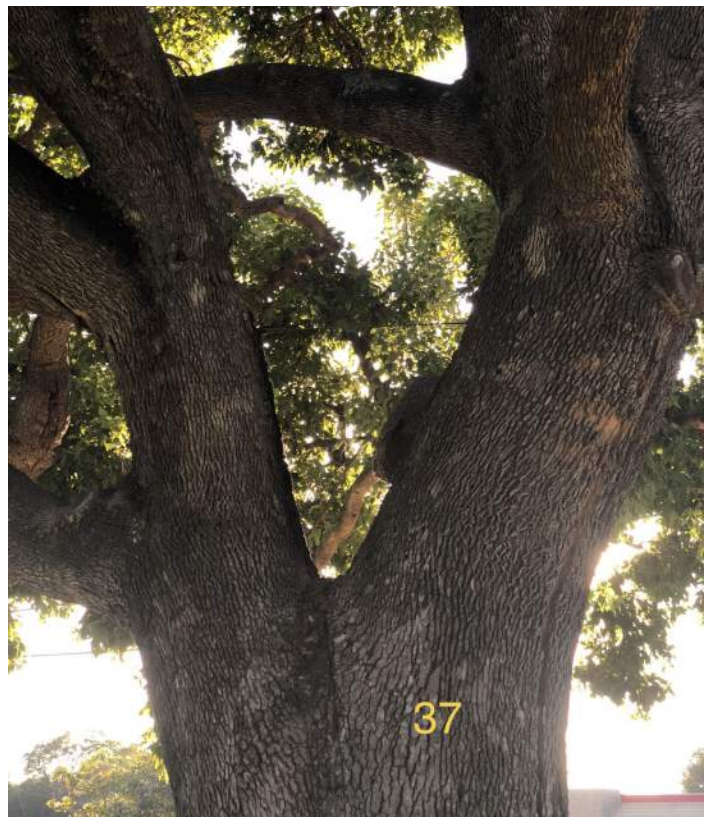
Observations: This is a beautiful mature red flowering gum specimen. Preservation will require some attention to preserve the weak attachment at the lowest crotch. It looks like the tree was cabled many years ago when it was much younger.

This image shows the cabling that was performed on this tree many years ago to add strength to this weak attachment. The tree has outgrown this cabling location and should be cabled higher in the crown to provide additional support. 22

Recommendations: One or two additional cables installed higher in the crown would help balance wind forces throughout the crown.

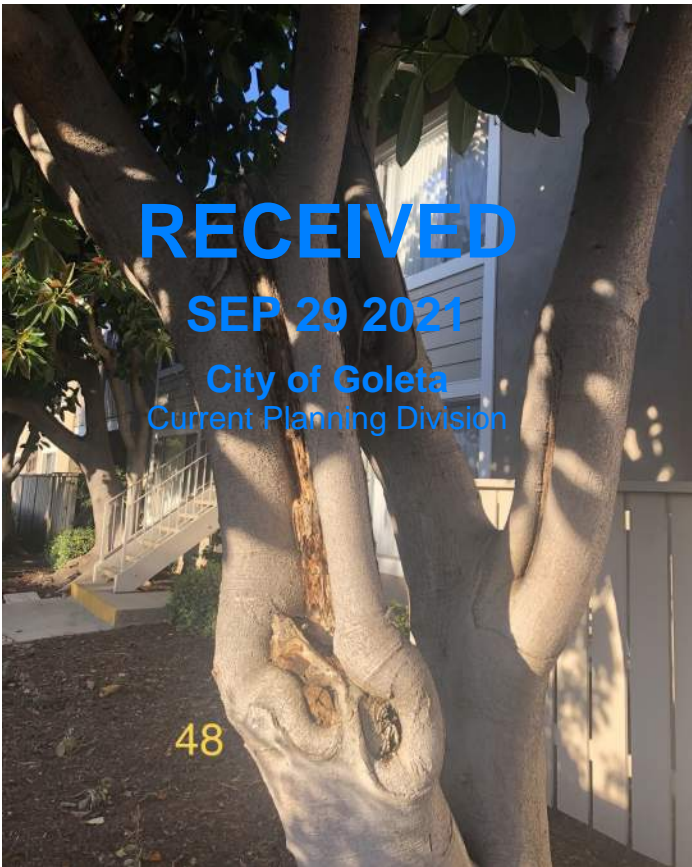
This is a typical image of the exposed heartwood and visible decay present on the rubber trees onsite. This damage likely stems from a long history of overpruning to maintain the small size they exist in today.

Recommendations: These trees are severely damaged from many years of overpruning and their surface roots will continue to damage nearby hardscape and building foundations as they mature. Consider the establishment of a replacement program to replace these specimens with a more suitable species.

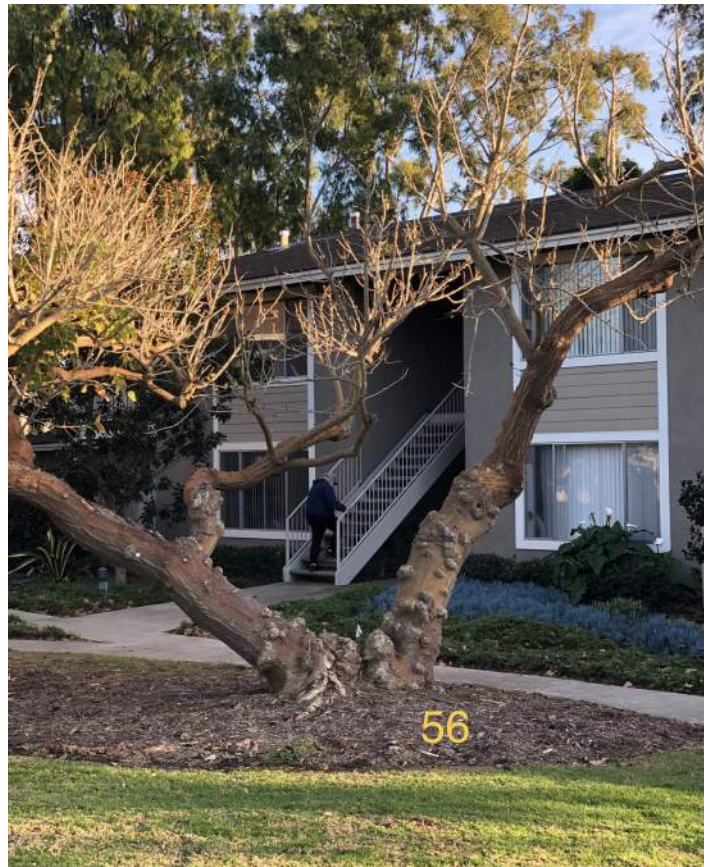
This is a typical image of the larger South African coral trees onsite. It's evident that a long history of overpruning has kept these trees small and created the strange form and character seen onsite.

Recommendations: Specimens with moderate structure in larger areas should remain, but those in confined spaces or with structural defects should be considered for removal.

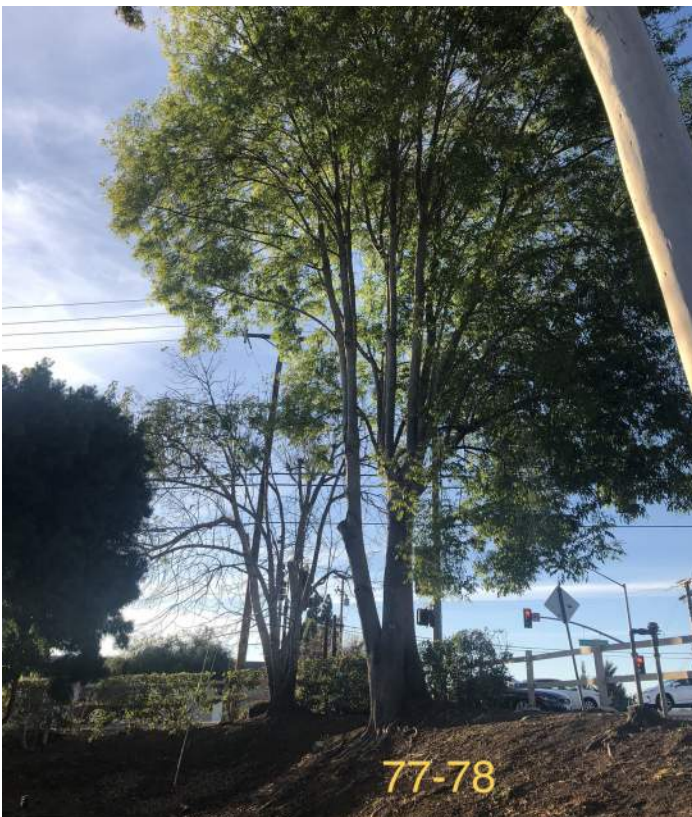
These large ash trees are likely mature volunteers from years ago. This is a typical form of the evergreen ash and their attachments tend to hold up well over time. They are located close to the public sidewalk and utility lines, which limits their preservation suitability.

Recommendations: Both trees should be monitored for stability. Tree 78 may be considered for removal by the local utility.

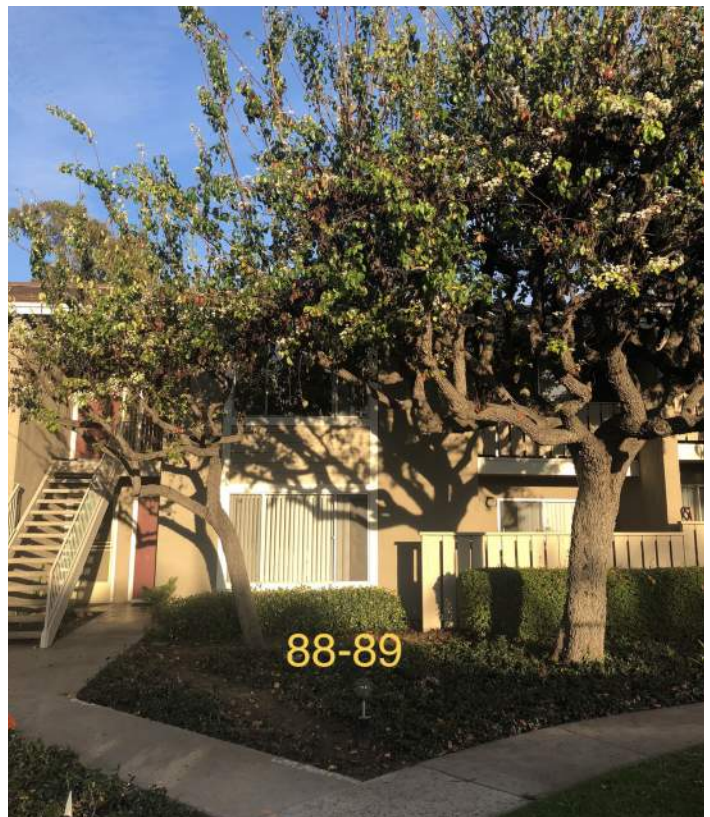
This image shows the variability of blight observed in the pears onsite. The mature tree 89 (right) is severely blighted, while tree 88 (left) shows a minor blight issue.

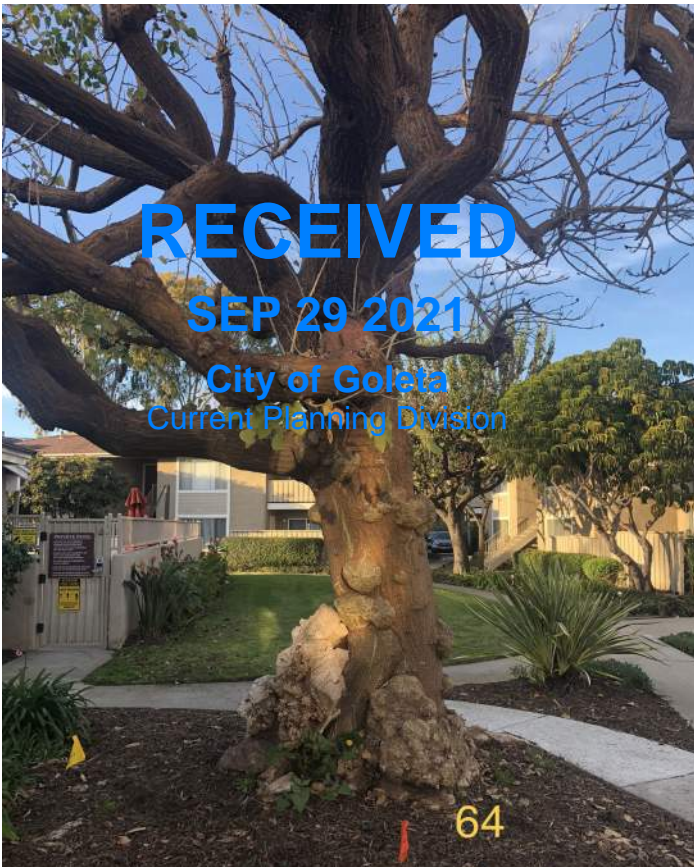
Several South African coral trees were observed with evidence of severe root pruning, or remaining deadwood from the consistent removal of suckers.

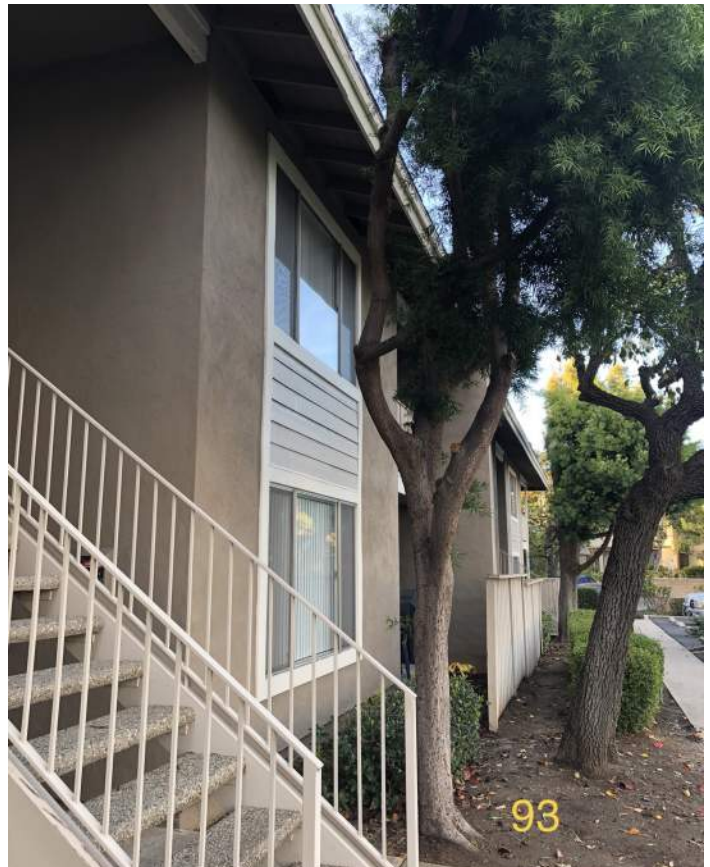
This image represents a the typical planting conditions of the African fern pines observed onsite. Many are severely crowded by adjacent structures and should be replaced further from the structures (or elsewhere onsite) with a suitably sized species.

Recommendations: Many of these trees can remain but will require frequent maintenance to maintain clearance to nearby structures and other trees. Trees located within 36" of a structure should be considered for removal or replacement in a more suitable location onsite.

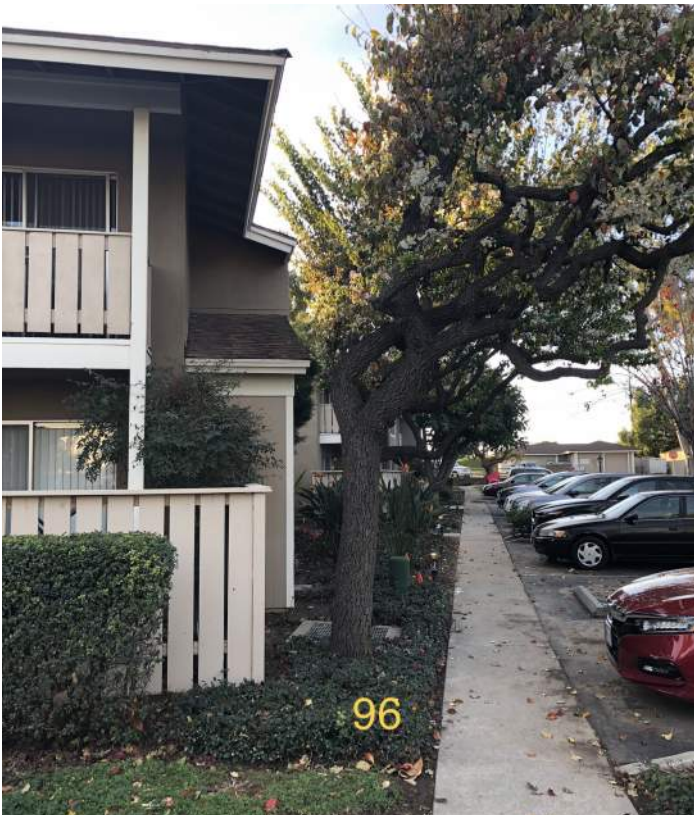
Several of the pears are severely topped and pruned to keep the crown away from the building eaves. These trees are mature and will require extensive maintenance to maintain this form into the future.

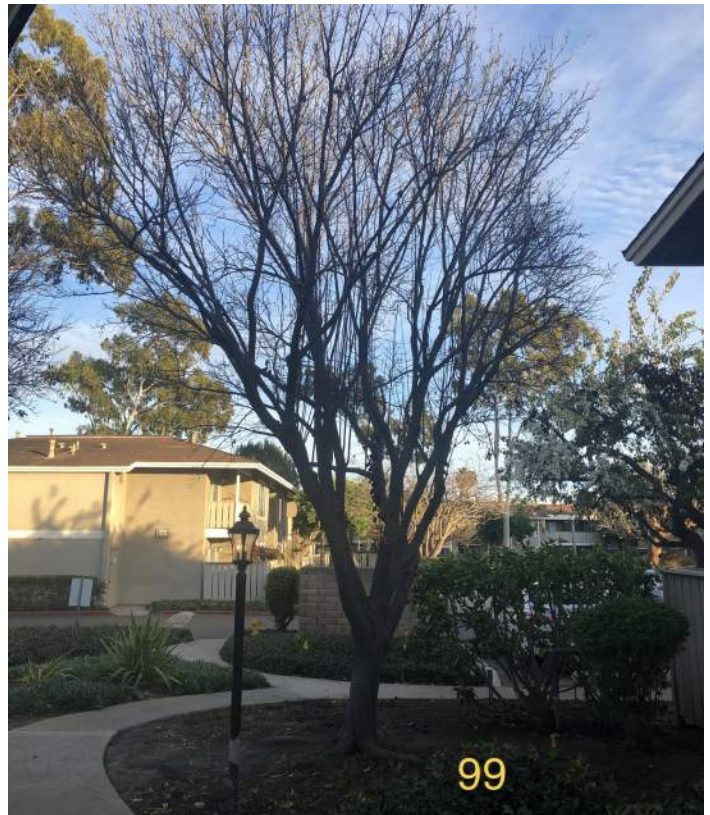
This is a typical image of the stressed purple-leaf plums observed onsite. Note the extensive pruning that has created a vase shaped crown and the resulting stress in the form of severe epicormic growth.

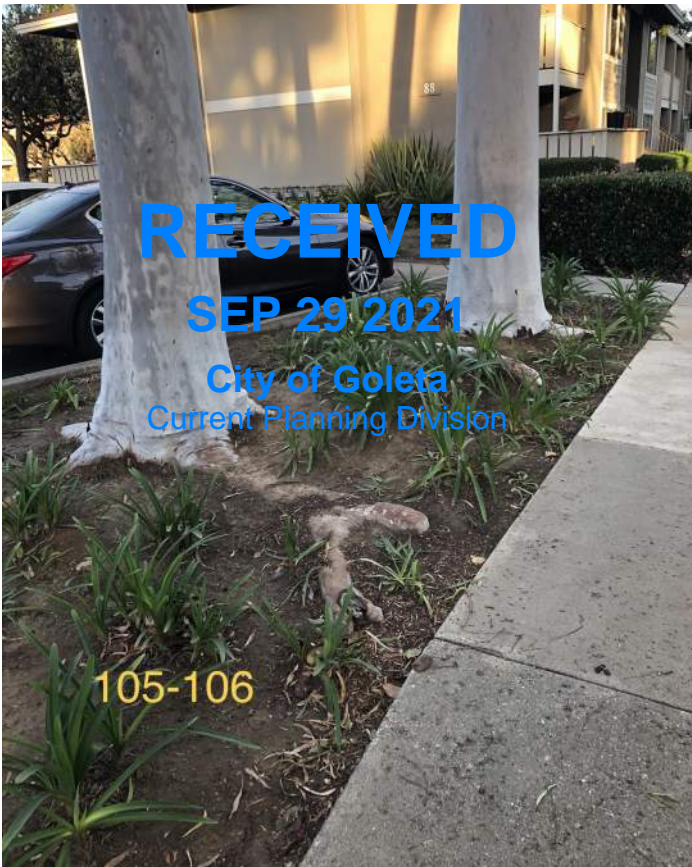
Several specimens showed evidence of root pruning in the critical root zone very close to the root collar. This is commonly performed by concrete contractors when asked to fix damaged hardscape surfaces. It is unlikely that they understand that this can destabilize the tree and will cause long term damage.

This image shows evidence of root pruning on these stressed lemon scented gums. It's likely the roots damaged the paving, and the paving contractor removed the surface roots to repour the pavement in place.

Recommendations: To mitigate damage from large falling limbs, the lower limbs of these specimens should be pruned regularly to reduce weight or removed completely as the tree matures. Roots should not be pruned to repour adjacent hardscape surfaces because the problem will occur again a few years down the road. Consider the establishment of a replacement plan to replace these specimens with a more suitable species. Given the size and quantity of this species, a phased approach to the replacement plan is recommended, replacing approximately 5 trees per year for the next 5 years.

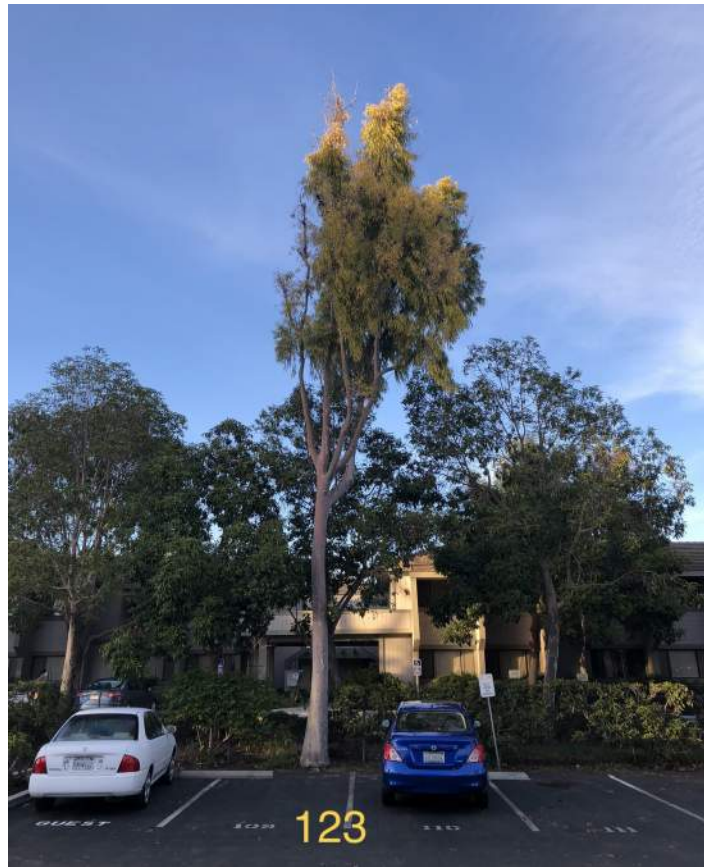
Many of the lemon scented gums are in moderate condition with minor signs of crown dieback. Tree 123 is the exception to this. This tree shows signs of decline and should be monitored.

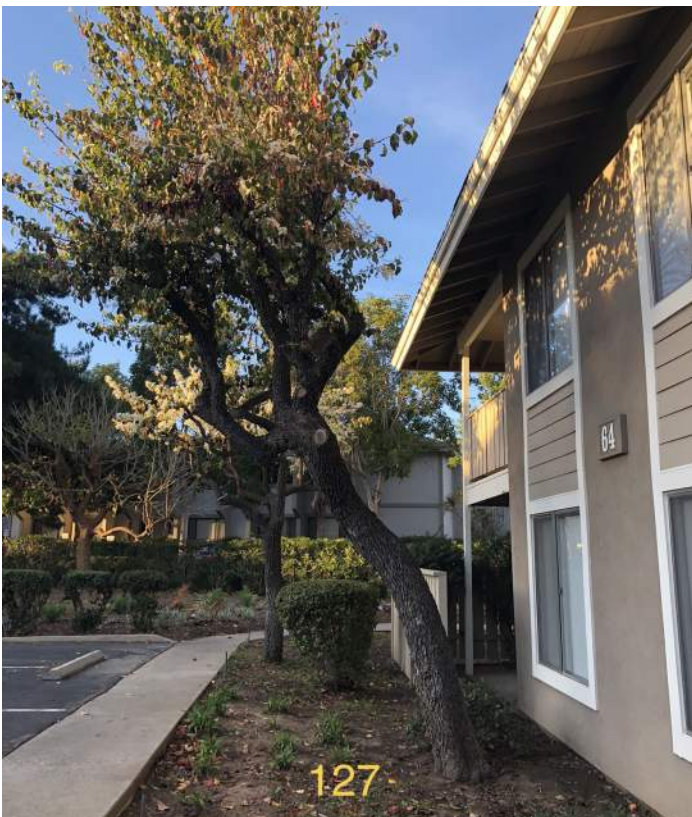
This is another example of the pears that are severely crowded by structures and have been extensively pruned to maintain adequate distance. This is a good candidate for replacement.

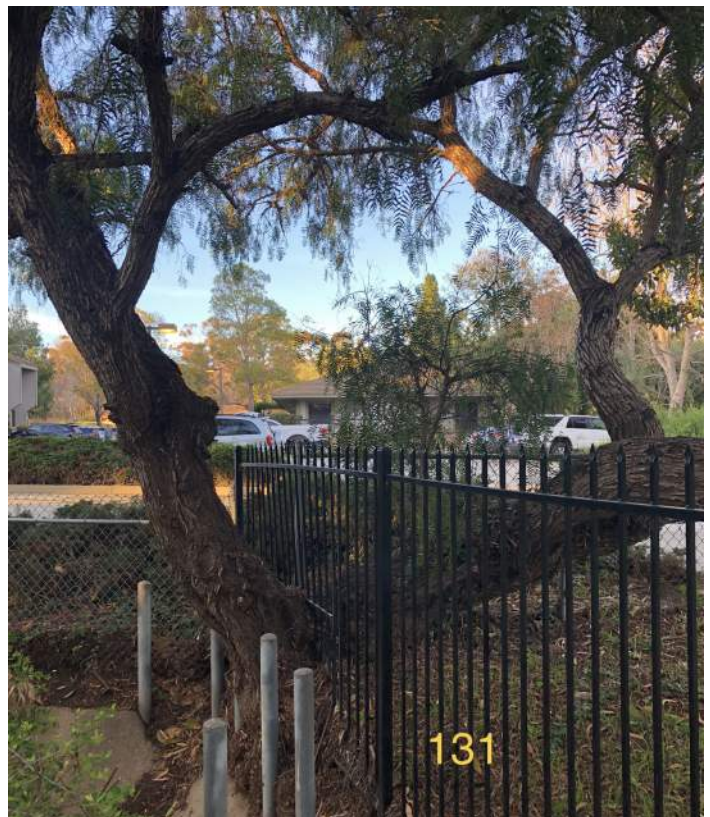
This California pepper tree appears to be a volunteer. It is damaging the wrought iron fence and may damage the large drain inlet in the future. It should be considered for removal.

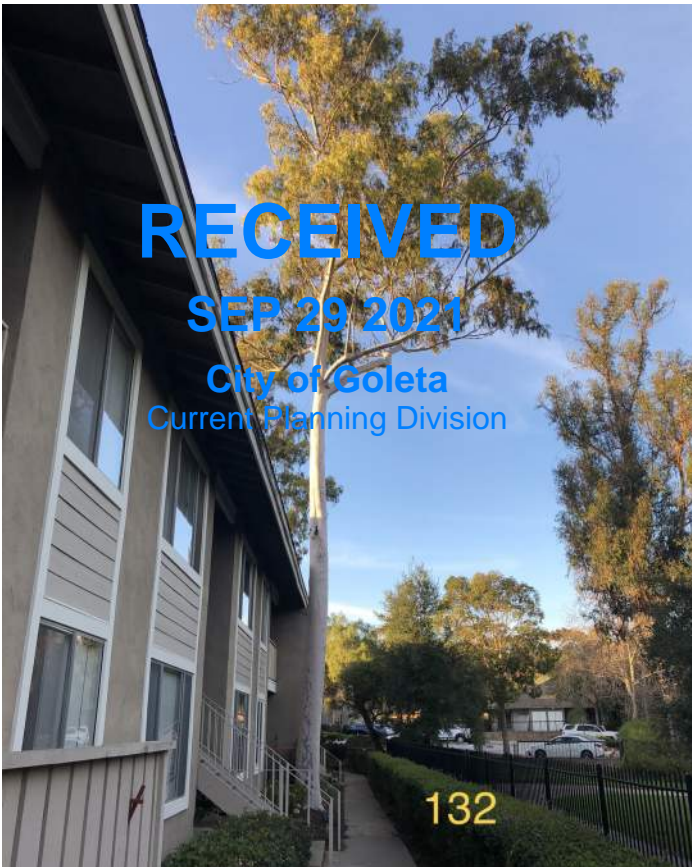
There are several lemon scented gums that are located very close to structures and the crowns have grown past the eaves. Although not currently posing a major threat to the structure, as the trunk diameter increases over time it may begin to conflict with the structure.

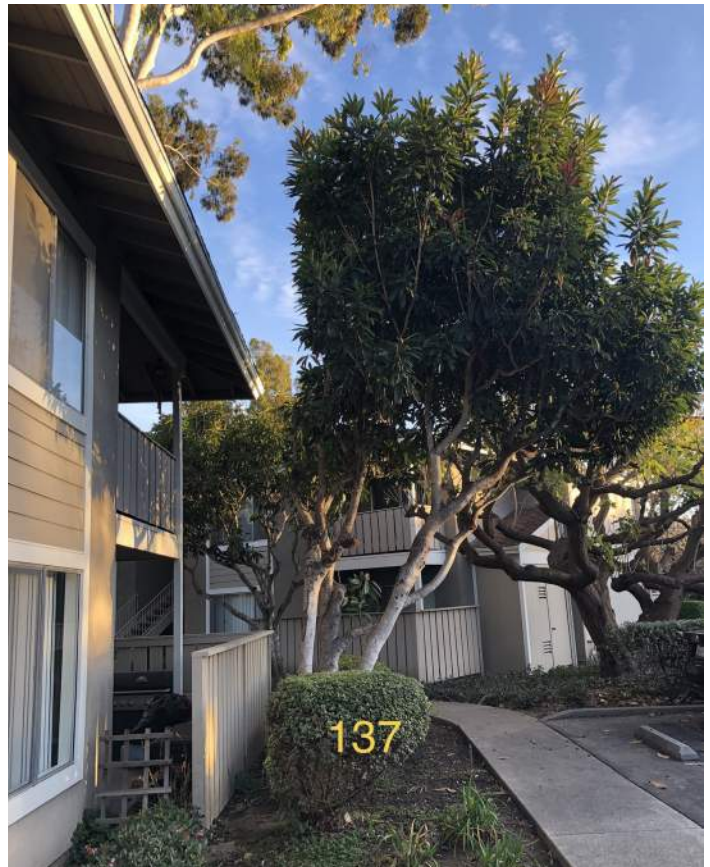
This is a typical image of the multi-leader bronze loquat trees observed onsite. Most have matured only to be topped and reduced to maintain clearance from the structure.

Recommendations: Consider removal of the specimens located within 48" of structures and continue to monitor the remaining specimens. Consider the establishment of a replacement plan to replace these specimens with a more suitable species.

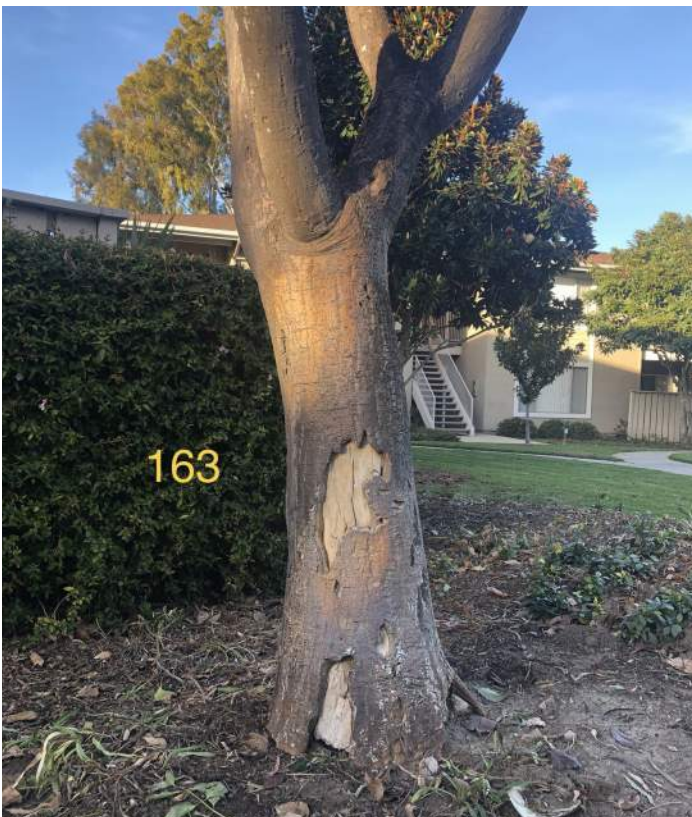
Tree 163 was the only hazardous specimen observed onsite. There is visible decay around the root collar, which has created stability issues. This tree should be removed.

Recommendations: Tree 163 has extensive structural defects and should be removed immediately. Other specimens with visible decay should be considered for removal to mitigate risk associated with tree or limb failures.
