**Lead-Based Paint Survey**

**Goleta Train Depot  
27 South La Patera Lane  
Goleta, California, 93117**

**November 30, 2023**

**APEI Project No. 14242.00**

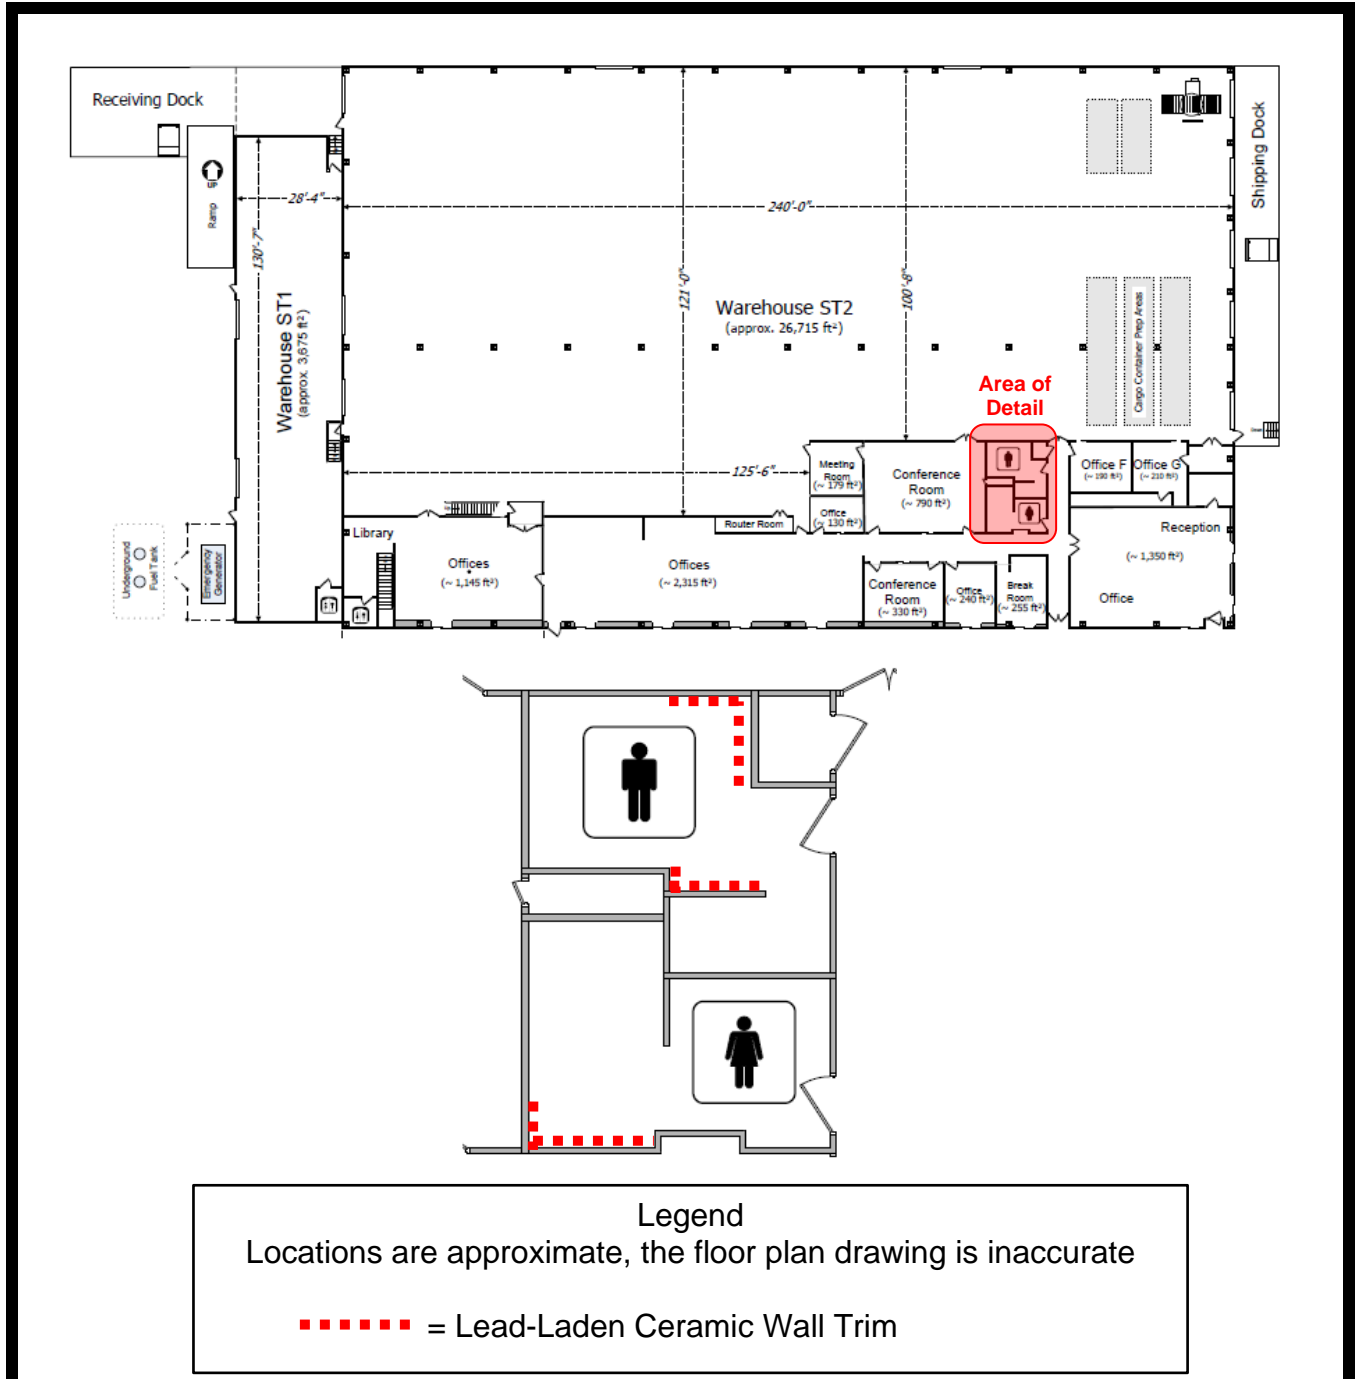
Figure 1: Location of Lead Containing Component  
Date Sampled: November 16, 2023  
Scale: None  
Project: Goleta Train Depot  
Project Number: 14242.00

Based on XRF measurements, lead-based paint above the regulatory action level was detected only in the interior ceramic wall trim in the men's and women's bathrooms in the office area. There was approximately 120 square feet of this material. Appendix C contains a drawing of the location of this material and Appendix D contains photographs of the material.

Lead-based paint above the regulatory action level was detected only in the interior ceramic wall trim in the men's and women's bathrooms in the office area. There is approximately 120 square feet of this material. Appendix C contains a drawing of the location of this material and Appendix D contains photographs of the material. The following lists detail the XRF readings that were identified as lead containing. Appendix B contains the complete list of all XRF results both positive and negative.

- The only identified lead based paint component was the lead-laden ceramic wall trim in the office area men's and women's bathrooms. There was approximately 120 square feet of this material on several of the walls in these rooms.
- The lead-laden ceramic wall trim in bathrooms were non-friction surfaces and warrant no immediate removal in its current intact condition. Occupants should be advised of the presence of lead in this material. This component should be removed by a California licensed lead abatement contractor prior to the planned demolition of the Building. It is advised that the removal of the lead-laden ceramic tile be added to the scope of work for the asbestos abatement since most contractors who remove asbestos also remove lead-based paint components.

- Until the lead-laden ceramic wall trim is removed, it is advised that it be maintained in good condition. Never sand, dry scrape, power wash, or sandblast any painted surfaces unless they have been tested and have no lead. Lead dust from the paint can spread and poison your family, workers, and neighbors. In the human body, low levels of lead damage the brain and nerves in fetuses and young children, resulting in learning deficits and lower IQ.
- Because of the scattered testing protocol and the consistent and definable nature of the results, untested components are assumed to follow the same pattern.

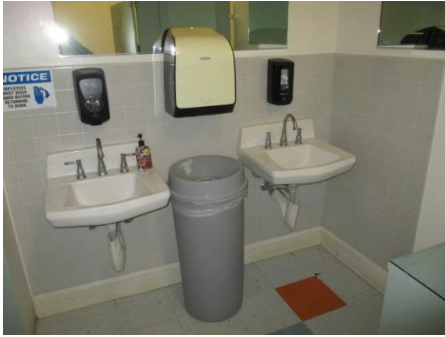
Lead-laden ceramic wall trim in the men's bathroom behind and next to sinks.

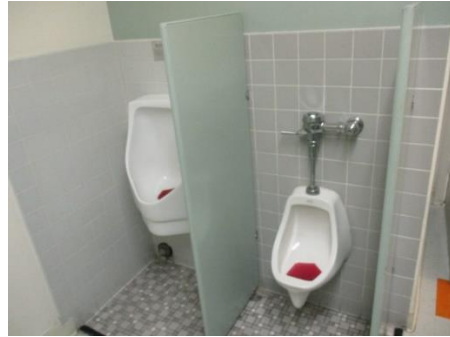
Lead-laden ceramic wall trim in the men's bathroom behind and next to urinals

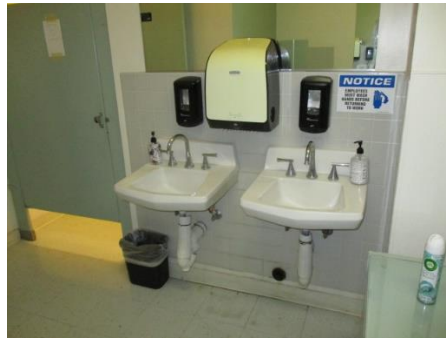
Lead-laden ceramic wall trim in the woman's bathroom behind and next to sinks.
