**Asbestos Survey and Hazardous Materials Inspection**

**Goleta Train Depot  
27 South La Patera Lane  
Goleta, California, 93117**

**December 6, 2023**

**APEI Project No. 14242.00**

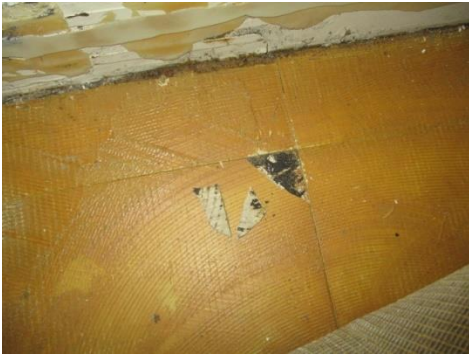
Asbestos was detected in black floor tile mastic in samples 01-1, 10-1, 12-1, and 13-1. Because these were found to contain asbestos, the subsequent black mastic layers from these homogeneous groups were not analyzed (01-2, 01-3, 10-2, 10-3, 12-2, 12-3, 13-2, and 13-3). The mastic was found to contain between three and five percent (3%-5%) chrysotile asbestos. This material was non-friable and was in good condition. There were approximately 7,975 square feet of asbestos containing black mastic in the subject property building.

Because the black asbestos containing mastic remains adhered to the floor tile, even though the floor tile itself does not contain asbestos, it must be treated as asbestos containing during removal.

Asbestos containing black floor mastic and floor tile contaminated with the mastic.

Because the subject property building is to be demolished, a California licensed asbestos abatement contractor must first remove and properly dispose of these materials prior to disturbance or demolition.

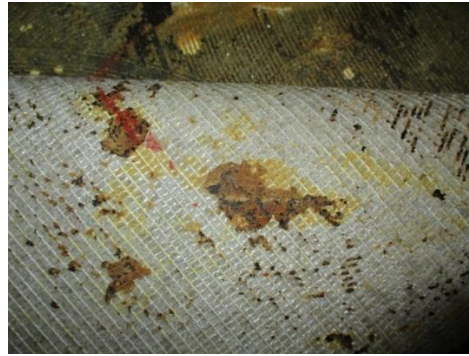
In addition, when peeling back the carpeting to sample the flooring, it was noted that in areas where there was no floor tile below the carpeting and the carpet was placed directly over the black floor tile mastic, the black mastic adhered to the carpeting in some areas. In these instances, the carpet would be contaminated with the asbestos containing mastic and must therefore be removed and disposed of as asbestos containing.

Asbestos containing black floor mastic and carpeting contaminated with the mastic.

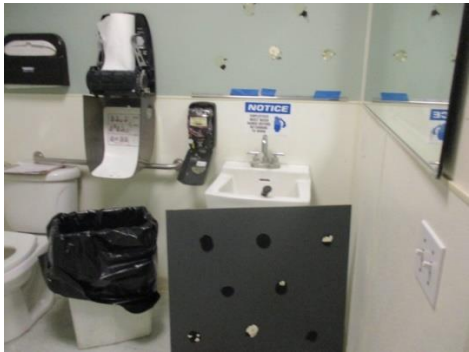
The mastic adhering the mirrors to the walls in the bathrooms (samples 14-1, 14-2, and 14-3) contains five percent (5%) chrysotile asbestos. Because sample 14-1 was found to contain asbestos, samples 14-2 and 14-3 were not analyzed. This material is non-friable and was found to be in good condition. There are an estimated 120 square feet of this material.

Asbestos containing mirror mastic.

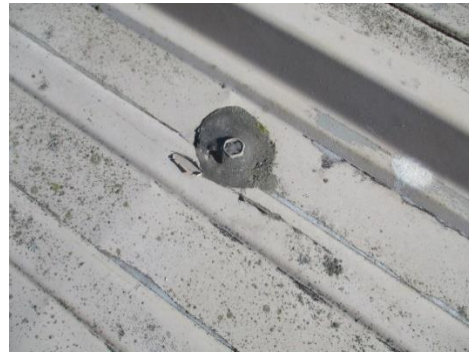
The bolts on the roof that are holding down the sheet metal roof had been sealed with a roof tar (samples 19-1, 19-2 and 19-3) that contains five percent (5%) chrysotile asbestos. Because the first sample of this tar was found to contain asbestos, the subsequent samples were not analyzed. This material is located throughout the roof where there is a small dollop of tar sealing each bolt. This material is non-friable and was found to be in good condition.

Asbestos containing roof tar sealing bolts penetrating the roof.

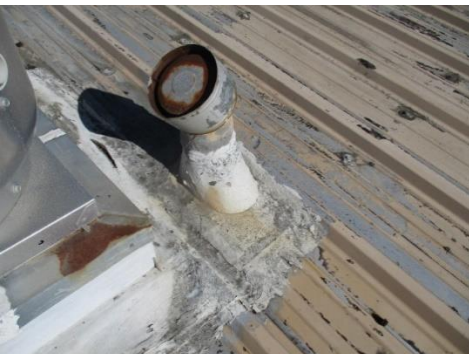
A flue that runs through the building and through the roof (sample 22-1) contains thirteen percent (13%) chrysotile asbestos. This material is located near the office bathrooms and is presumed to run from the floor through the roof of the building. This material is non-friable and was found to be in good condition. There is an estimated thirty feet of this four inch diameter flue.

Asbestos containing transite flue on roof.

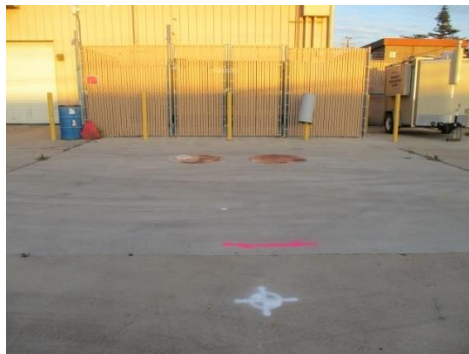
1,800 gallon diesel UST.

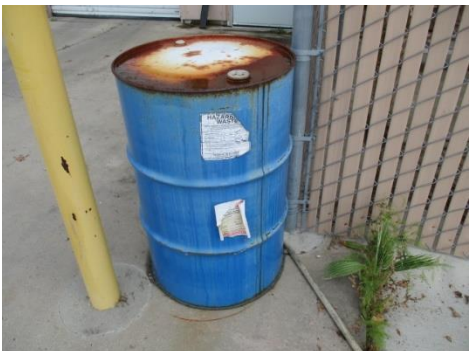
One 55 gallon drum labeled, "Hazardous Waste" was observed next to the emergency generator on the west side of the subject property building. The specific contents were not identified on the container. There were no signs of spills or releases from this drum. If the contents of this drum were not a result of work performed by, or for, the City of Goleta, then it is advised that the subject property tenant be asked to define its contents and remove the drum. If the drum is not the responsibility of the tenant, then its contents must be tested by the City and the material be properly removed and disposed of.

55 gallon drum of unknown contents labeled as hazardous waste.

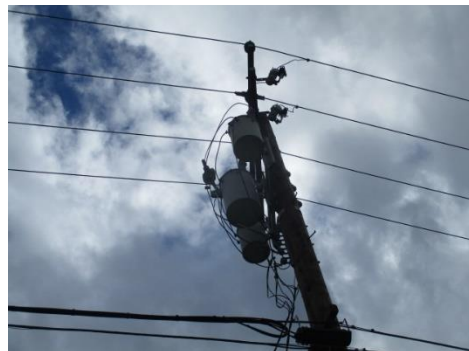
Six pole-mounted electrical transformers were observed along the south subject property border. PCBs were typically removed from transformers in the southern California area in the late 1970s and early 1980s. The units appeared in good condition and evidence of leaks was not observed. These transformers are the property of the Southern California Edison (SCE), the electrical utility. It is the responsibility of SCE to remove these from the subject property and properly handle or dispose of the hydraulic fluids.

Pole-mounted transformers along the south subject property border.

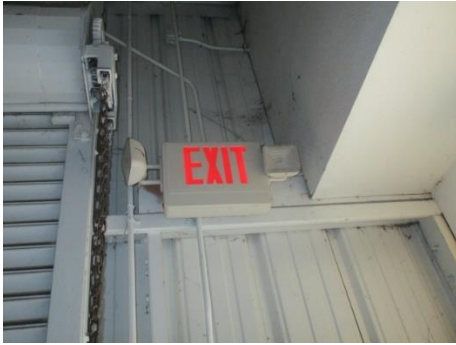
Typical battery powered exit sign and emergency lights.

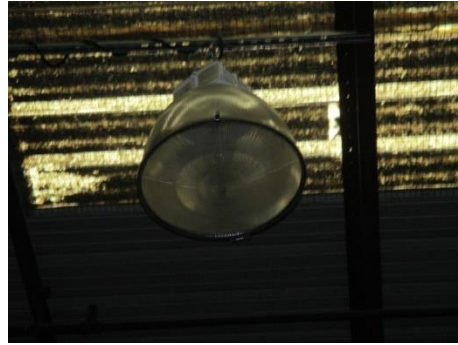
Where feasible, it is advised that all mercury lights be reused. Mercury vapor lights were observed in the warehouse areas of the Building. The presence of mercury vapor lights in the Building is not a threat to the health of the tenants or the environmental integrity of the Property. Their disposal, however, is regulated.

Mercury vapor light in the warehouse.

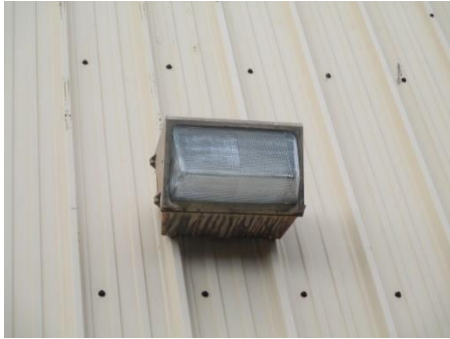
Where feasible, it is advised that all mercury, sodium, or halogen lights be reused. These types of lights were observed mounted on the exterior walls of the Building. The presence of these lights is not a threat to the health of the tenants or the environmental integrity of the Property. Their disposal, however, is regulated.

Mercury, sodium, or halogen light on exterior of building.

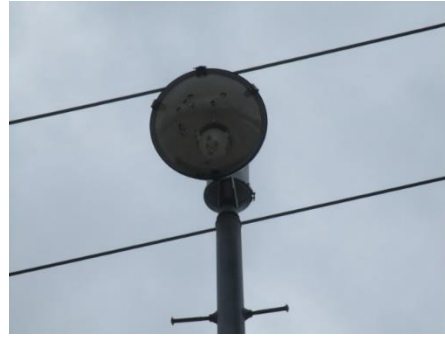
Unidentified exterior light type on pole.

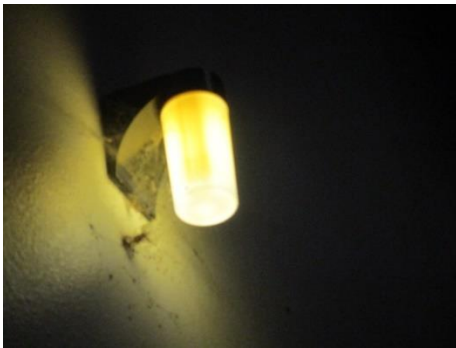
Unidentified light type inside the subject property building.

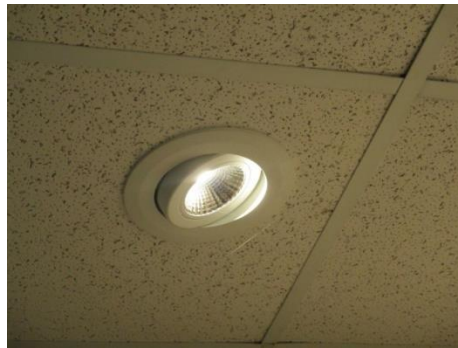
Unidentified light type inside the subject property building.
