ENGINEERING

NORTH SLOPE FIRE STATION #10

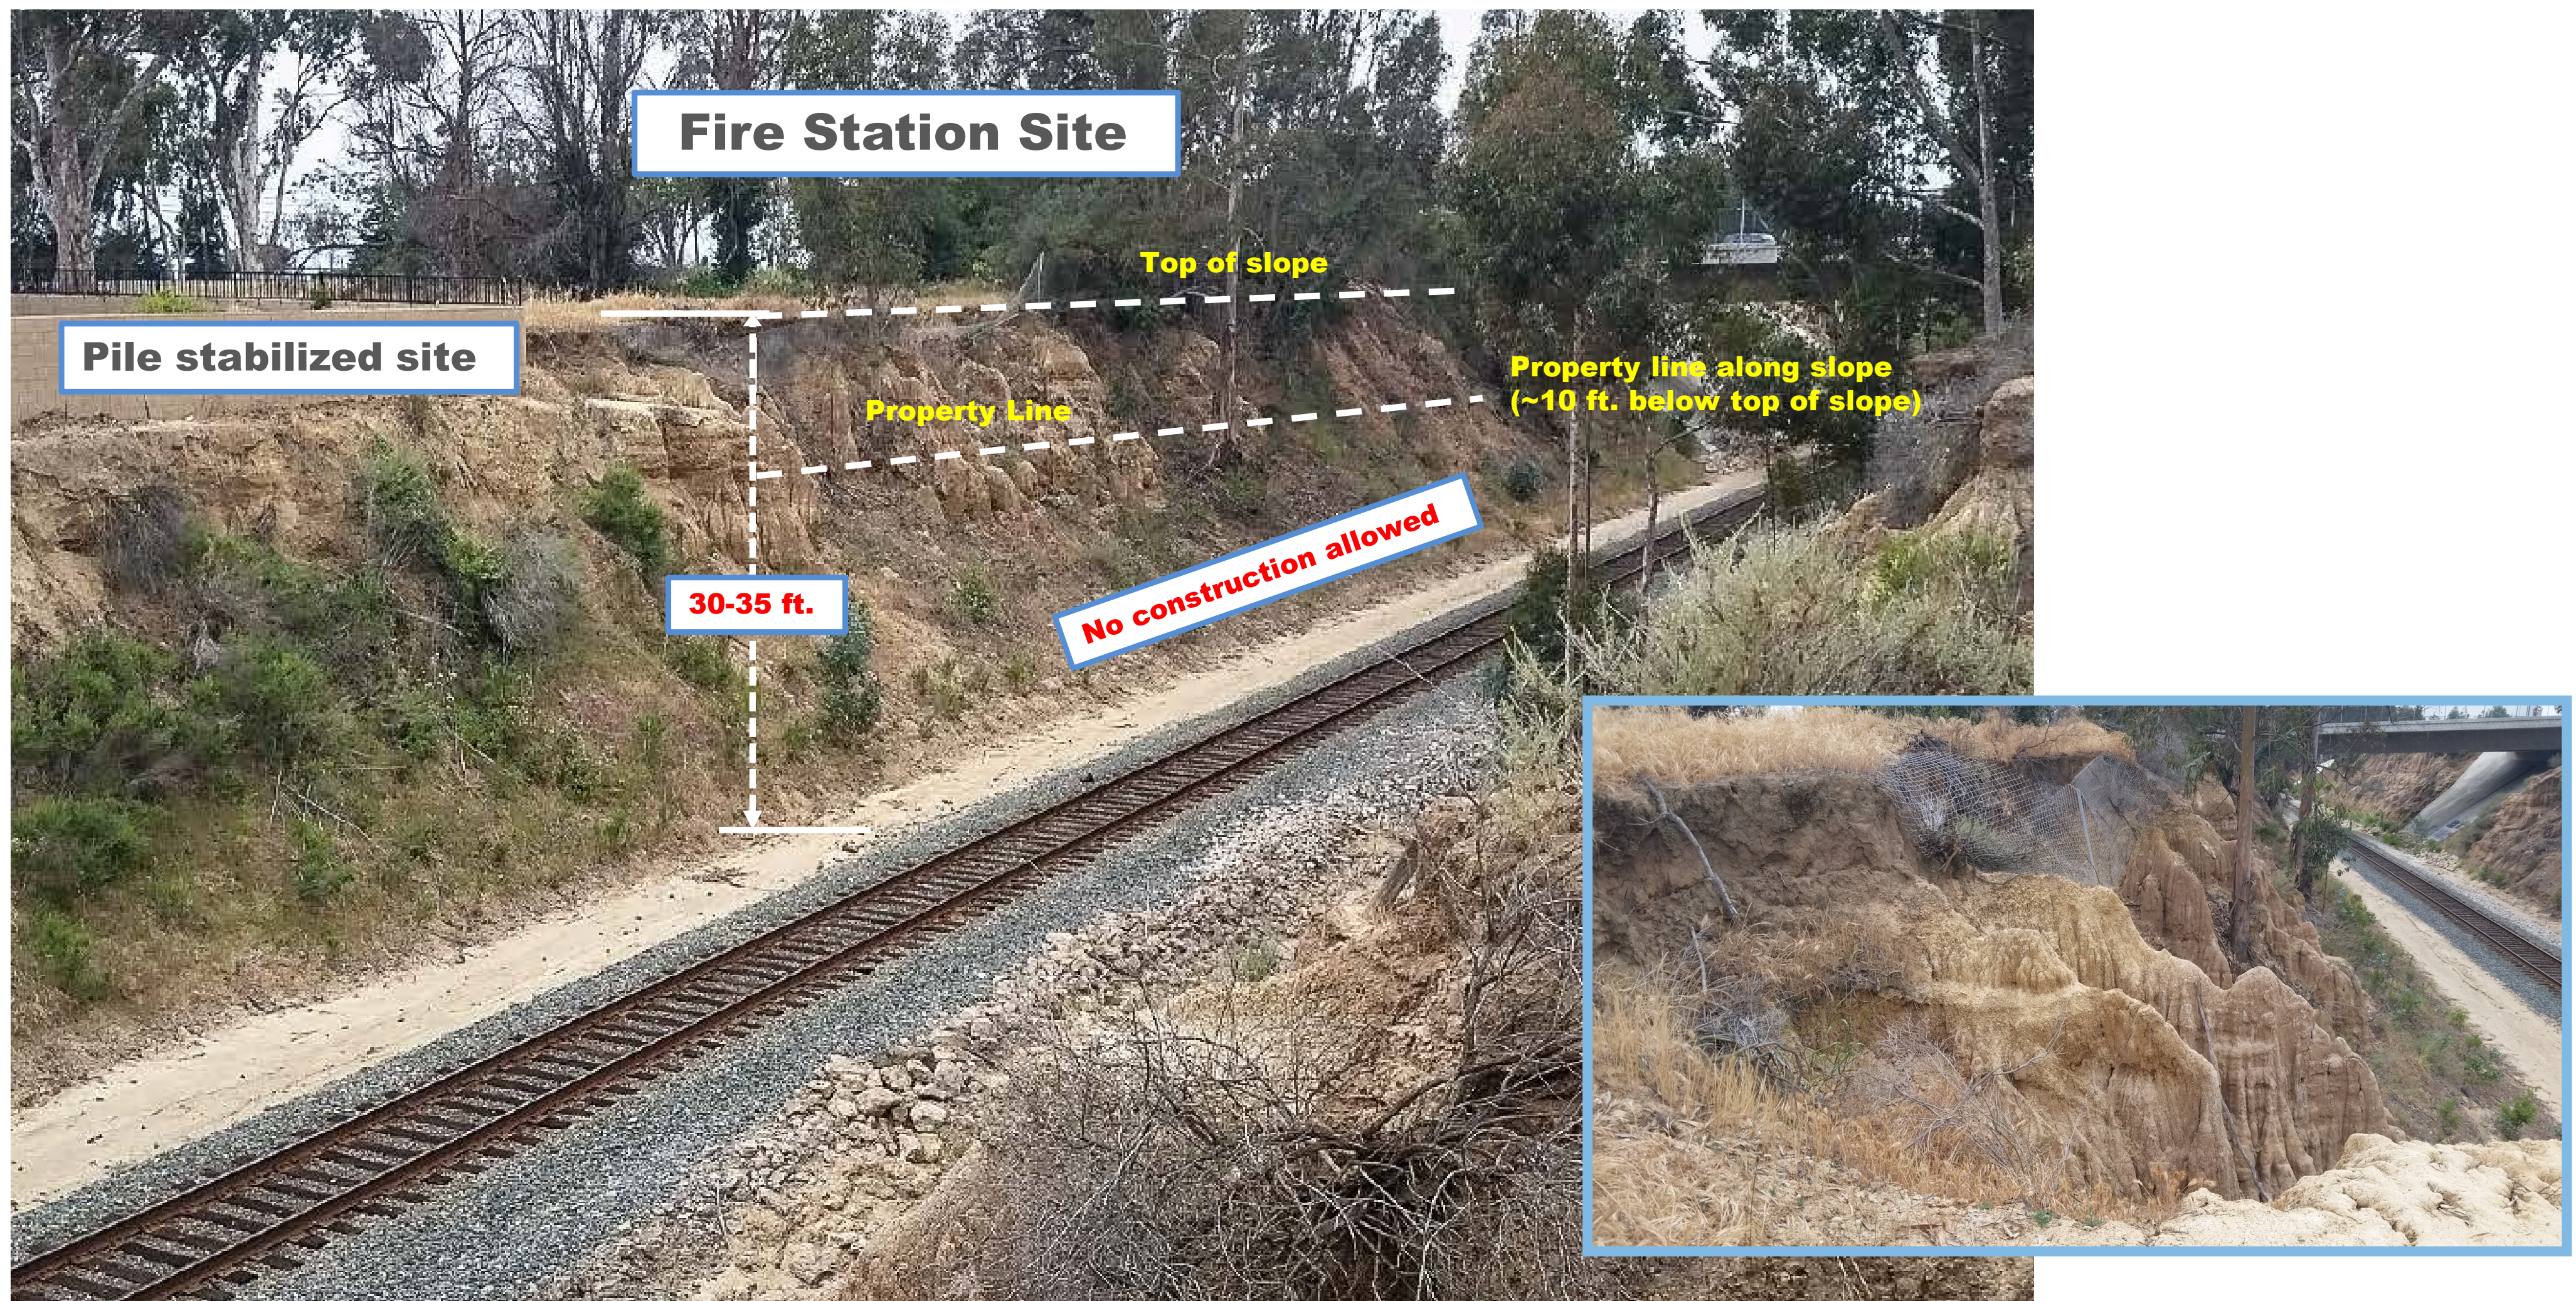
EXISTING SLOPE CONDITION - Erosion Prone Marine Terrace Deposits (sands and silts), requires stabilization
