Historic Resource Potential Impact Study

POTENTIAL IMPACT STUDY

GOLETA COMMUNITY CENTER GOLETA, CALIFORNIA [16128]

FEBRUARY 2017

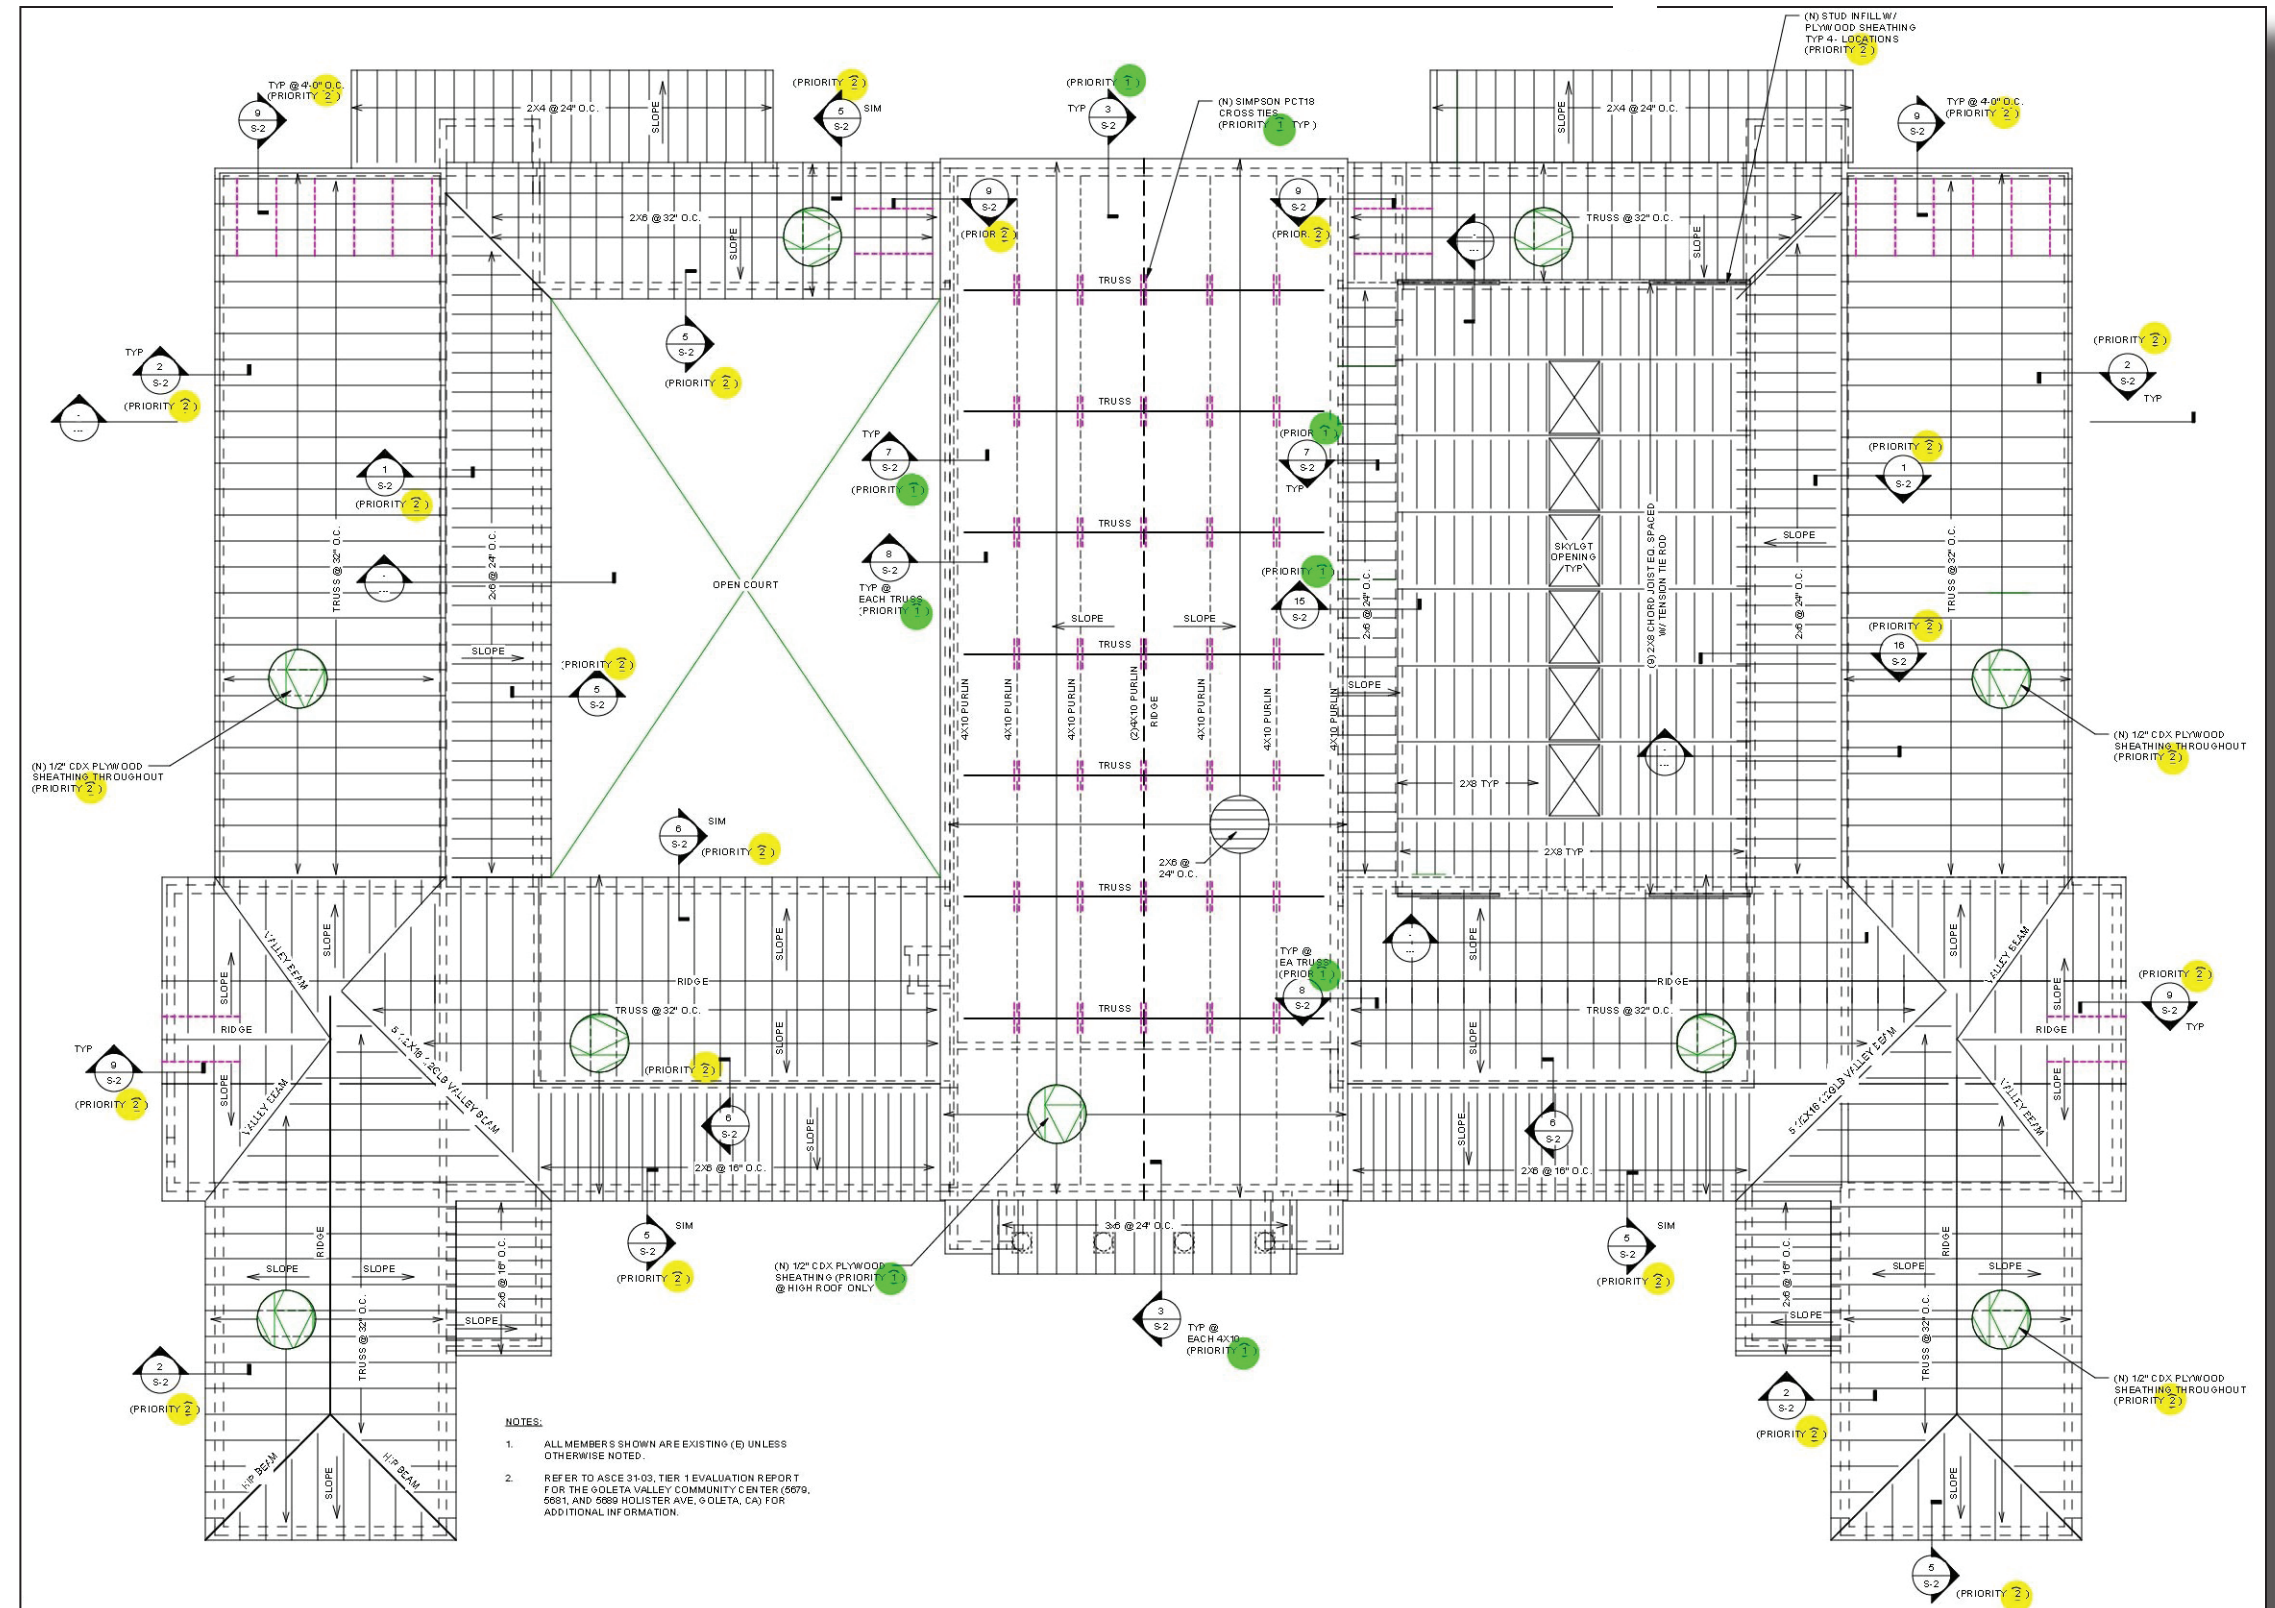
Figure 14. Seismic Assessment for Building A, Adapted from Crosby Group, ASCE 31-03 Tier 1 Evaluation Report, Goleta Valley Community Center, report (2013).

In April 2013, Crosby Group completed an ASCE 31-03 Tier 1 Seismic Evaluation. The Crosby Group report identified components that currently do not comply with ASCE 31-03 and categorized the deficiencies by priority (**Figure 14**). Priority 1 items are considered to be of greatest risk to life-safety and are limited to deficiencies in the Auditorium, including inadequate truss-to-wall connections; non-compliant roof diaphragms; and inadequate connection of roof diaphragms to walls. Priority 2 items include strengthening roof diaphragms at the remainder of the building and improving the connection between diaphragms and walls throughout the Main Building; these items are ad-

Below are more detailed discussion of the three upgrade components to address Crosby Group's Priority 1 deficiencies.

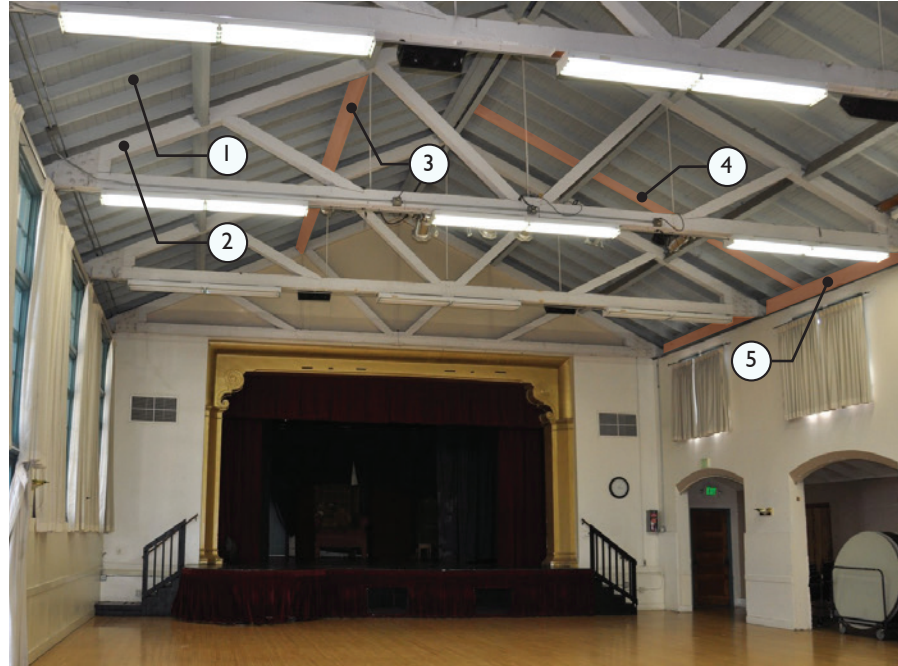
Figure 15. Auditorium, annotated with key framing elements.

- ① Exposed 2x6 Wood Tongue and Groove Sheathing
- ② 6x8 Truss Member, Typical
- ③ 4x10 Purlins, Typical
- ④ 2x6 Rafters, Typical
- ⑤ 4x beam on 2x sill at East and West Walls

- The new plywood should be added from the top or roof side to keep the Auditorium's exposed ceiling visible. The plywood proposed is typically 1/2 inch thick and should not impact the visual quality of the gable roof form, exterior eaves or exposed wood rafters.
- Nailing of new plywood sheathing from the top should consider the spacing of existing structural members and engage the existing 2 inch x 6 inch rafters below.
- Coordinate the roof diaphragm with roof edge details, like drip edges and gutters, to minimize the thickness of the roof edge.

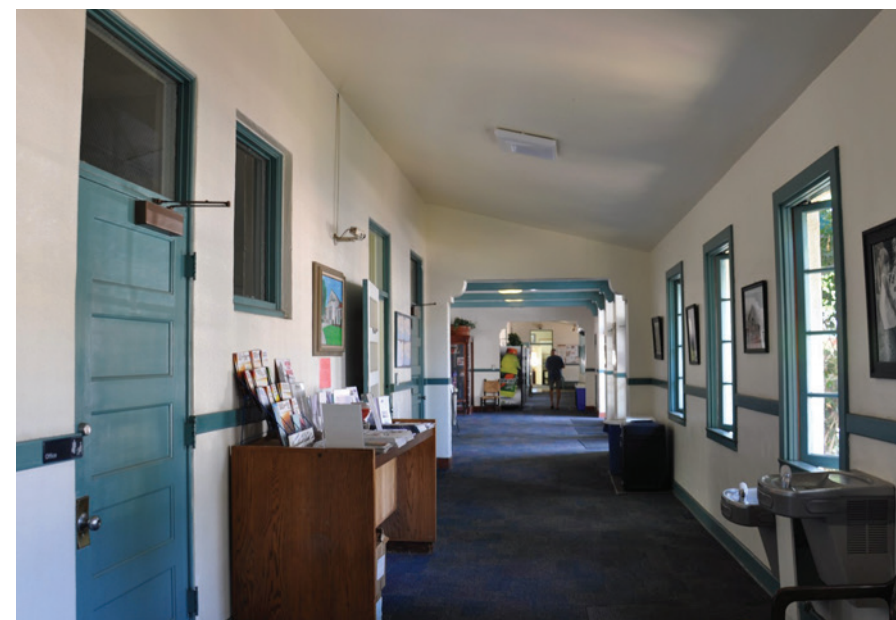
Figure 16. Wood paneled doors and corridors are character-defining features that can be adapted with ADA-compliant hardware.

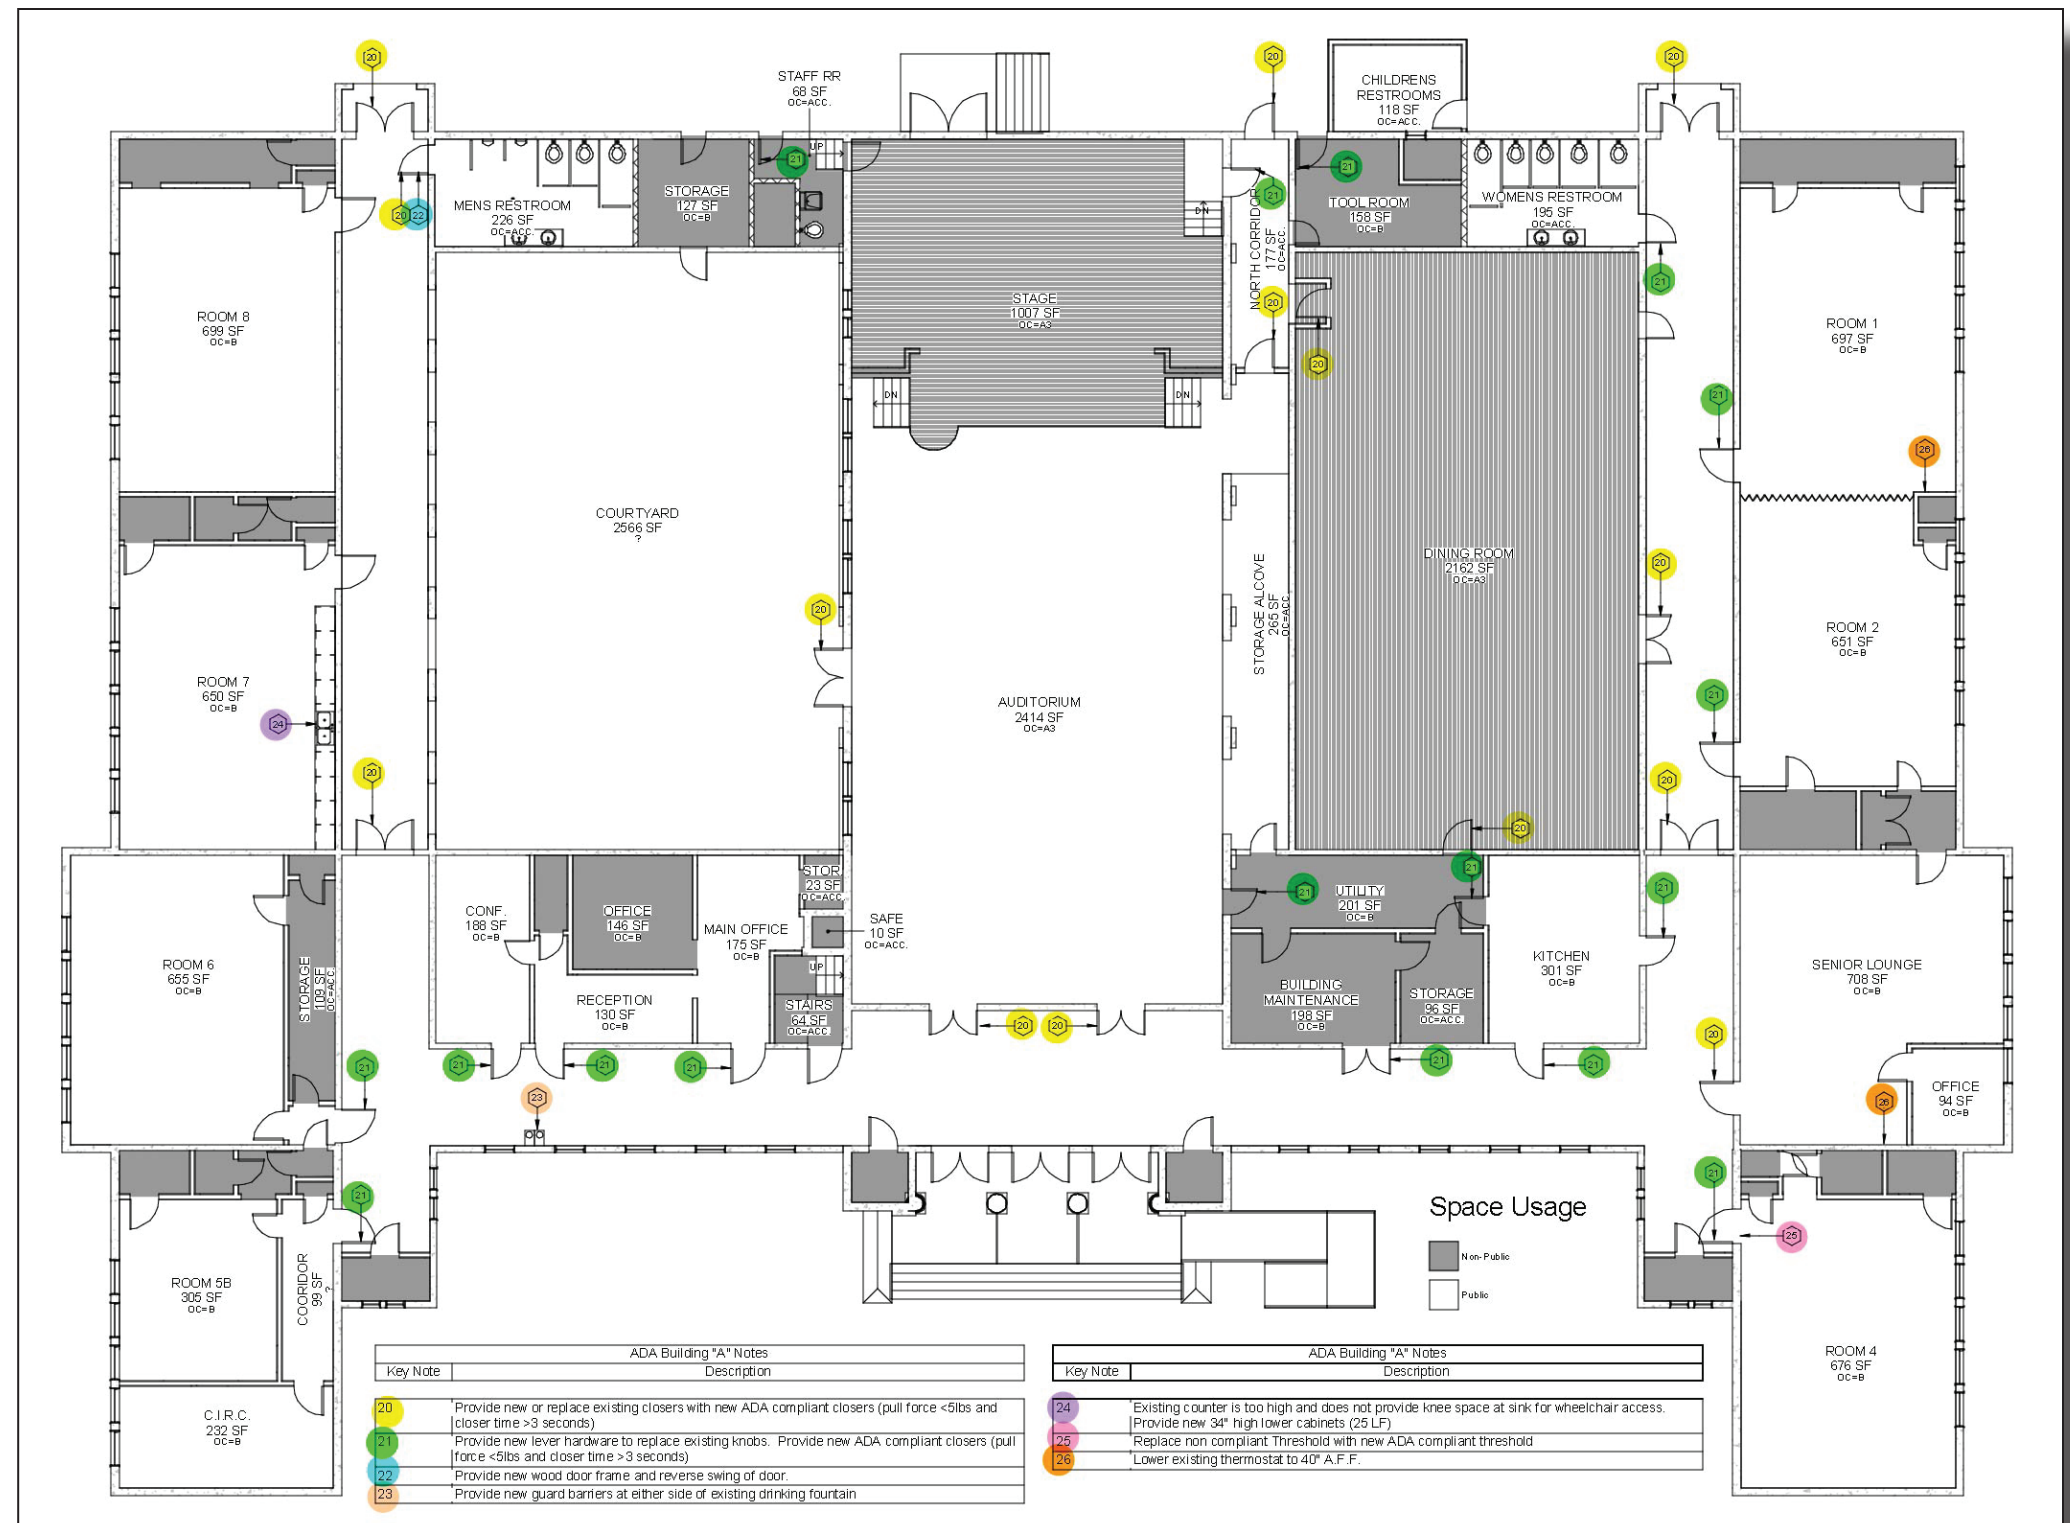
Figure 17. Accessibility Assessment for Building A, Adapted from Crosby Group, *Accessibility Assessment, Goleta Valley Community Center & The United Boys & Girls Club of Goleta*, report (2013).

- 20: PROVIDE NEW DOOR CLOSER
- 21: NEW DOOR LEVER HARDWARE
- 22: NEW DOOR FRAME AND REVERSE SWING
- 23: PROVIDE GUARDS AT DRINKING FOUNTAIN
- 24: PROVIDE ADA-COMPLIANT COUNTER
- 25: PROVIDE NEW THRESHOLD
- 36: LOWER THERMOSTAT BOX

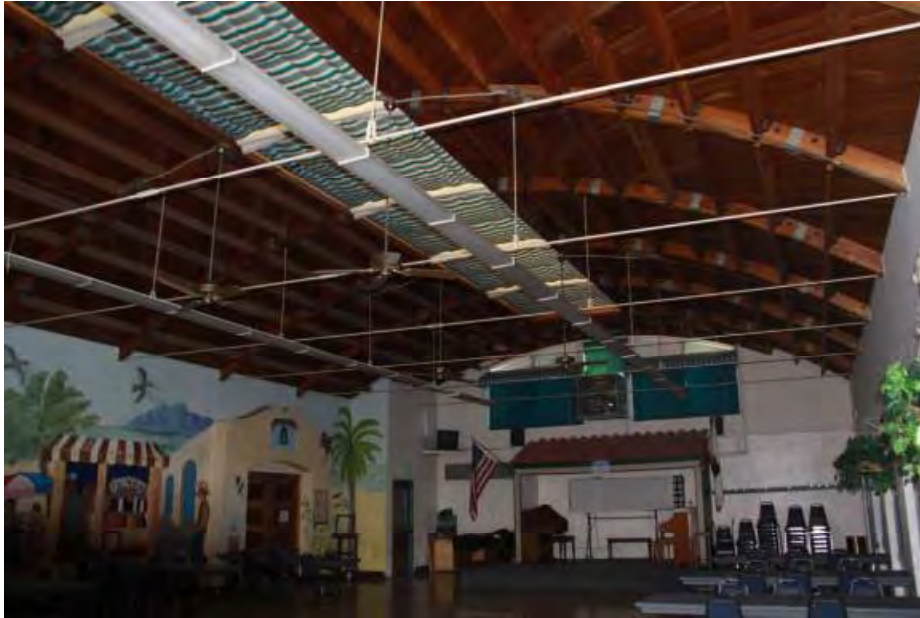
Figure 4 – Building A, Barrel Vaulted Roof Addition

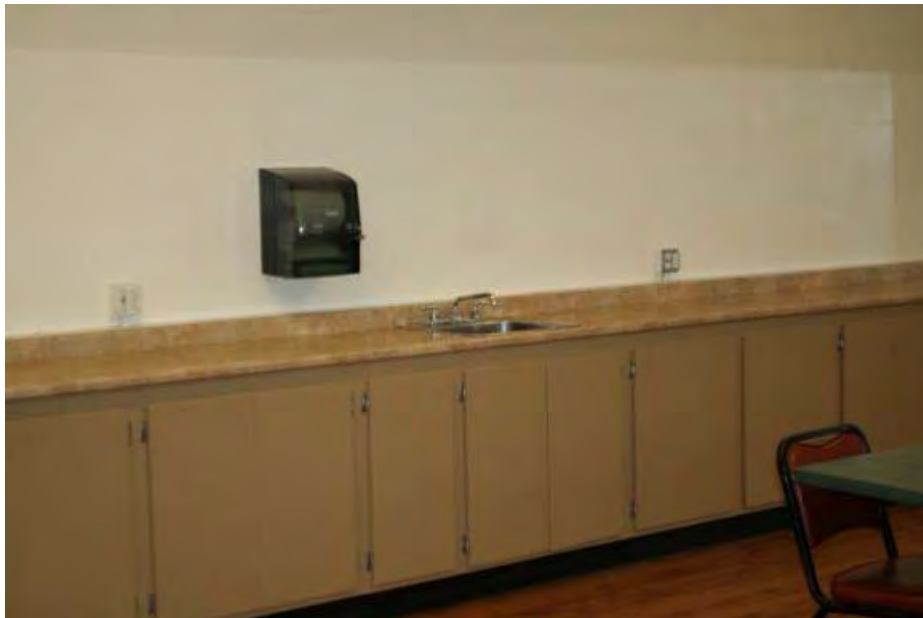
Figure 8 – Building A, non-compliant cabinet and sink
