## Public Workshop #2

Goleta Valley Community Center

February 26, 2020

# CREEK & WATERSHED MANAGEMENT PLAN PUBLIC WORKSHOP

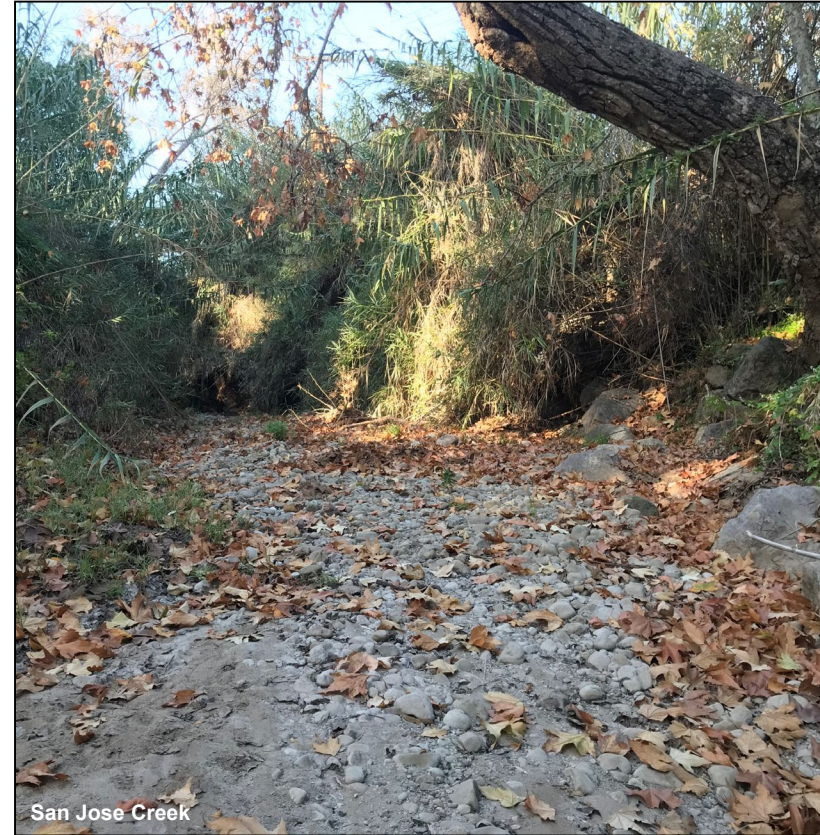
- Approx. 660 acres survey area
- Vegetation/Land Cover Types
- Creek characteristics, such as:
  - Riffles, pools, runs
  - % canopy cover
  - % substrate embeddedness
  - Substrate/soil composition
  - Non-native invasive species
  - Abundances of instream habitat components (e.g., filamentous algae, emergent vegetation, woody debris, live tree roots, artificial structures, undercut banks, etc.)
  - Understory density and structure
- Suitability for plants, benthic macroinvertebrates, invertebrates, fish, amphibian, reptiles, birds, and mammals (including special-status species)

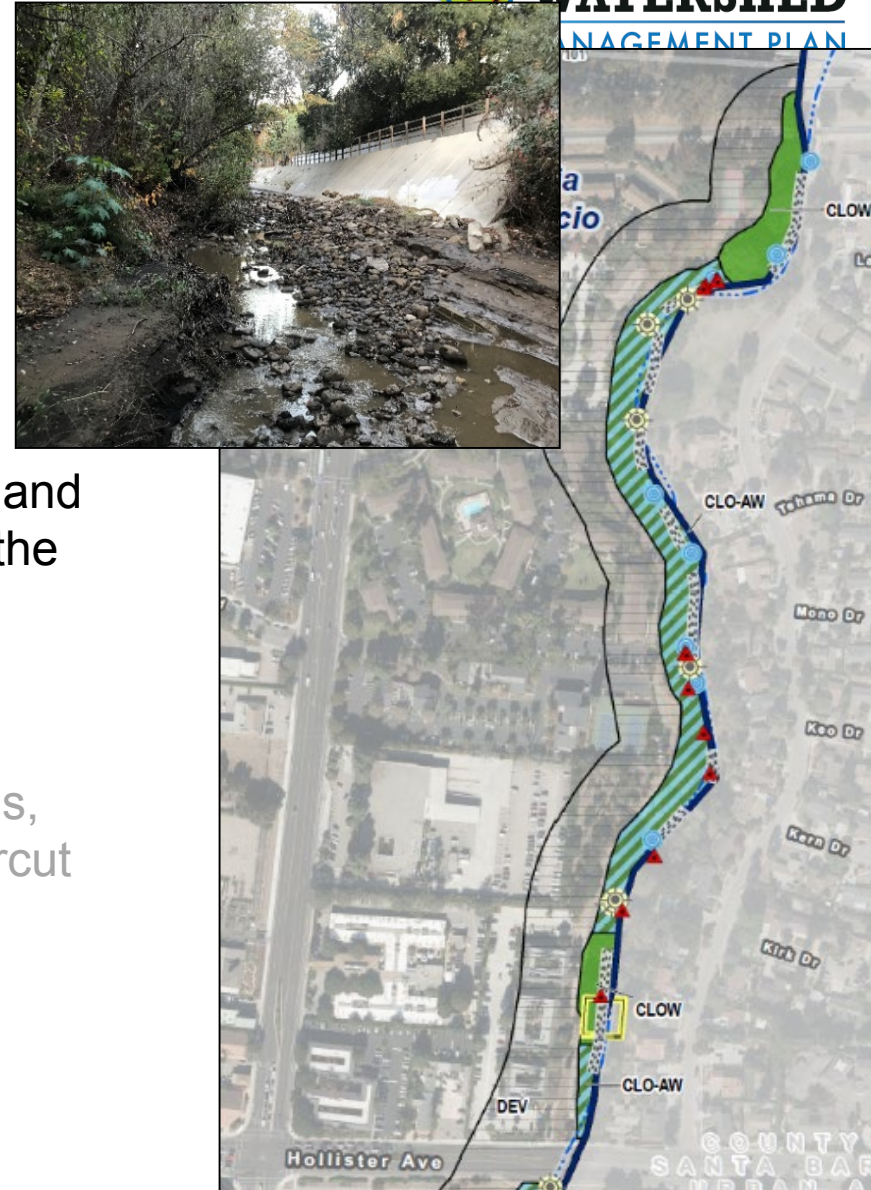
- Example: Maria Ygnacio
- Primarily CLOW-AW; CLOW
- Creek characteristics, such as:
  - 14 separate riffles, 8 pools
  - Well-shaded creek canopy cover (98%)
  - 0-80%, average 40% embeddedness
  - Sandy; medium loam under the top soil and medium to very fine, sandy loam along the banks
  - Arundo, cape ivy
  - Complex instream habitat components (e.g., emergent vegetation, woody debris, live tree roots, artificial structures, undercut banks)
  - Understory density and structure
  - Variety of common and special-status wildlife

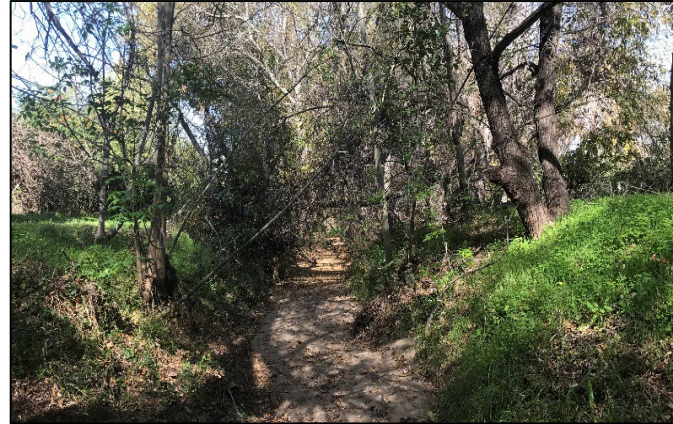
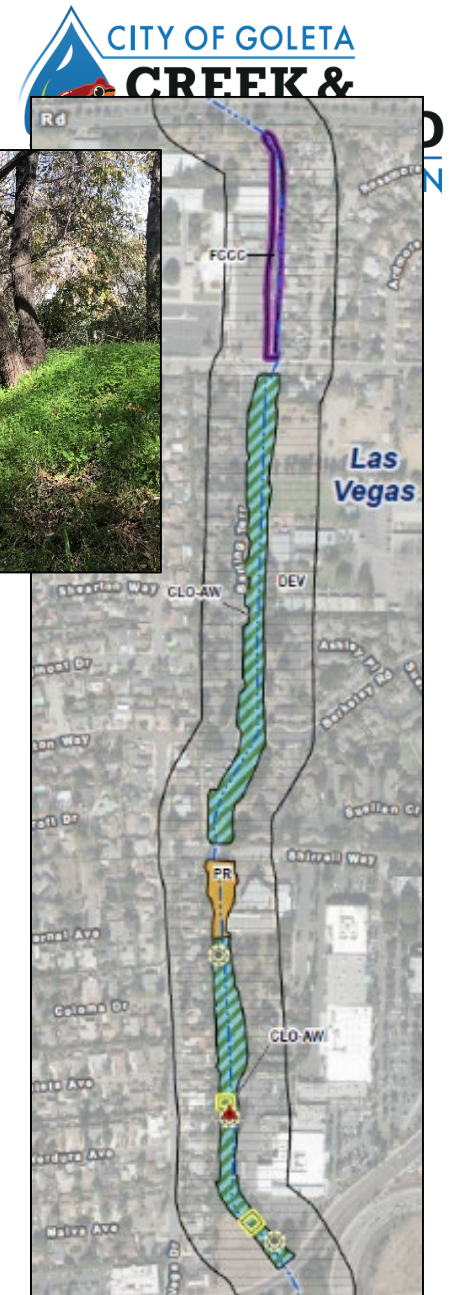
- Example: Las Vegas
- Primarily CLOW-AW
- Creek characteristics, such as:
  - No particular riffles or pools
  - Well-shaded south of Shirrel Way
  - Narrow sandy channel
  - Few non-native, invasive species
  - Complexity instream habitat components (e.g., emergent vegetation, boulders, woody debris, live tree roots, artificial structures, undercut banks)
  - More open understory
  - Variety of common species; some possibility for special-status wildlife
