Phase I Environmental Site Assessment

Goleta Train Depot Project
27 South La Patera Lane
Goleta, California

prepared for
The City of Goleta

prepared by
Rincon Consultants, Inc.

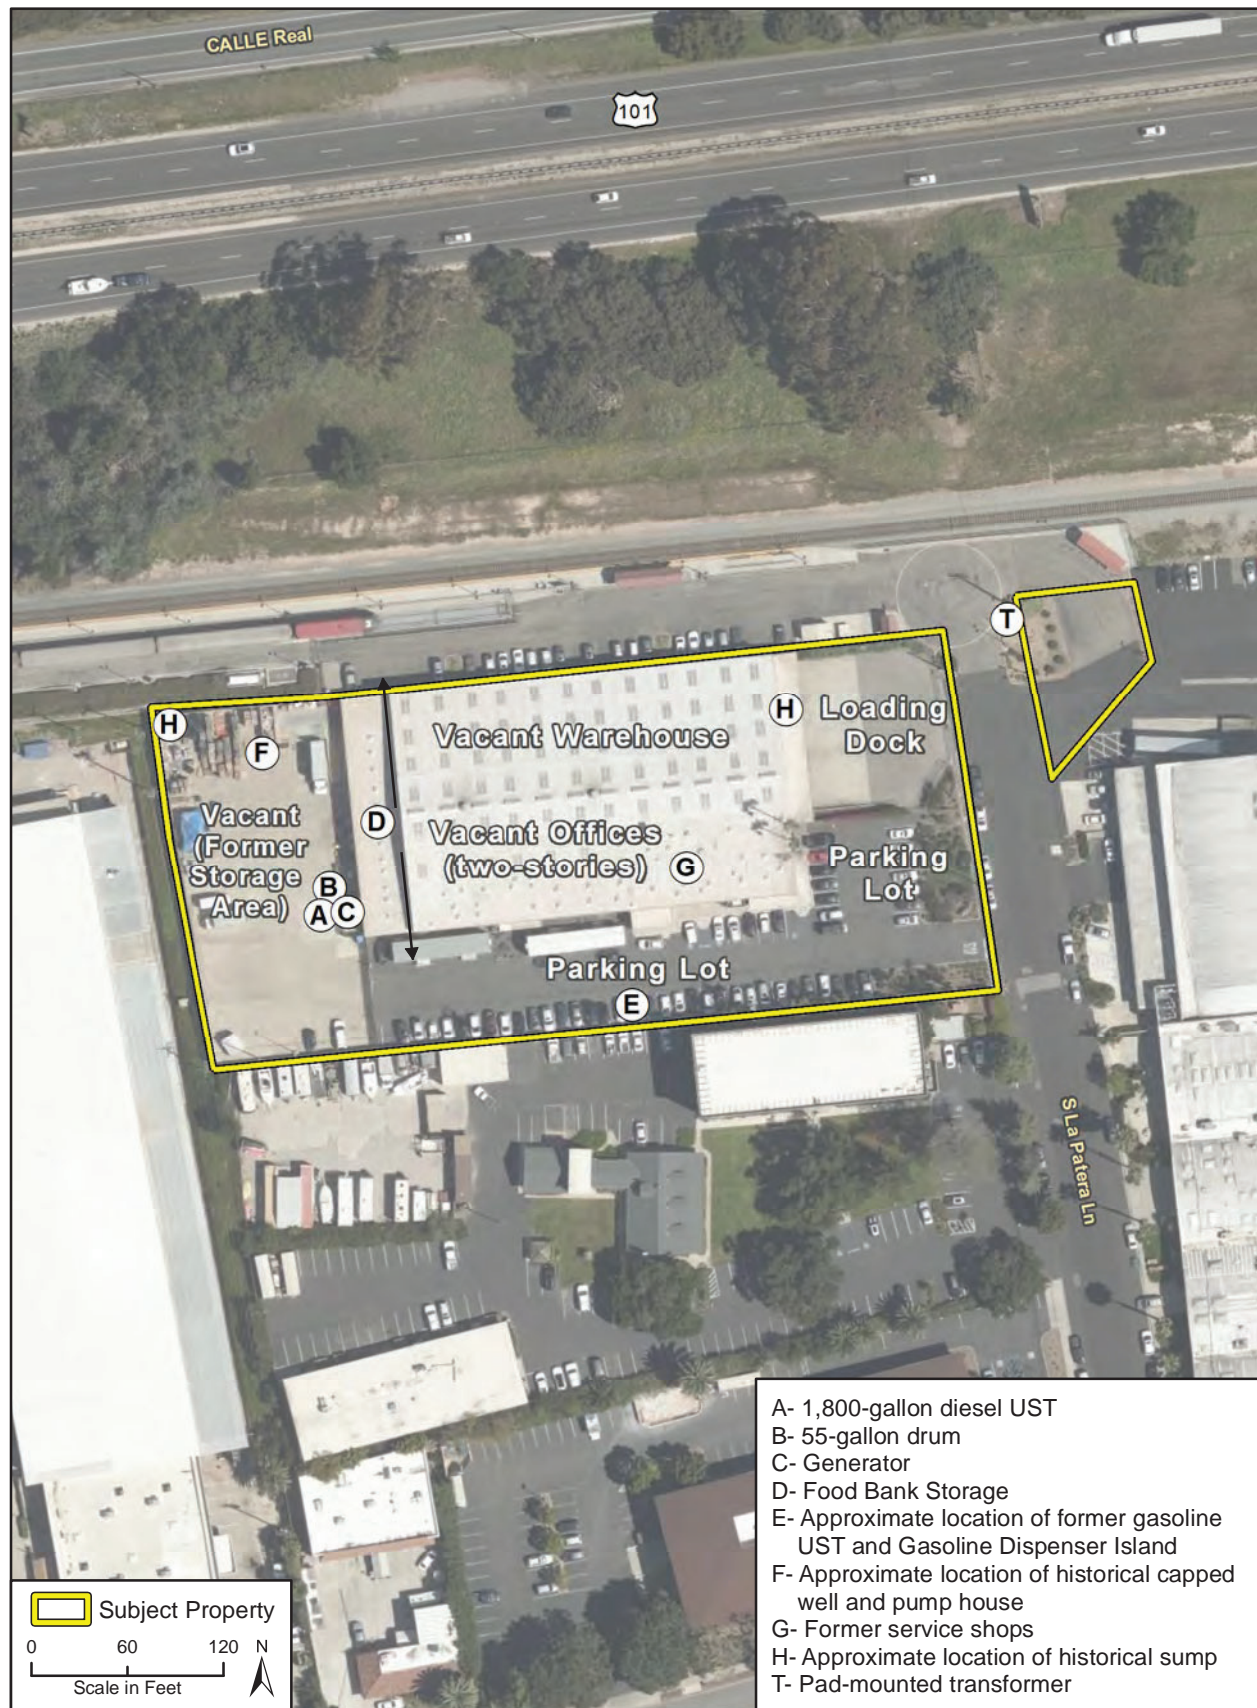
Figure 2

Site Map

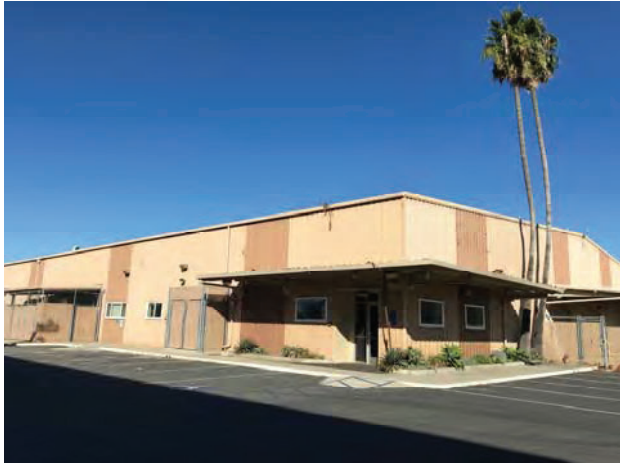
Photograph 1. View of the building on the subject property, facing northwest.

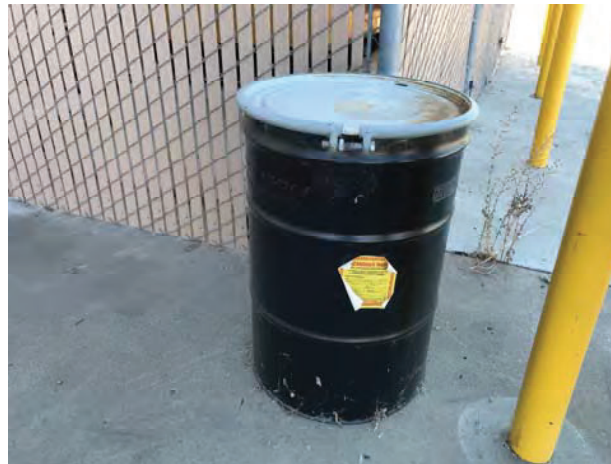
No other drums were reported by the site representative or observed during the site reconnaissance. Rincon did not observe indications of releases from the drum on the subject property.

During the site reconnaissance, Rincon observed one 55-gallon drum on the subject property (with a hazardous waste sticker dated 4/12/19 and labeled as containing rainwater). It is presumed that the

Photograph 5. View of a 55-gallon drum (hazardous waste sticker labeled as containing rainwater) located on the western portion of the subject property.

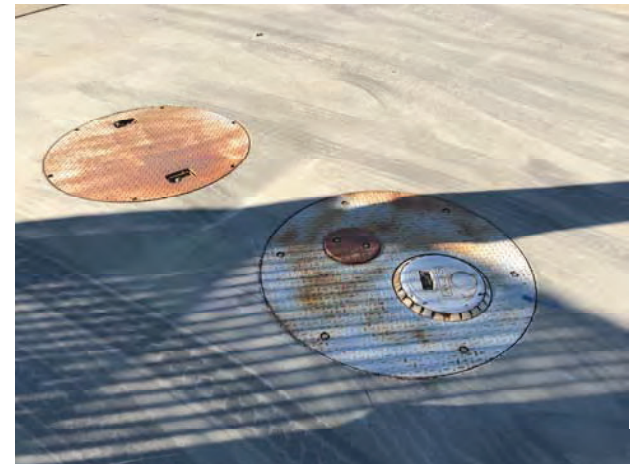
According to EDR, the UST listing indicates a UST is located onsite and is regulated by the Santa Barbara County Fire Department. During the site reconnaissance the location of the existing UST was observed in the southwestern portion of the subject property. According to documents provided by the Santa Barbara County Public Health Department (SBCPHD), a 1,800- gallon diesel double walled fiberglass tank was installed in 2009. No spills or incidents related to the USTs were identified in the EDR report or in the documents provided by the SBCPHD. No additional information pertaining to the UST was available on GeoTracker or EnviroStor websites. Although no releases of hazardous materials have been reported in association with the UST, unreported hazardous materials releases may have occurred and have the potential to be adversely impacting soil and groundwater beneath the subject property.

1. The mechanical line leak detector installed is not capable of activating an audible/visual alarm. The monitoring system is not being checked by daily inspections or by remote electronic access.
2. Facility failure to keep water out of the secondary containment of UST systems installed on or after July 1, 2003. Water is continuously entering the vent box. Returned to compliance on 6/17/2019.

3. Facility failure to maintain the interstitial space such that a breach in the primary or secondary containment is detected before the liquid or vapor phase of the hazardous substance stored in the UST tank is released into the environment. Brine in the vent sump, and low brine level in the fill sump brine canister. Returned to compliance on 8/23/2019.

During the site reconnaissance, Rincon observed evidence of one below-ground diesel fuel storage tank on the subject property. According to Mr. Baris, the UST contains 450-gallons of diesel fuel with a maximum capacity of 1,800-gallons to supply the onsite generator. Mr. Baris indicated that the UST is currently in compliance with local and state regulations. No other above-ground or below-ground tanks were reported by the subject property representative or observed during the site reconnaissance.

Photograph 6. View of the location of an 1,800-gallon UST in the western portion of the subject property.

To evaluate the potential subject property impact associated with the current diesel UST located on the western portion of the subject property, Rincon recommends a soil matrix assessment in the vicinity of the UST to determine if impacted soil is present in the vicinity of the existing UST beneath the subject property.

In addition, if the UST is to be removed as part of the redevelopment of the subject property, then Rincon recommends proper tank abandonment and removal in accordance with local and state regulatory agency protocols.

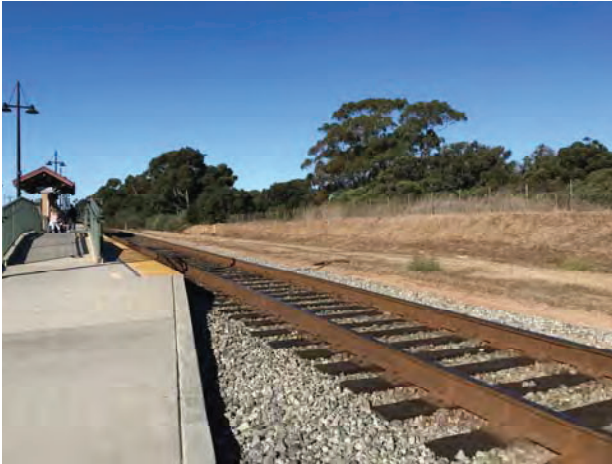
Photograph 7. View of the northern adjacent railroad tracks, facing northwest.

To evaluate the potential subject property impact associated with the northern adjacent railroad tracks, we recommend a shallow soil sampling assessment on the northern boundary of the subject property to determine if hydrocarbons, metals, herbicides, and semi volatile organic compounds from the railroad activities are present in the shallow soil on the subject property. In addition, based on the historical agricultural use of the area, we also recommend that soil samples be analyzed for pesticides, as these chemicals may have been transported via railcars/railroad tracks.

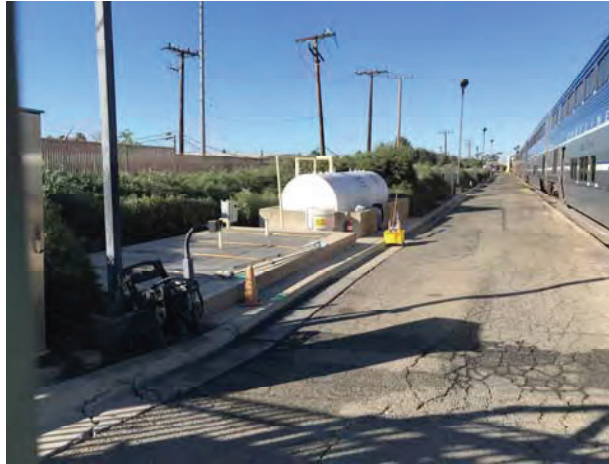
Photograph 8. View of the northwestern adjacent 3,000-gallon waste oil AST, facing west.

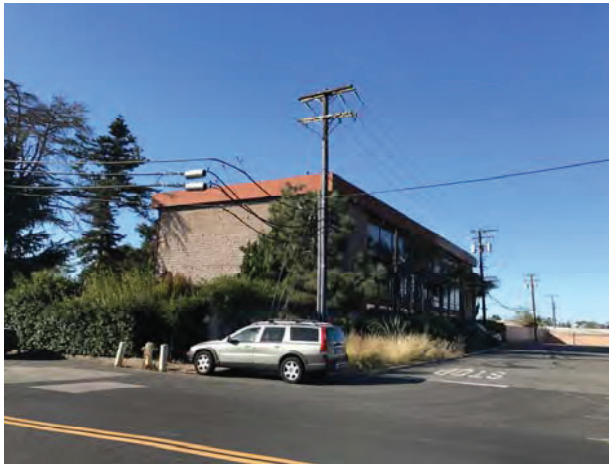
Photograph 11. View of the southern adjacent commercial office building and pole-mounted transformers (33 S. La Patera Lane), facing southwest.
