Hollister Avenue Bridge Replacement Project

Off-site Mitigation Plan at Lake Los Carneros

REVISED June 2021

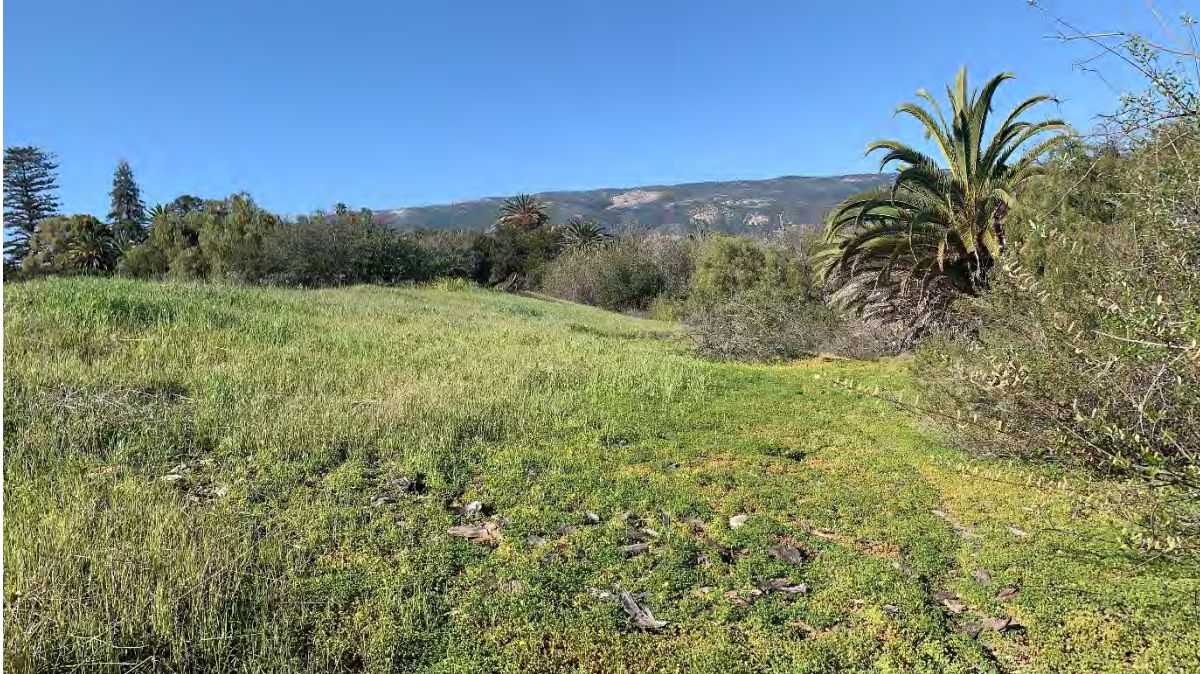
Photograph 1. Restoration Area 11. Non-native grassland habitat to be restored in center and ornamental trees in mid-ground/right to be removed. Existing native arroyo willow habitat on right. March 3, 2020.

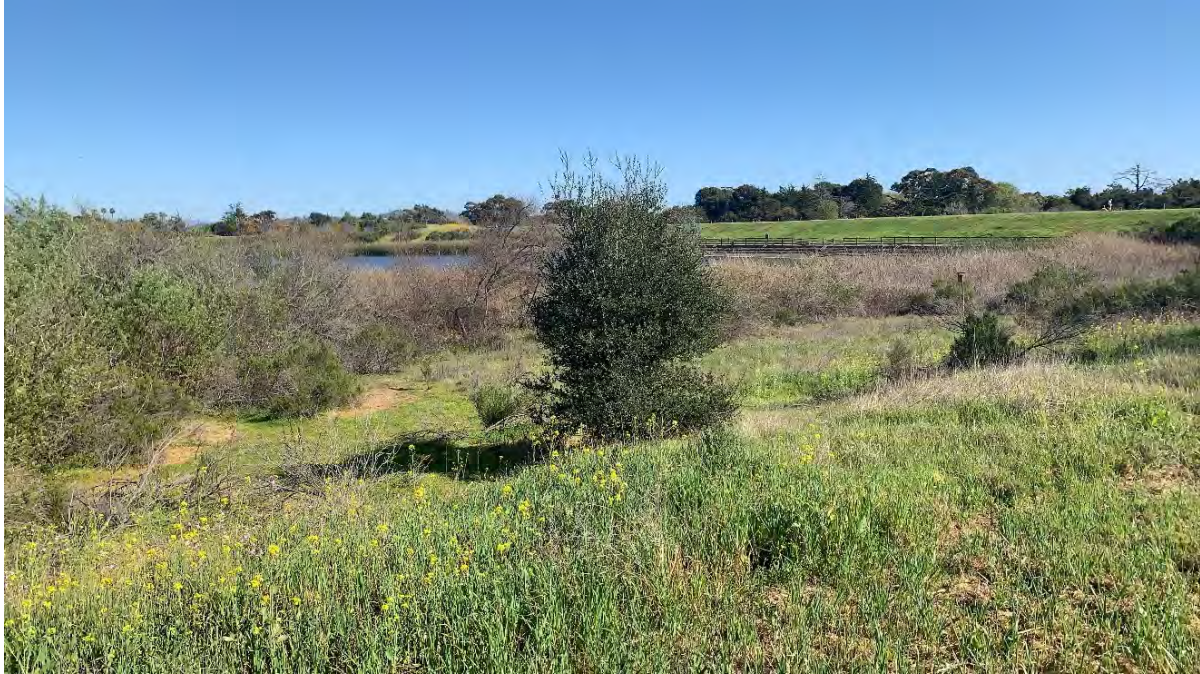
Photograph 3. Northern portion of Restoration Area 10. Non-native grasses in foreground to be restored. Existing native arroyo willow habitat in background. March 3, 2020.
