**DRAFT 4**  
*City of Goleta, California*  
May 2004  
**BACKGROUND REPORT NO. 24**

**Hydrology and Water Quality**

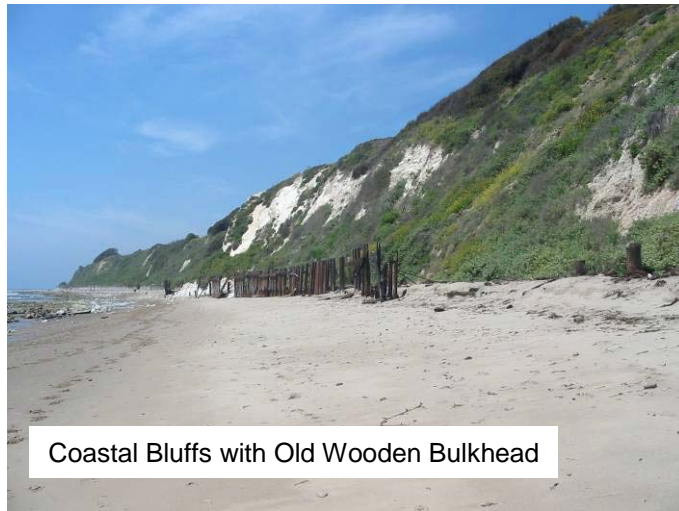
Coastal Bluffs with Old Wooden Bulkhead

rock structures have in the past been erected at the base of the bluff to protect the land from these coastal processes. Most of the wooden structures have now deteriorated providing little protection.

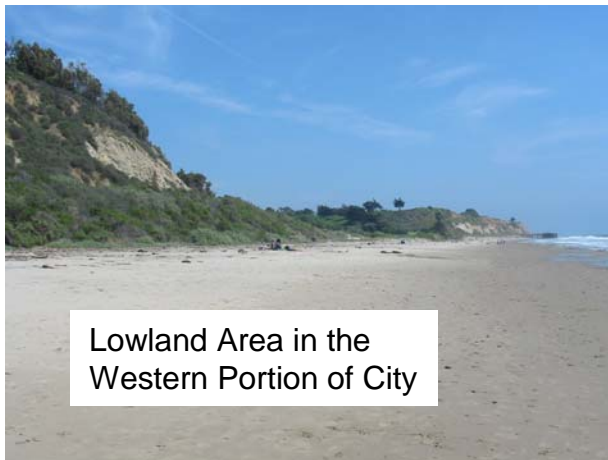
Lowland Area in the Western Portion of City

Most of the coastline is a mesa consisting of a high bluff, 40 to 85 feet above sea level. The only lowland areas abutting the beach are found at the western end of the Golf course property (south of the Veneco Plant) and the eastern Bacara parcel where Tecolote and Winchester Creeks have cut paths to the sea.

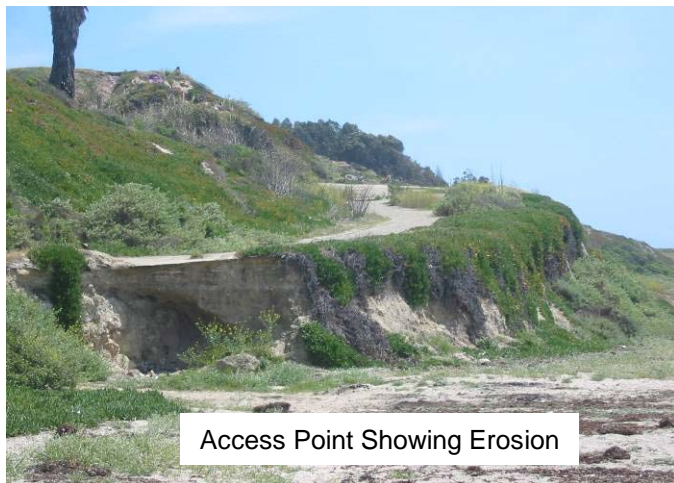
Access Point Showing Erosion

Coastal wave action continually erodes and deposit sands all along the coastline, changing the characteristics of the beaches on a regular basis. Storms and high tides erode the base of cliffs causing the bluffs to gradually recede. Protective wooden and

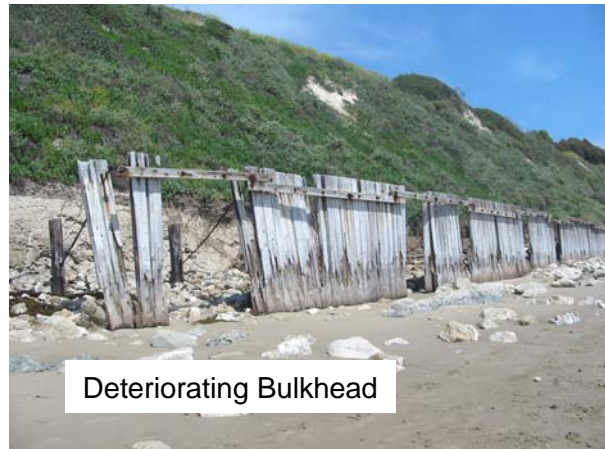
Deteriorating Bulkhead

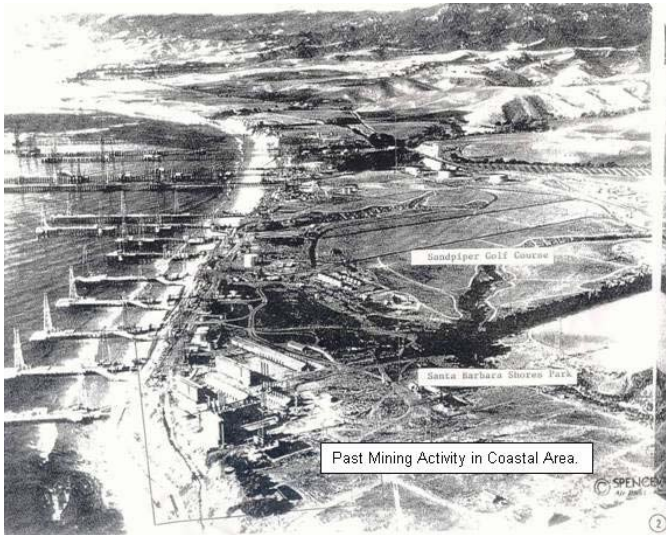
Past Mining Activity in Coastal Area.

While much of this area appears to be relatively undeveloped, it has in the past been the site of intense human activity in the form of extensive oil drilling. Today most of the oil excavation and processing activity has left the area, however remnants of these prior activities remain behind.

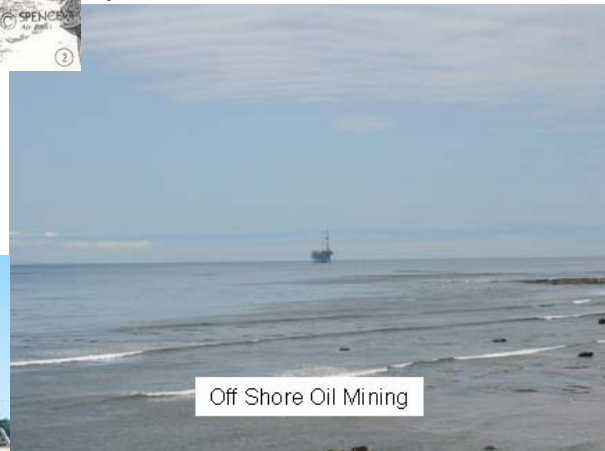
Off Shore Oil Mining

present day oil and gas mining occurs offshore with gas and oil piped to the Veneco Facility for processing.

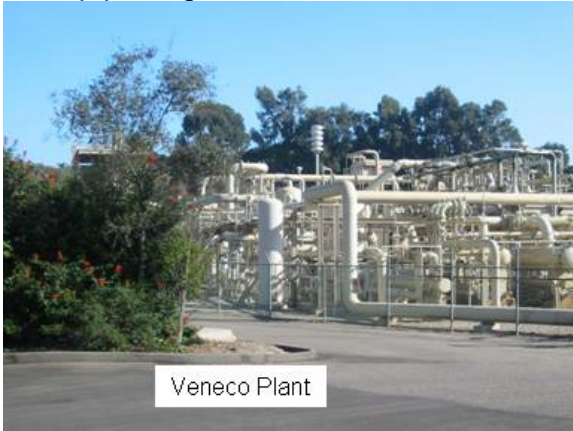
Veneco Plant

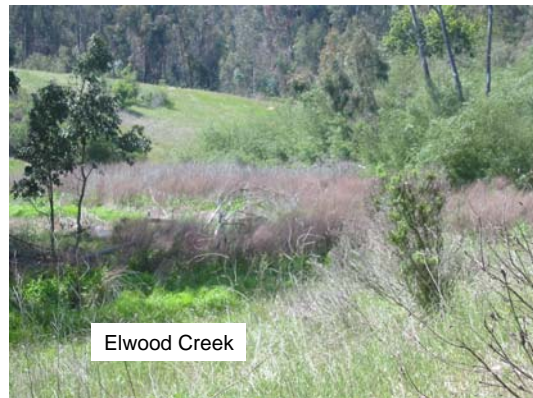
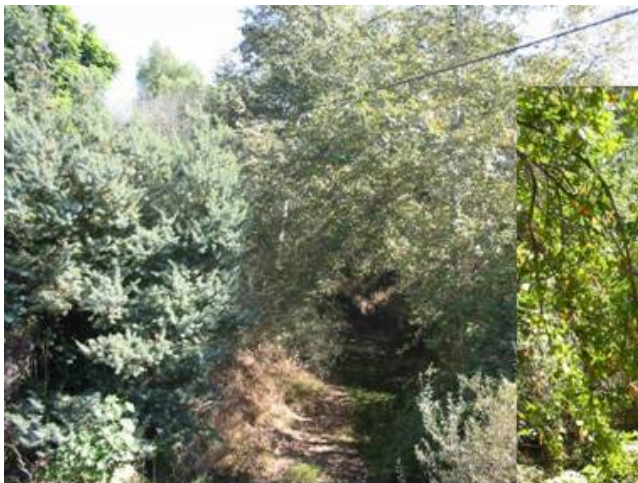
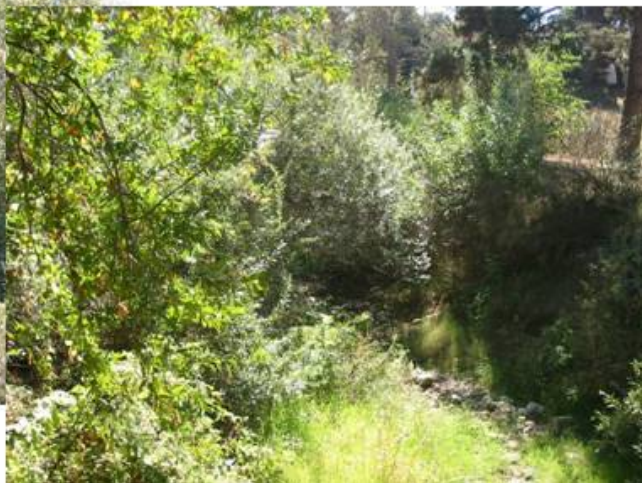
Typical Creek Beds

The physical character of the creek beds in the City vary. Some creeks beds (as identified on Map 1, have been extensively modified with concrete floors and banks as means to protect adjacent properties from flood or erosion. Such concrete structures may cover all of the creek bed and banks (as shown in the accompanied picture) or may have only one bank so constructed. Similar concrete

modifications are also found at road crossings. Other creeks beds may still be relatively natural in character without extensive modification.

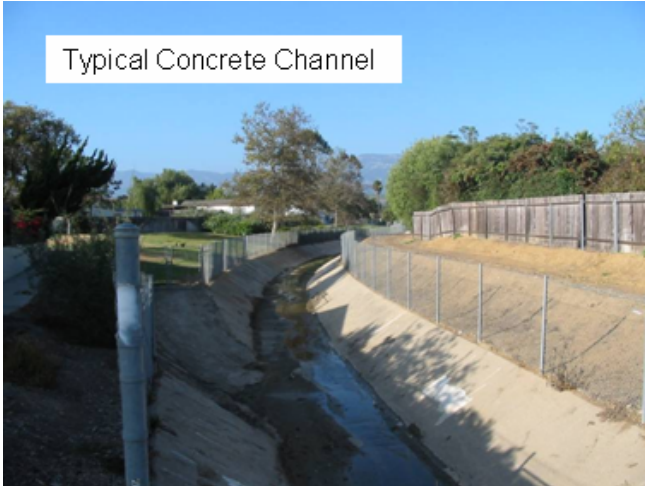
Typical Concrete Channel

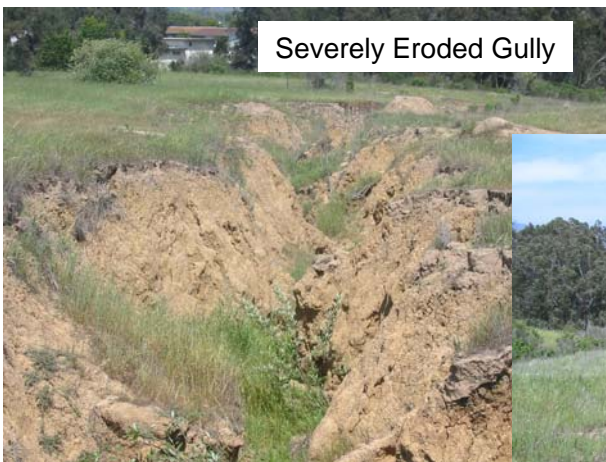
Severely Eroded Gully

Many of the creek beds and tributaries have a high erosion potential, as

illustrated in the attached photographs. Such erosion not only damages adjacent areas, posing as a constraint to its use and development. Such erosion also

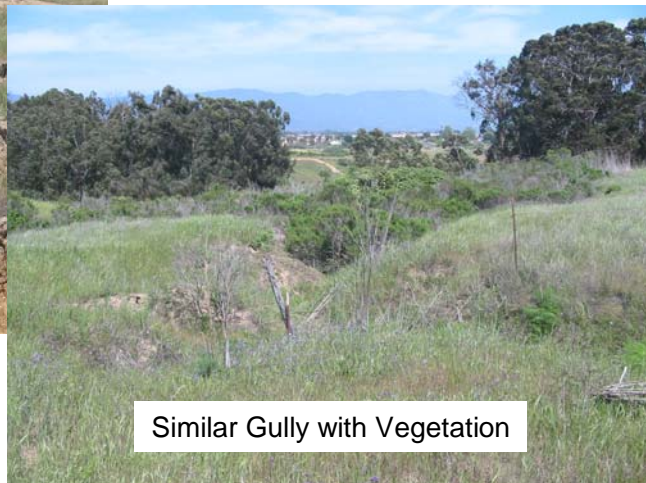
Similar Gully with Vegetation

increases sedimentation in the creek beds and sloughs. Vegetative cover does serve to reduce the rate and extent of this erosion.

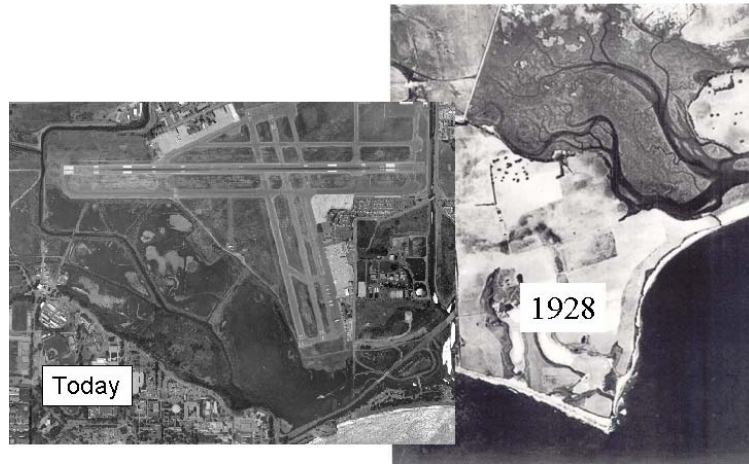
The dominant hydrological feature of the Goleta Valley is the Goleta Slough located just outside the City limits to the south. While the slough has been heavily impacted by development and other human activity it nonetheless continues to support a rich and diverse coastal ecosystem. The extent of the modification to the slough has been extensive as illustrated on the aerial photographs of the Slough in 1928 compared to today. Map 2 compares the loss of estuarine area from historic times to today. The area mapped as estuarine is estuarine habitat as defined by the Goleta Slough Management Plan. While this area does not include all of the important wetland areas that are associated with an estuary it does identify the heart of the system. The map illustrates a loss in direct estuarine habitat from about 665 acres to 113 acres.

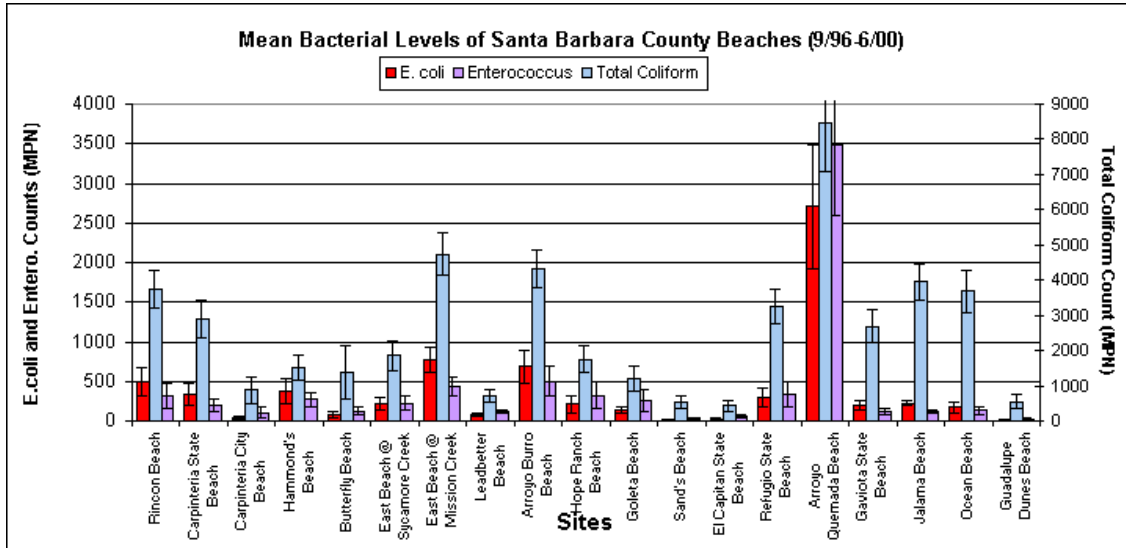
Scientific research has demonstrated a link between storm water runoff and high levels of bacteria in creeks and ocean water. Exposure to such bacteria can pose a health risk to humans. In 1995, County Environmental Health Services began testing local beaches for bacteria. The tests found that several local beaches had high levels of both fecal and total coliform bacteria. Such bacteria can cause skin rashes, sinus infections, and other adverse health affects. Figure 1 compares the testing at 19 beaches on the south coast.<sup>3</sup>

Two of the beaches shown on Figure 1 are in the Goleta Area. Goleta Beach is located just south of Goleta Slough at the Slough's outfall. Sands Beach is at Coal Oil Point just east of the Elwood Mesa. As illustrated on Figure 1 the average water quality on Goleta area beaches was generally better than other beaches to both the east and west of the City.

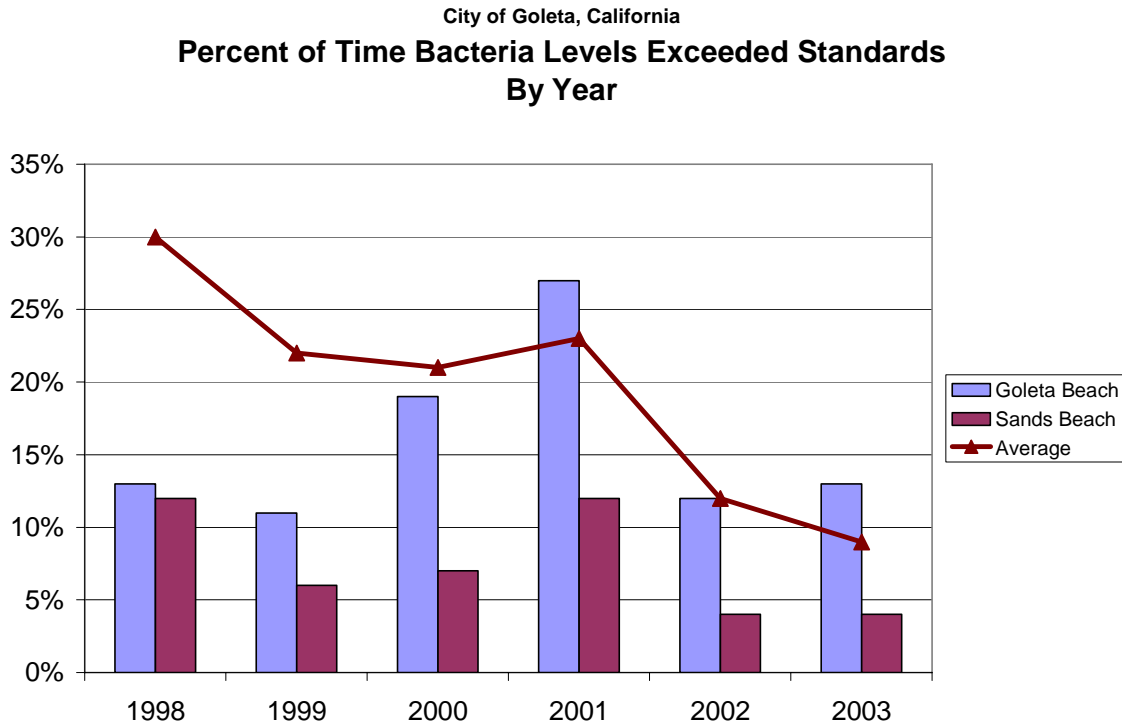
Bacteria levels vary from time to time. Figure 2 compares the percent of time bacteria counts exceeded standards on Goleta Area beaches compared to the average for all 19 beaches. As noted over the entire period, water quality has been better on Goleta Beaches than the average. However, since the average bacterial count has declined substantially, the average is now comparable to the beaches in Goleta.
