FACILITY RESERVE STUDY

CITY OF GOLETA

AMTRAK BUILDING

EMG Project #: 92184.10R-006.052
Date of Report: August 31, 2010
On site Date: August 9, 2010

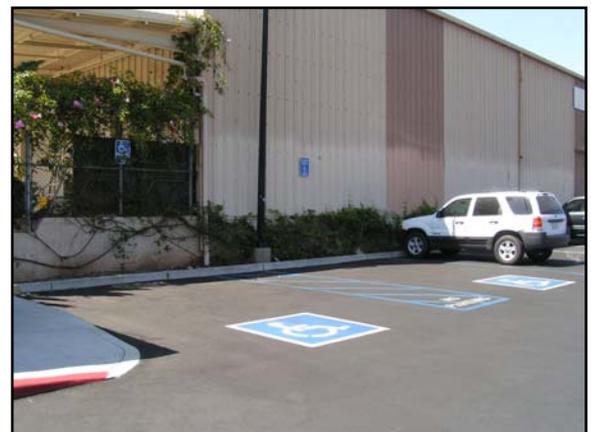
The sidewalks throughout the property are constructed of cast-in-place concrete. Cast-in-place concrete steps and ramp with metal handrails are located at the train platform.

The curbs are constructed of cast-in-place concrete.

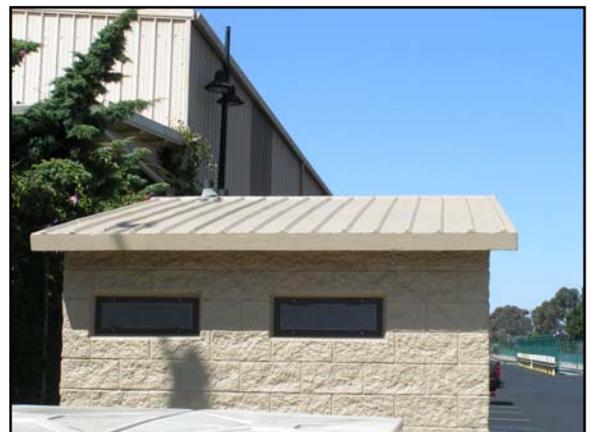
- According to the POC the City is not responsible for the maintenance of the roofing.
- The roof finishes are original. Information regarding roof warranties or bonds were requested but are not available.

- The roof waterproofing coating is in good condition. Based on its estimated Remaining Useful Life (RUL), the roof coating will require replacement during the assessment period. According to the POC the City is not responsible for the maintenance of the roof waterproofing.
- There is no evidence of active roof leaks.
- There is no evidence of roof deck deterioration. The roof substrate should be inspected during any future roof repair or replacement work.
- There is no evidence of fire retardant treated plywood (FRT).
- Roof drainage appears to be adequate.

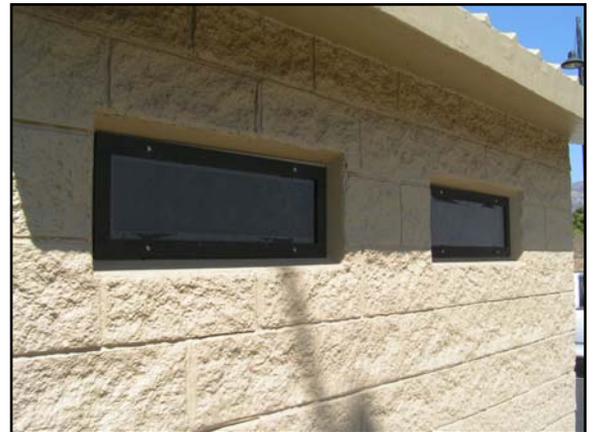
The building has unfinished concrete masonry unit (CMU) exterior walls.

Building sealants (caulking) are located between dissimilar materials, at joints, and around window and door openings.

- According to the POC the City is not responsible for the maintenance of the exterior walls.
- The exterior finishes are in good condition. Application of water resistant sealant will be required during the assessment period. According to the POC the City is not responsible for the maintenance of the exterior finishes.
- The sealant is flexible, smooth, and in good condition and will require routine maintenance during the assessment period. According to the POC the City is not responsible for the maintenance of the sealant.

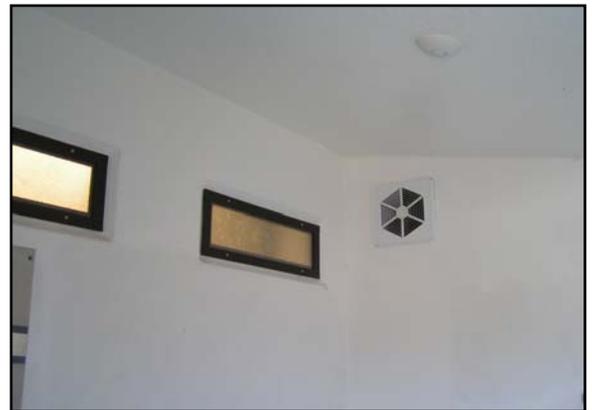
- The exhaust fans appear to be in good condition and will require routine maintenance during the assessment period. Replacements can be performed as part of the property management’s routine maintenance program. The cost of this work is not included in the cost tables.
