# FACILITY RESERVE STUDY

## HISTORIC TRAIN DEPOT

300 North Los Carneros Road

**EMG Project #:** 92184.10R-004.052  
**Date of Report:** September 1, 2010  
**On-Site Date:** April 28 and May 24, 2010

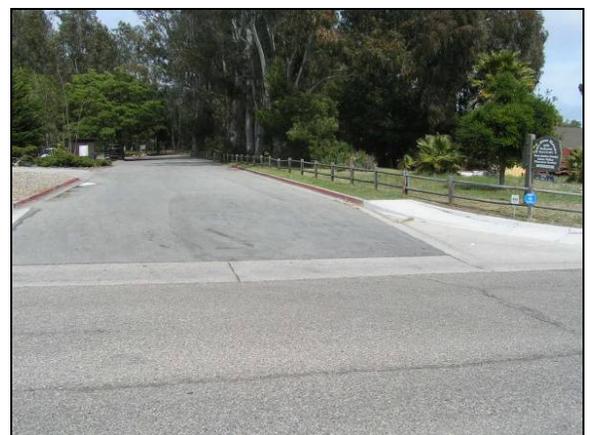
- Observations and comments related to the access drive and parking lot pavement are addressed in the Rancho La Patera and Stowe House reserve study.
- The concrete pavement is in generally good condition. There are no significant signs of cracks or surface deterioration however there are isolated areas of vertically displace sidewalks creating a potential trip hazard. These areas must be repaired to eliminate the trip hazard. The cost of this work is included in the **Immediate Repair Cost Estimate**. Epoxy sealing of minor cracks will be required during the assessment period as part of the property management’s routine maintenance program.

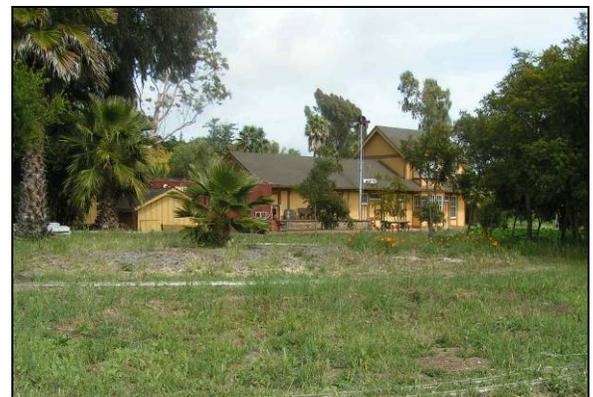
- The topography and adjacent uses do not appear to present conditions detrimental to the property.
- The landscape materials are in good condition and will require routine maintenance during the assessment period.
- The underground irrigation system appears to be in good working order. Replacement of sprinkler heads and minor repairs will be required during the assessment period. This work is considered to be routine maintenance.

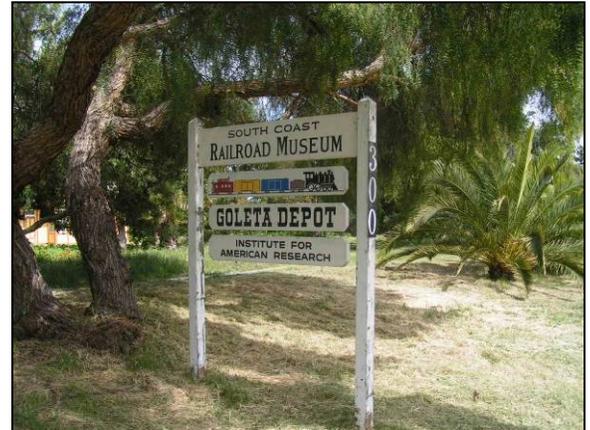
- The signs are in good condition. Routine maintenance will be required during the assessment period.
- The site light fixtures are in good condition. Routine maintenance will be required during the assessment period.
- The site fencing is in good condition and will require routine maintenance during the assessment period.
- The wood decking is in fair condition and is showing signs of wear and sun exposure. The need for replacement of the decking is anticipated in approximately 5-years. The cost of this work is included in the **Immediate Repair Cost Estimate**.

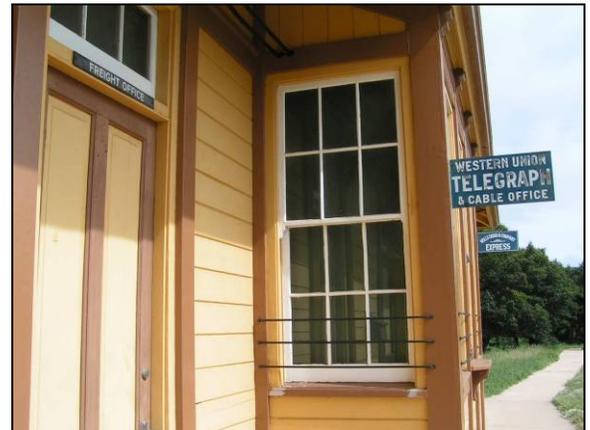
- There is no evidence of window leaks or window condensation. The windows are in good condition and will require routine maintenance during the assessment period.
- The exterior doors and door hardware are in good condition and will require routine maintenance during the assessment period.
- The door and window paint is in fair condition. The exterior doors and windows will require painting during the assessment period. The cost of this work is included in the **Replacement Reserves Cost Estimate**.

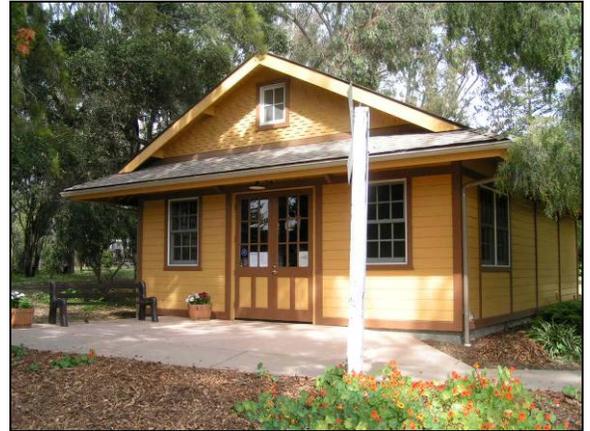
- The accessory structures are in good condition and will require routine maintenance during the assessment period.
- All of the accessory structures are owned by the Railroad Museum. The Museum is responsible for the maintenance of the accessory structures.

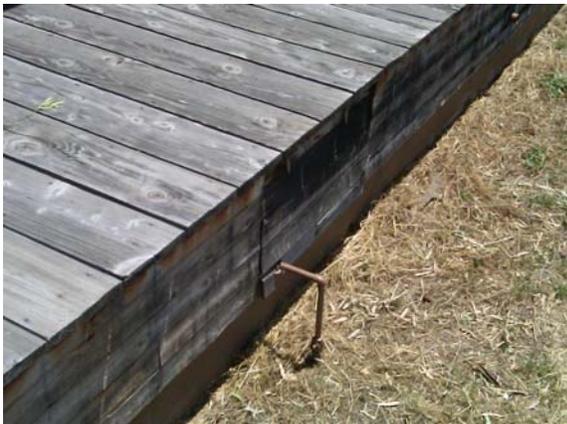
Photo #29:	Wood deck at east and north side of station
------------	---

5.2	37900	Concrete walkway patch, small area	20	20	0	30	SF	\$22.31	\$669	\$669																				\$669
5.5	38238	Wood decking, replace	25	20	5	420	SF	\$13.49	\$5,666					\$5,666																\$5,666
