Historic Resource Potential Impact Study

POTENTIAL IMPACT STUDY

GOLETA COMMUNITY CENTER GOLETA, CALIFORNIA [16128]

FEBRUARY 2017

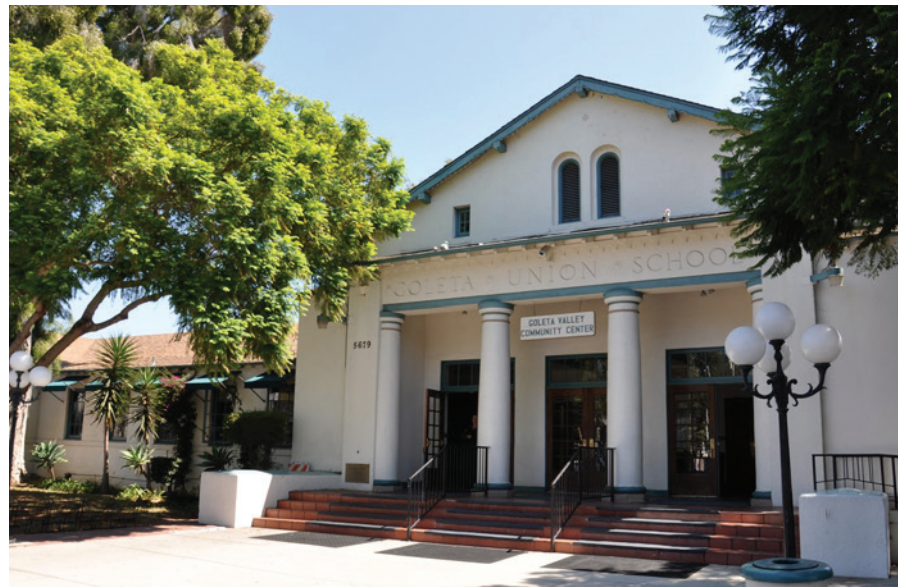
Figure 1. Main Building north facade at main entrance, looking south.

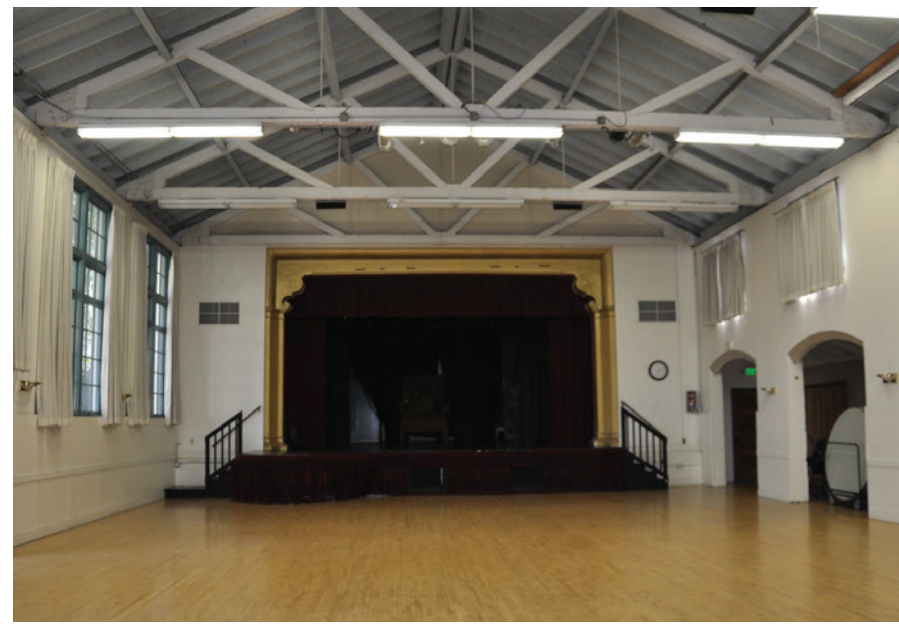
Figure 11. Auditorium, looking south. Note exposed ceiling and trusses and decorative stage surround.

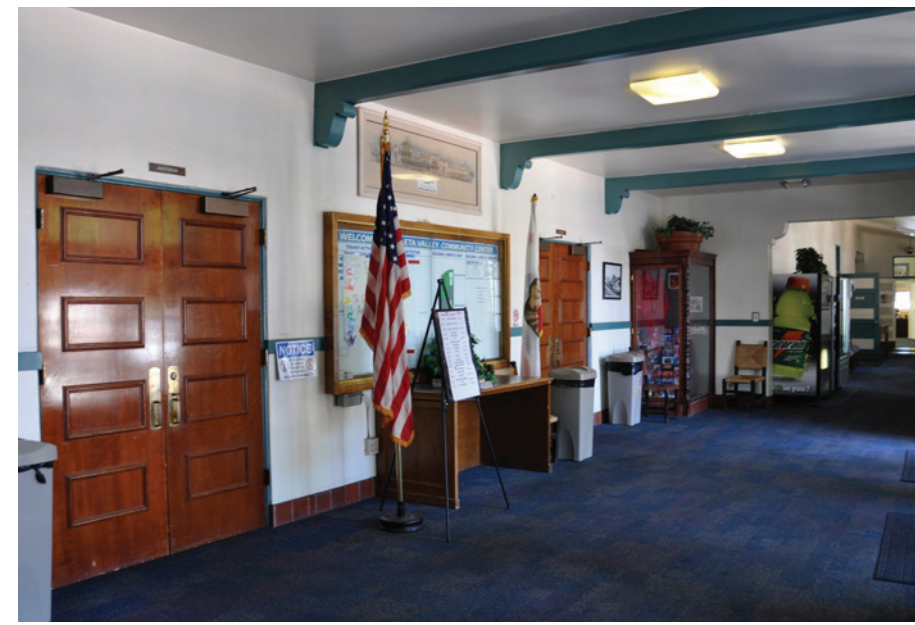
Figure 12. Entry corridor in front of Auditorium, looking southwest. Note the decorative beams.

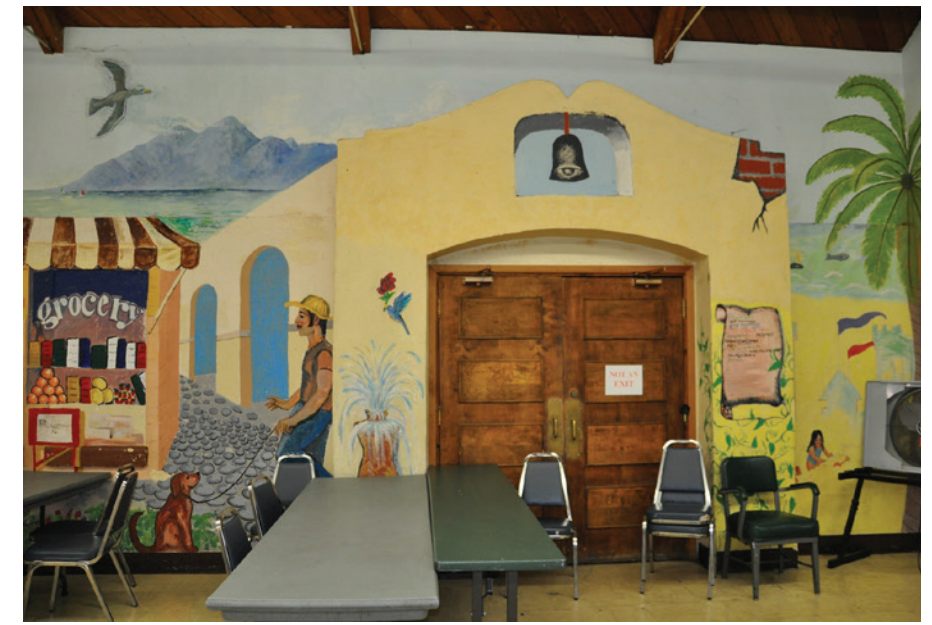
Figure 13. Decorative concrete door surround in Dining Room.

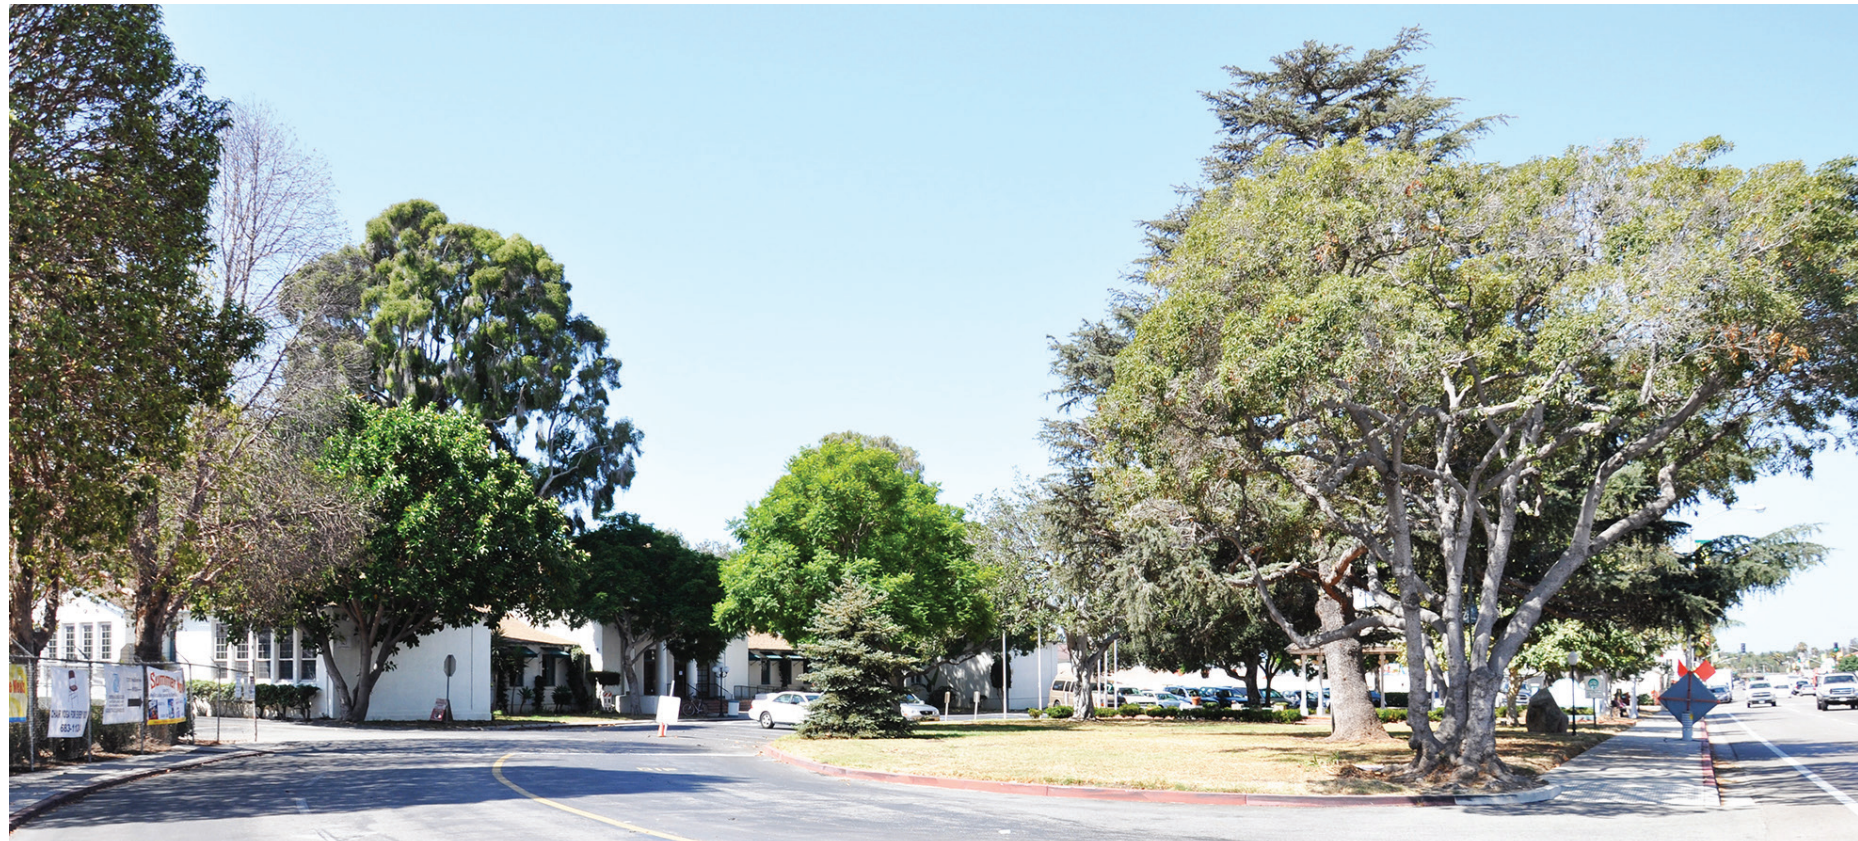
Figure 18. Main Building (left) set back from Hollister Avenue (right) behind semi-circular landscape area and driveway.

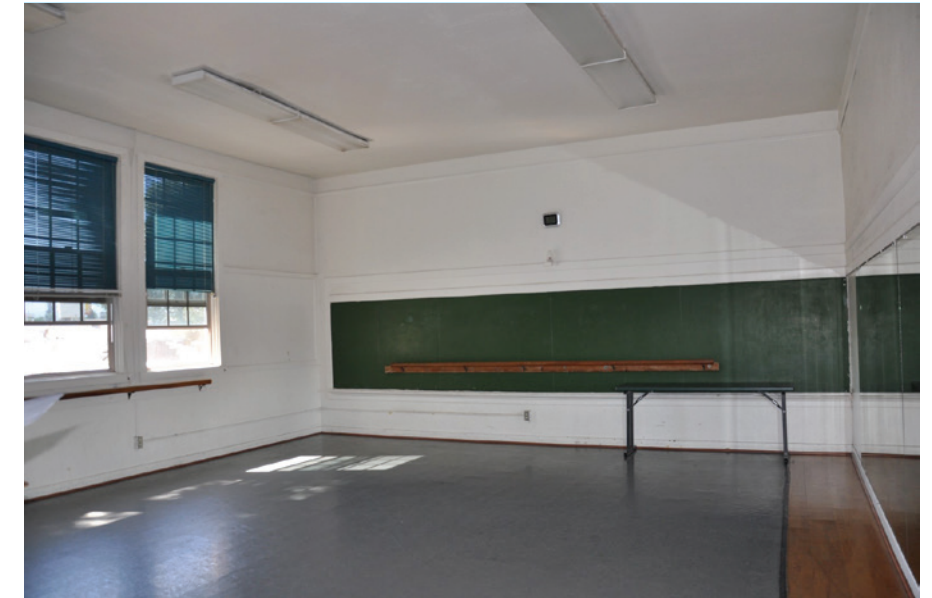
Figure 22. Typical Main Building classroom interior. Finishes can be upgraded and new systems installed without significantly altering the space.

- Interior finishes should not be gutted to install new systems like electrical wiring. If removal of interior finishes is required, it should be done selectively and the historic material shall be repaired in-kind to match adjacent finishes.
- Surface-mounted conduit and wiring may be done sensitively to avoid the need to channel into existing finishes. Select architectural-quality surface mounted conduit and locate to minimize impact on the character-defining qualities of the space.
- Deteriorated historic interior features shall be repaired rather than replaced.
- Maintain the type of historic finish. Painted surfaces shall remain painted. A paint analysis study is often helpful to understanding if finishes have changed over time.

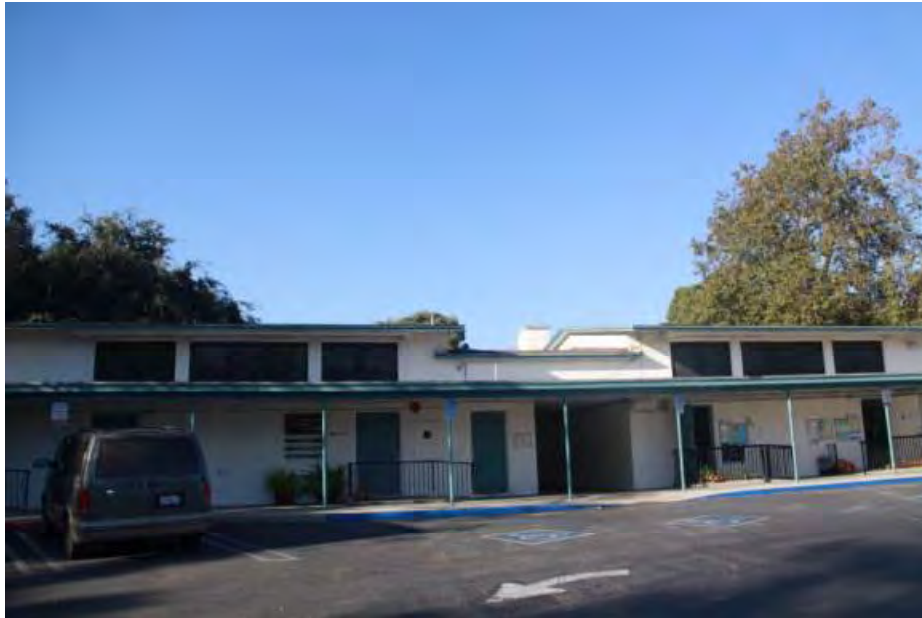
Figure 6 – Building B, Original building to the left, new addition to the right
