# Ekwill Street and Fowler Road Extensions Project

## Biological Mitigation and Monitoring Plan

**REVISED August 2022**

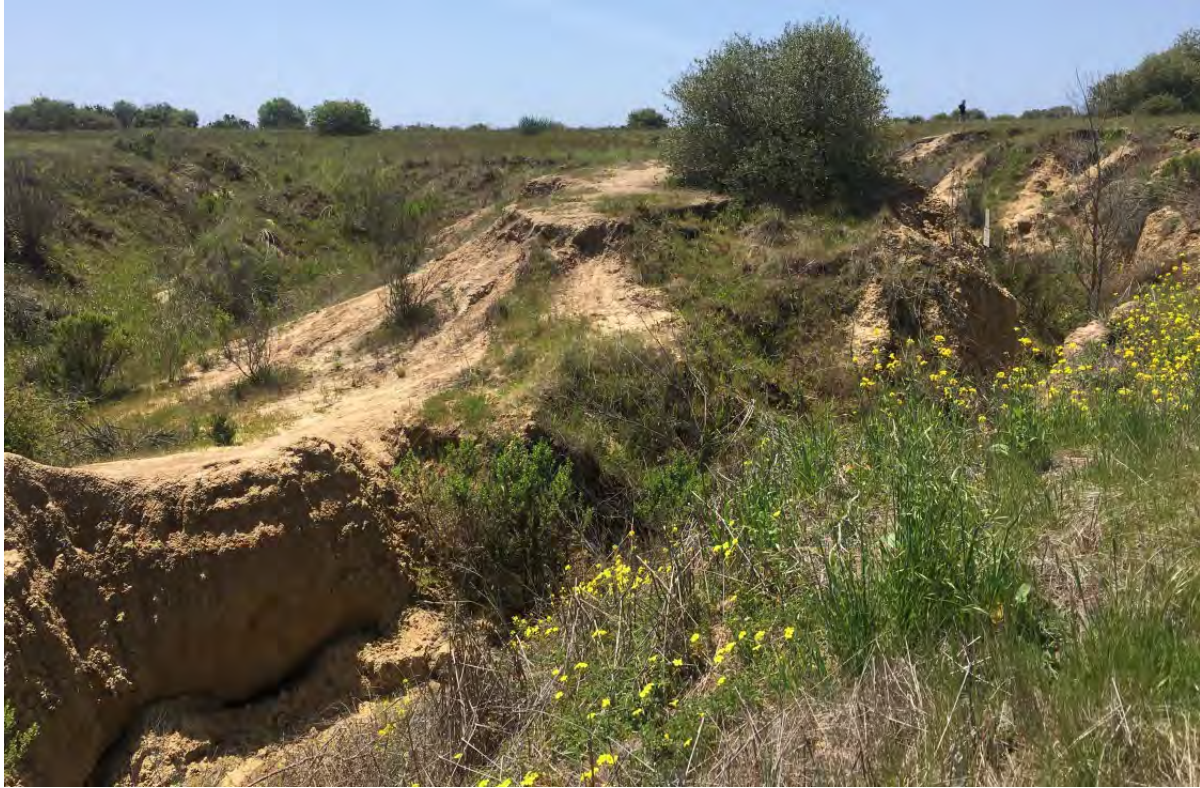
**Photograph 9.** View of southeastern erosional scar, facing southwest/upstream. April 25, 2018
