FACILITY RESERVE STUDY

GOLETA VALLEY COMMUNITY CENTER

5679, 5681, 5689 and 5717 Hollister Avenue
Goleta, California 93117

EMG Project #: 92184.10R-002.052
Date of Report: September 1, 2010
On-site Date: March 21, and 22, 2010

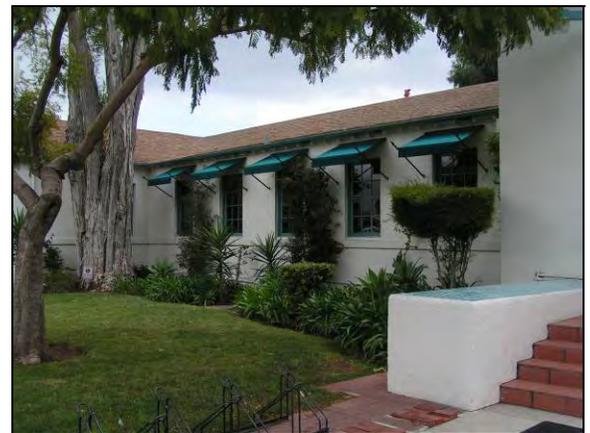
- The topography and adjacent uses do not appear to present conditions detrimental to the property.
- The landscape materials are in good condition and will require routine maintenance during the assessment period.

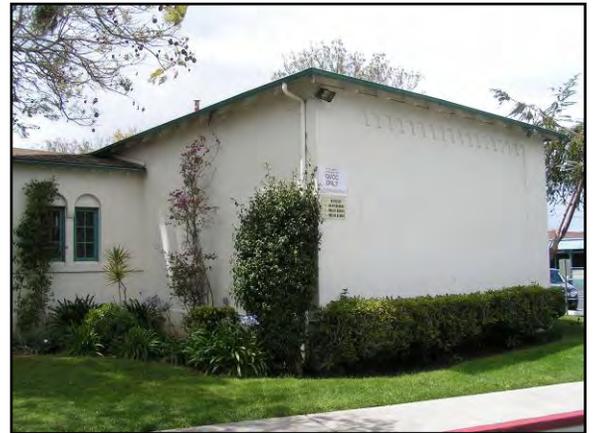
- The exterior finishes are in good condition. Painting and patching will be required during the assessment period. The cost of this work is included in the **Replacement Reserves**.
- The wood ceilings at the covered walkways at the Site-built Classroom Buildings and at the rear of the Main Building are in good to fair condition. There are isolated areas of loose and damaged boards. These boards should be reattached or replaced. This work is considered routine maintenance and is not included in the cost tables.
- The sealant is flexible, smooth, and in good condition and will require routine maintenance during the assessment period.

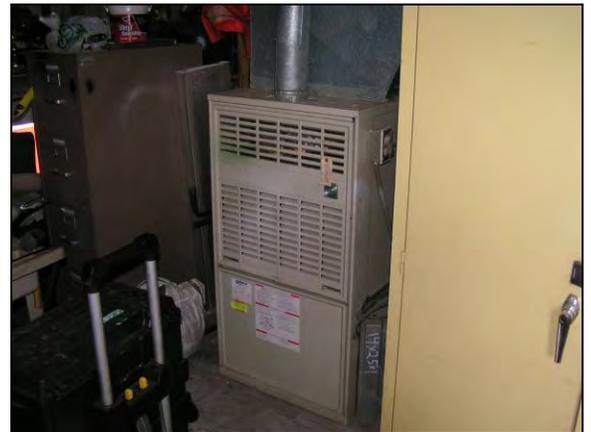
- The property does not have a dedicated HVAC repair and maintenance contractor.
- Records of the installation, maintenance, upgrades, and replacement of the HVAC equipment have been maintained since the property has been maintained by the City of Goleta.

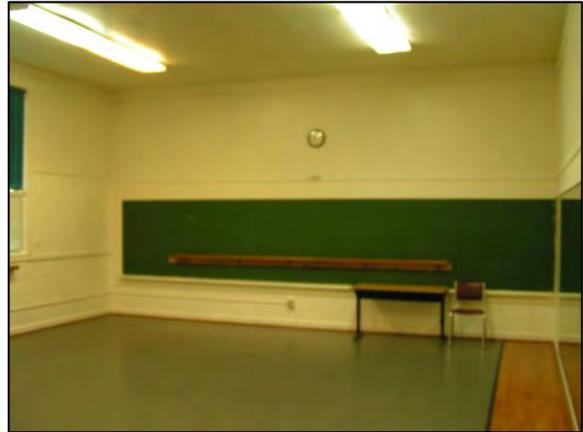
- The interior finishes in the buildings are in good condition.
- The interior finishes in the Classroom Buildings are the responsibility of the tenants.

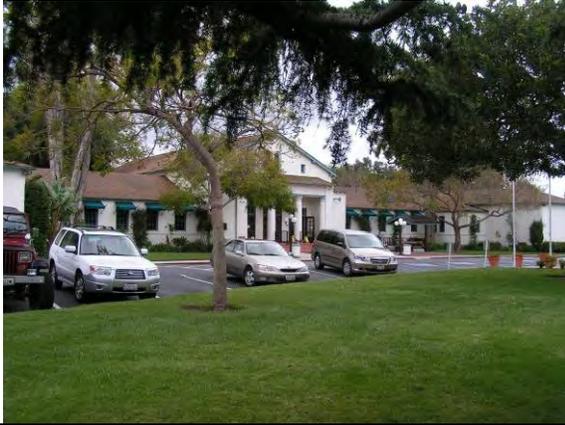
Photo #1: Front of main building

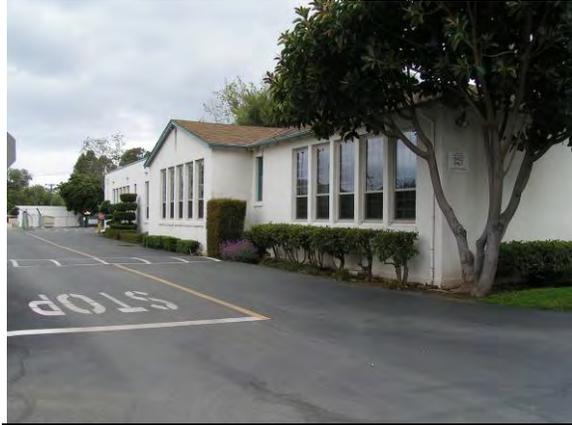
Photo #2: Left side of main building

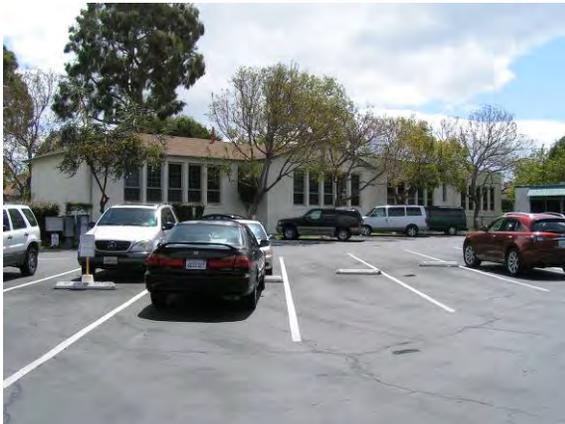
Photo #3: Right side of main building

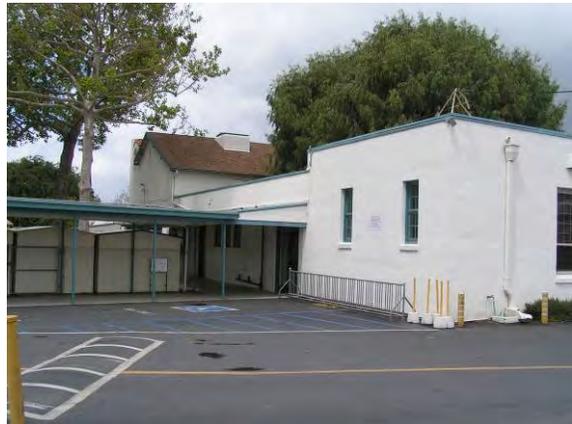
Photo #4: Rear of main building

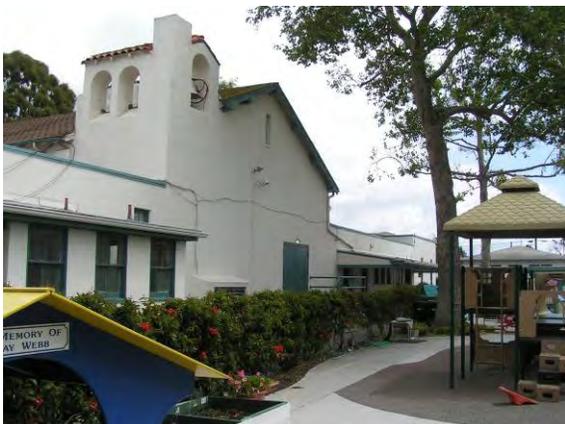
Photo #5: Rear of main building

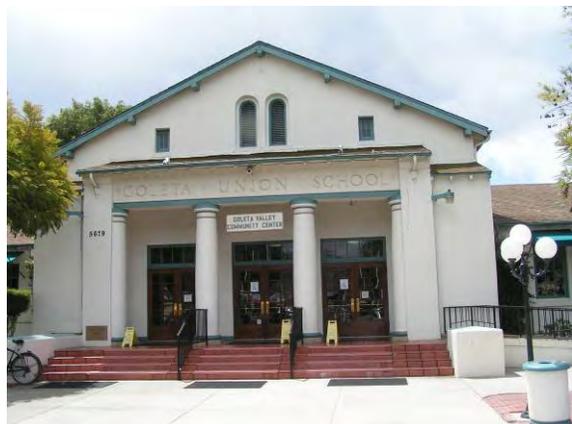
Photo #6: Main entrance of main building

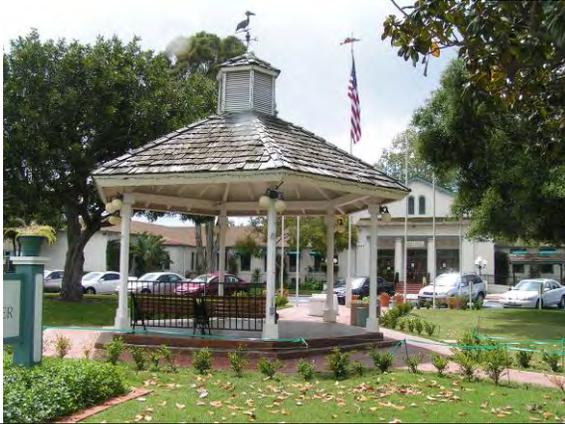
Photo #7:	Gazebo
-----------	--------

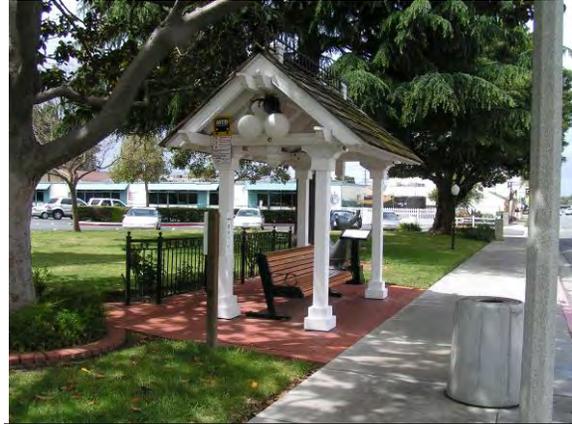
Photo #8:	Transit shelter
-----------	-----------------

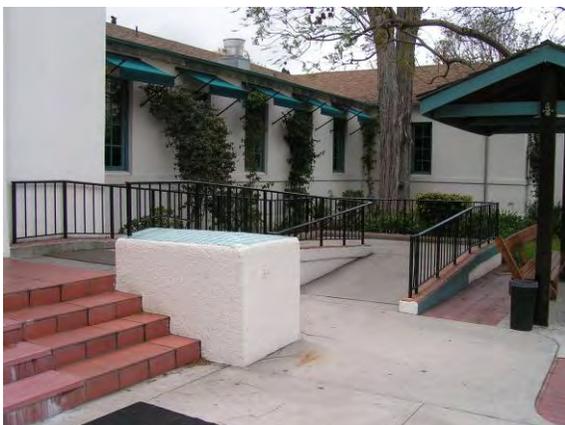
Photo #11:	Disabled access ramp at main entrance to main building
------------	--

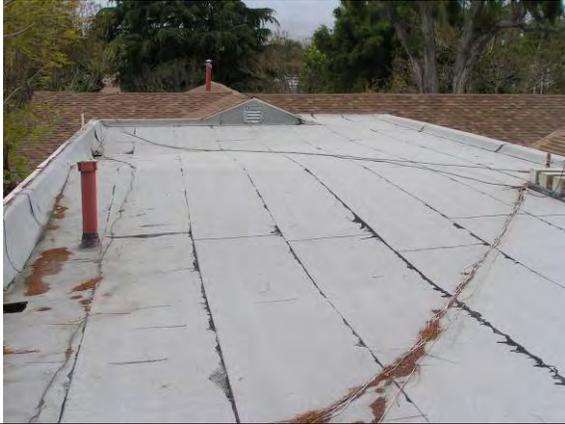
Photo #13: Flat roof at main building

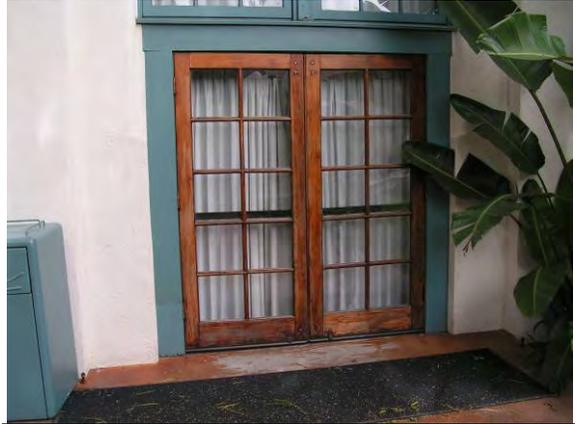
Photo #14: Exterior doors at patio at main building

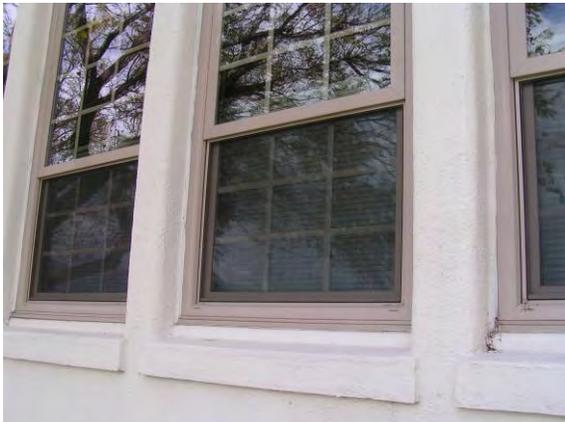
Photo #15: Wood double hung windows

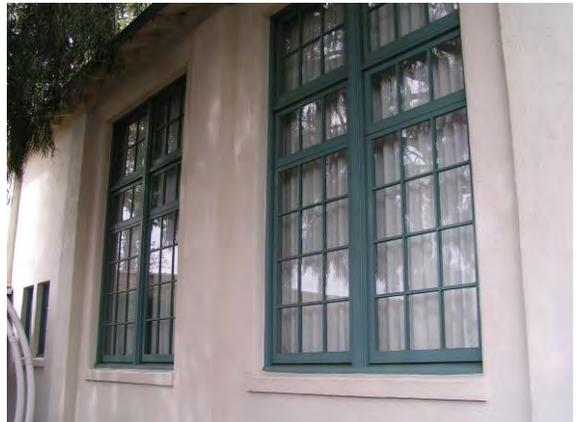
Photo #16: Decorative wood windows

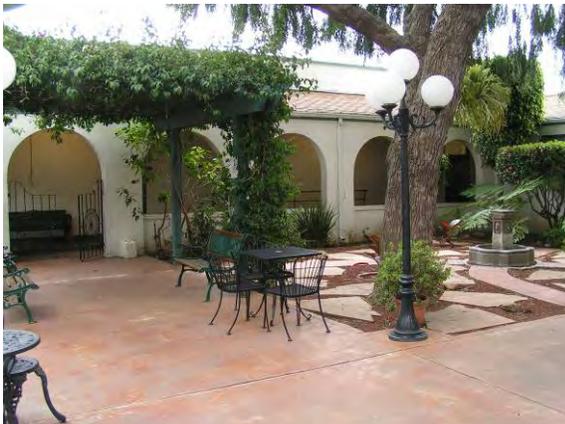
Photo #17: Patio at main building

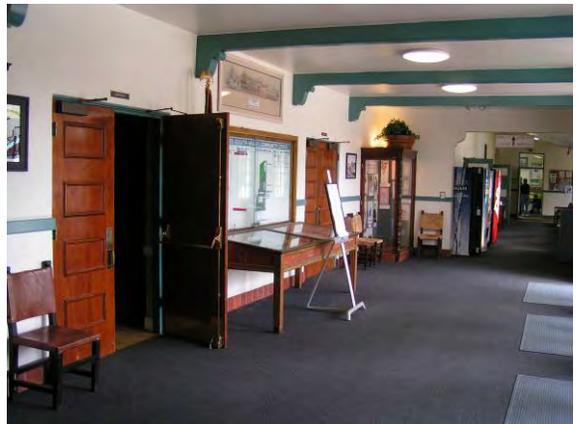
Photo #18: Main building lobby

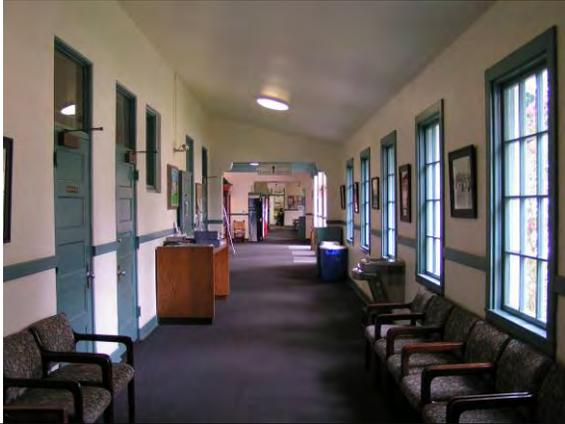
Photo #19: Main building corridor

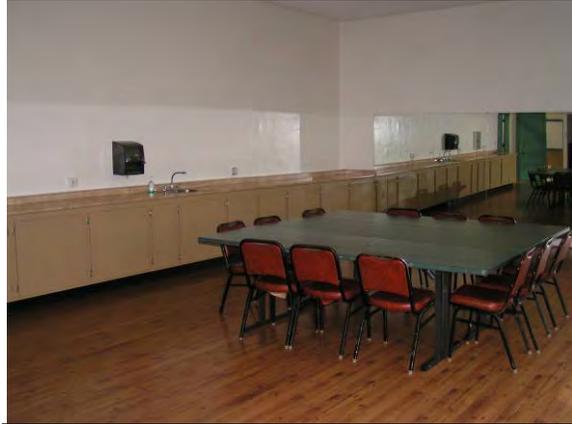
Photo #20: Main building meeting room

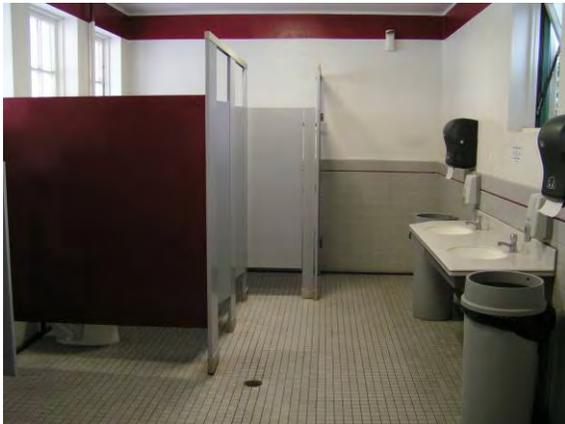
Photo #21: Main building restroom

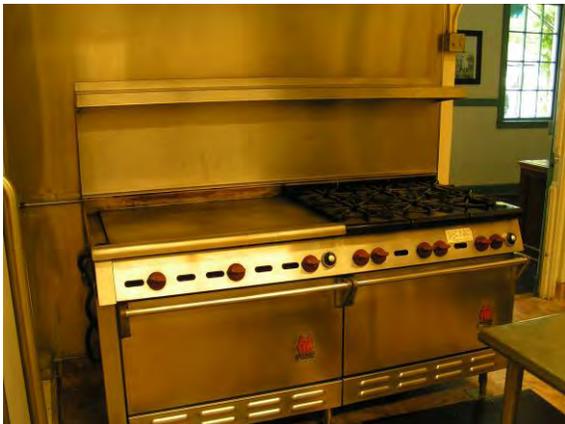
Photo #23: Range in main building kitchen

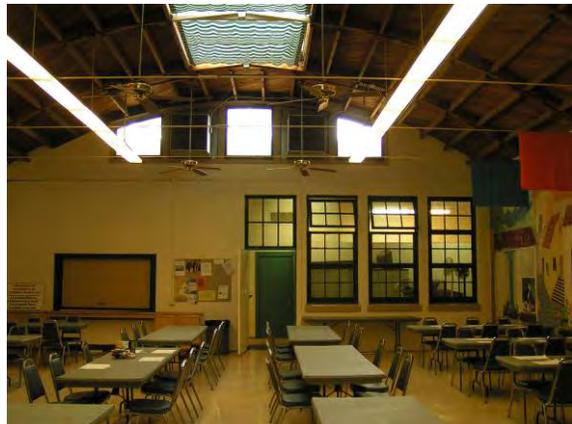
Photo #24: Main building dining room

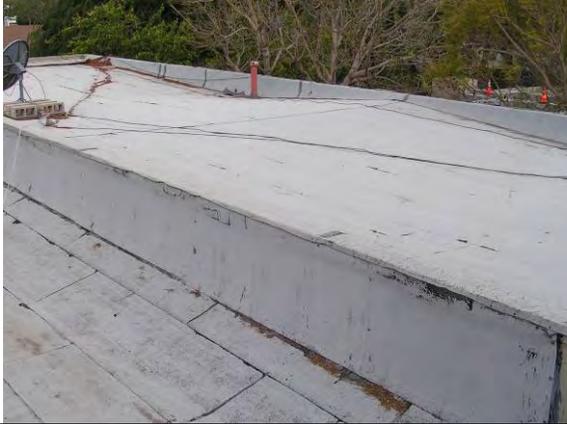
Photo #25: Main building flat roof

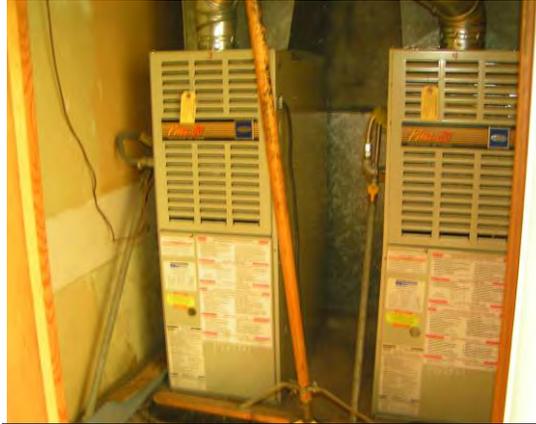
Photo #26: Furnaces at main building

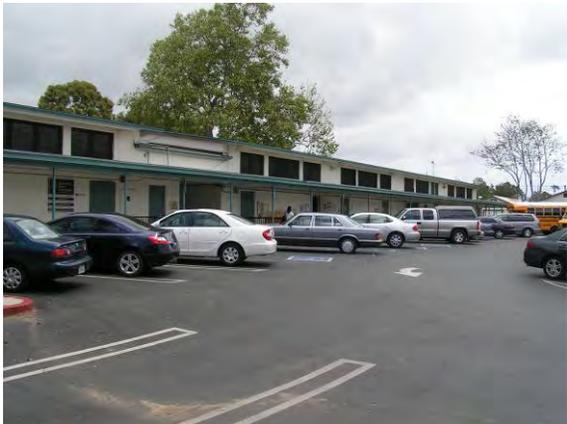
Photo #27: North site built classroom building front elevation and disabled parking

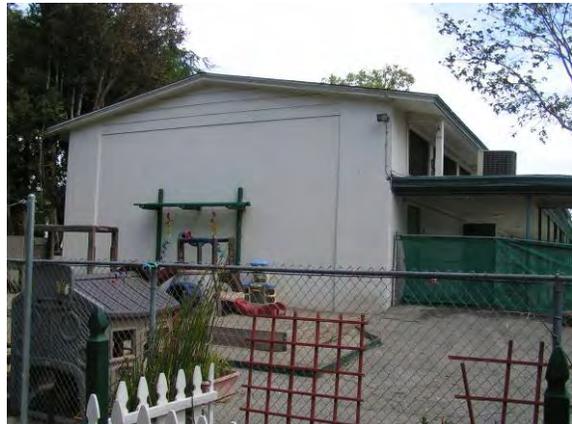
Photo #28: North site built classroom building left elevation

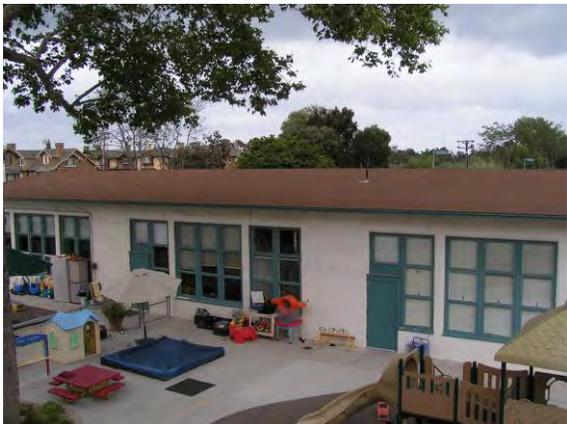
Photo #29: North site built classroom building roof and patio

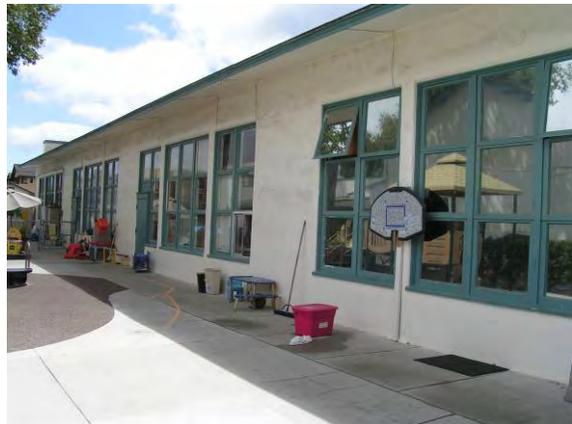
Photo #30: North site built classroom building rear elevation

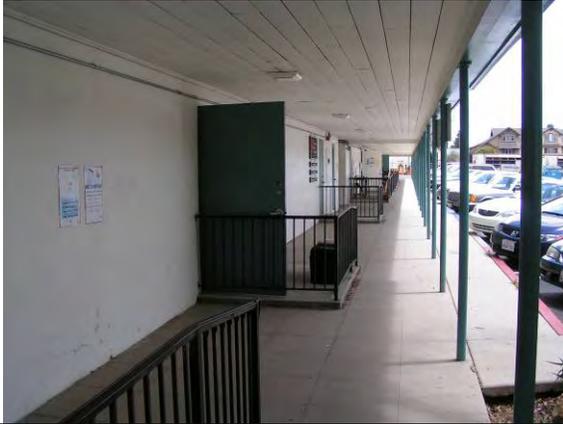
Photo #31: North site built classroom building covered walkway

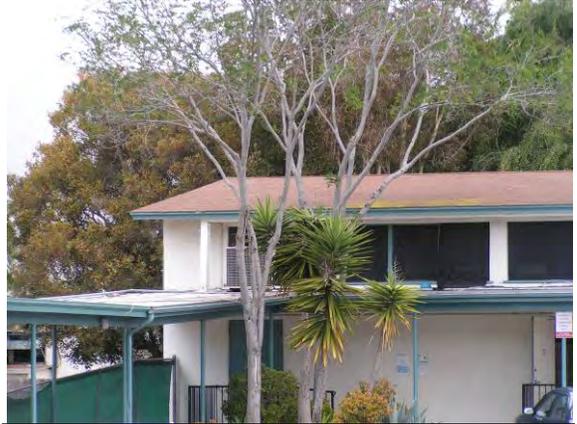
Photo #32: North site built classroom building and covered walkway roofs

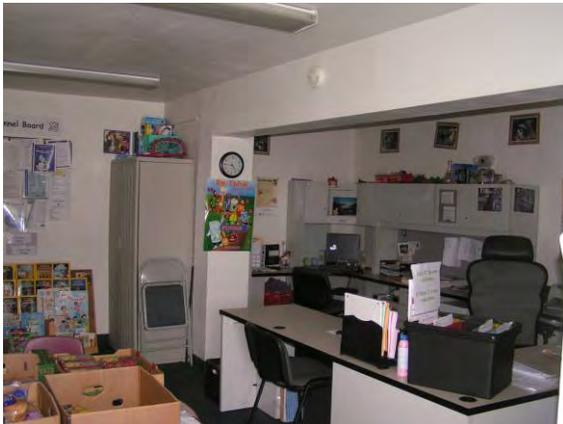
Photo #33: North site built classroom building office

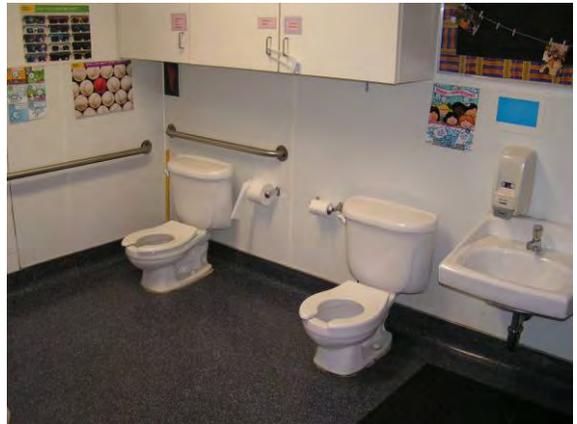
Photo #34: North site built classroom building classroom restroom

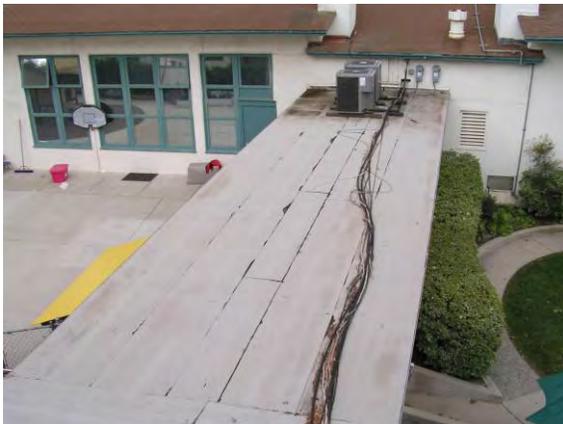
Photo #35: North site built classroom building covered walkway roof and air condition condensing units

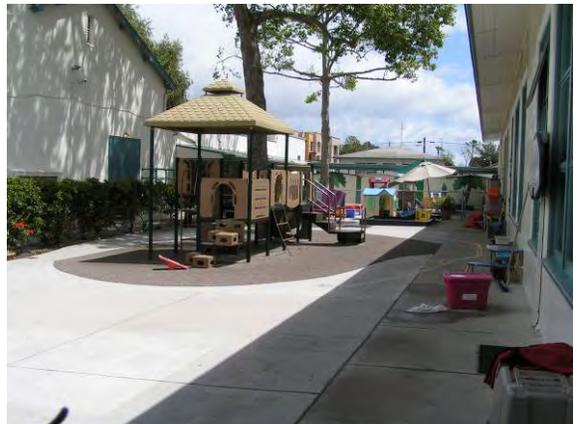
Photo #36: Play equipment at north site built classroom building

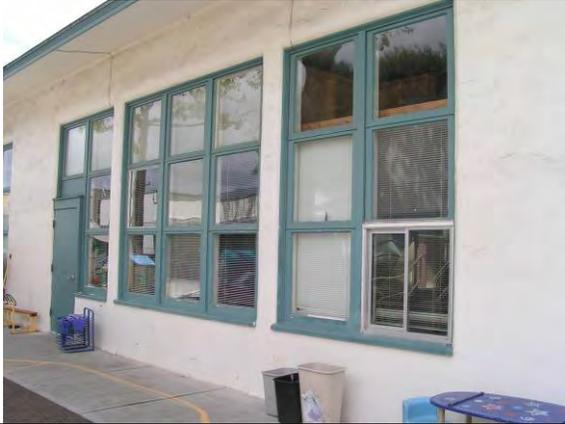
Photo #37: Windows at north site built classroom building

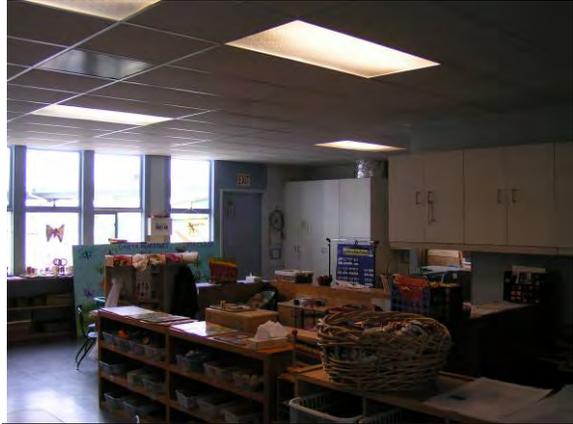
Photo #38: Typical classroom at north site built classroom building

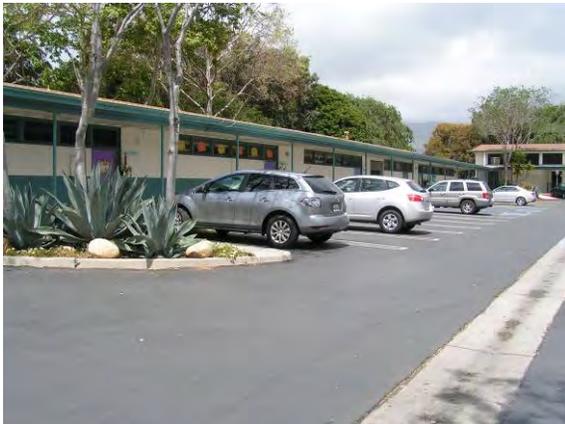
Photo #39: West site built classroom building front elevation and parking

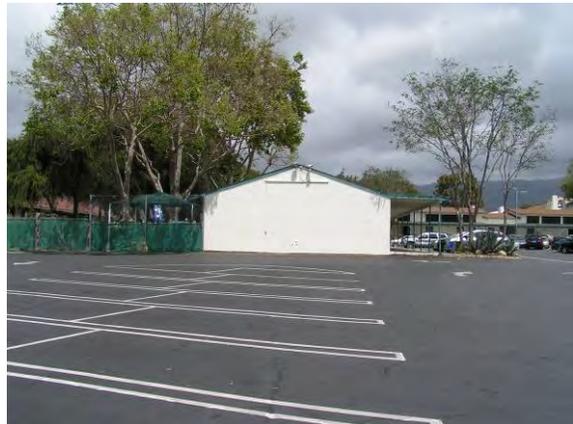
Photo #40: West site built classroom building left elevation and parking

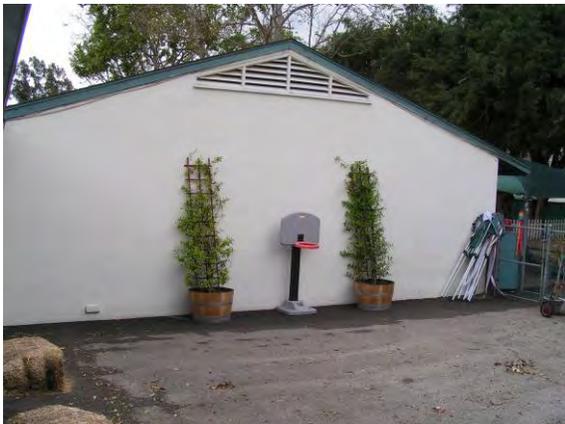
Photo #41: West site built classroom building right elevation

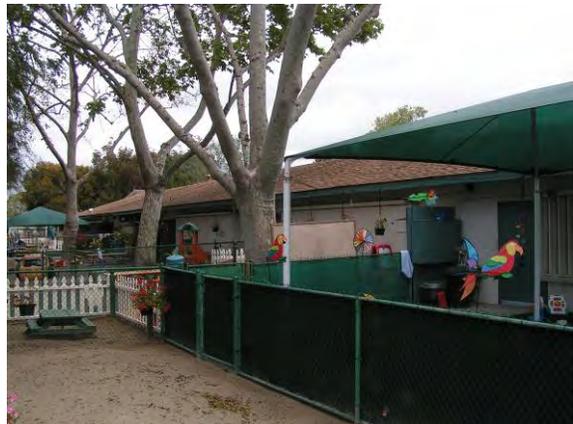
Photo #42: West site built classroom building rear elevation and play areas

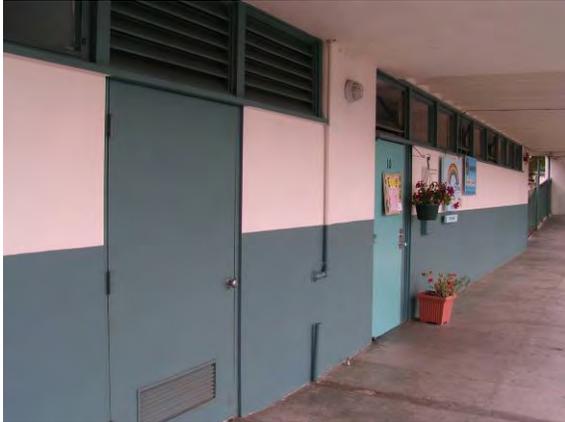
Photo #43: West site built classroom building doors and windows

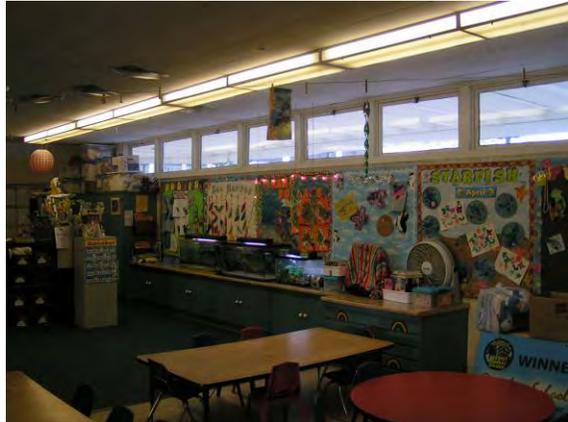
Photo #44: Typical classroom at west site built classroom building

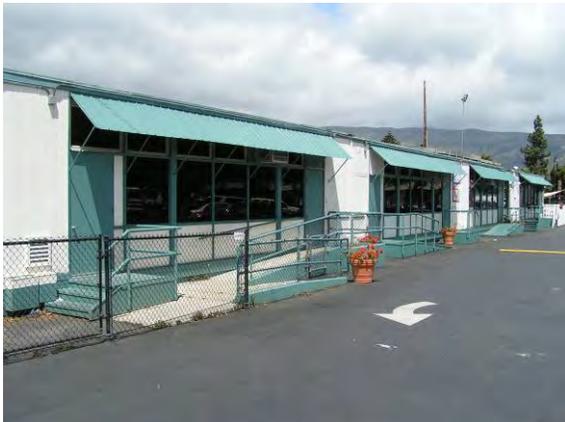
Photo #45: North pre-fabricated classroom building front elevation

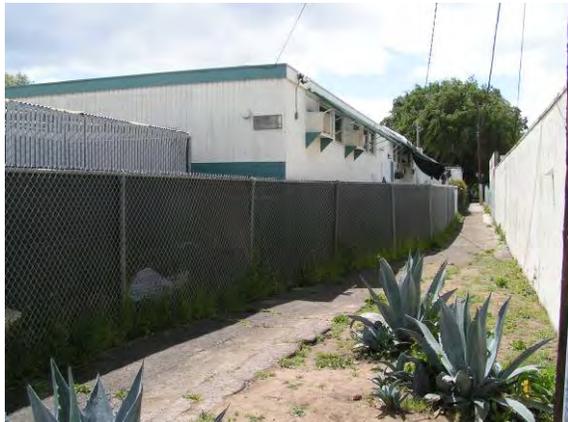
Photo #46: North pre-fabricated classroom building rear and right elevation

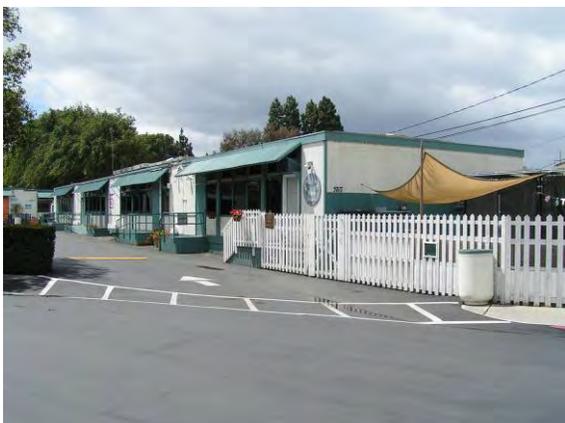
Photo #47: North pre-fabricated classroom building front and right elevation

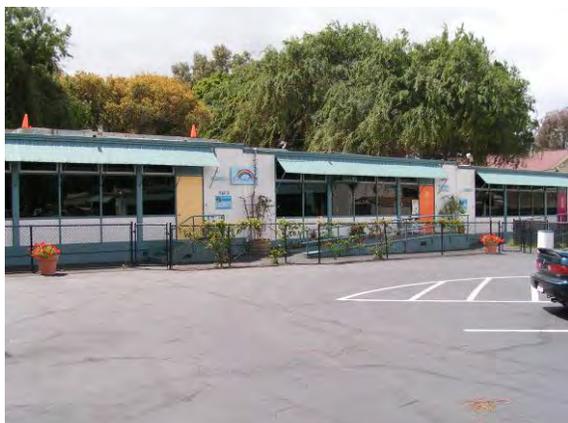
Photo #48: South pre-fabricated classroom building front elevation

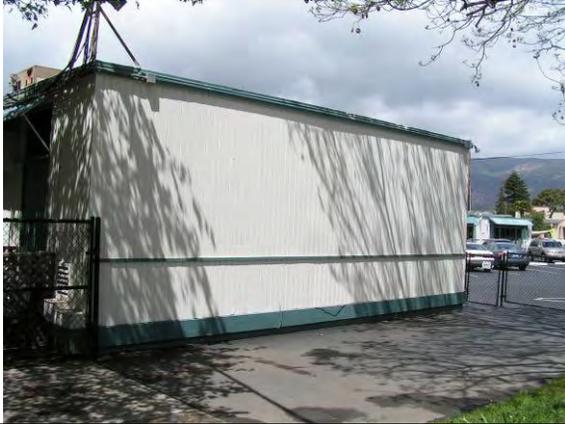
Photo #49: South pre-manufactured classroom building left elevation

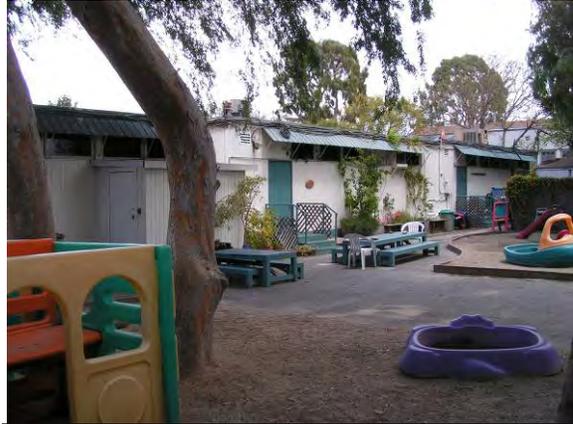
Photo #50: South pre-manufactured classroom building rear elevation and play area

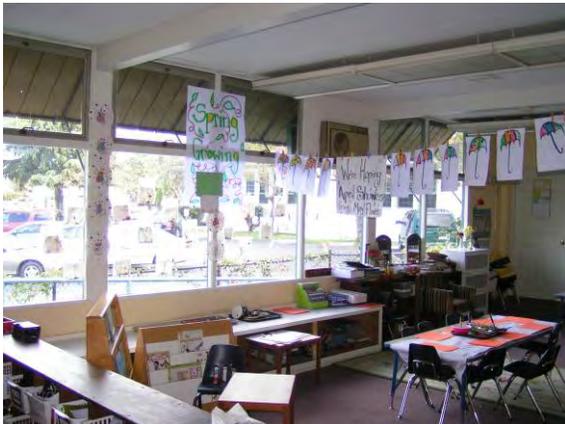
Photo #51: Typical classroom at South pre-manufactured classroom building

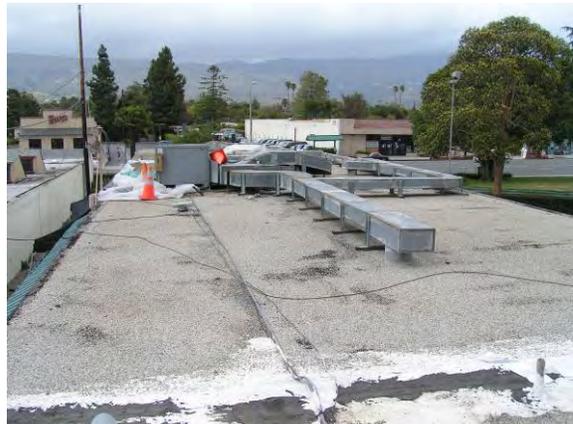
Photo #52: Roof of north Pre-fabricated classroom building

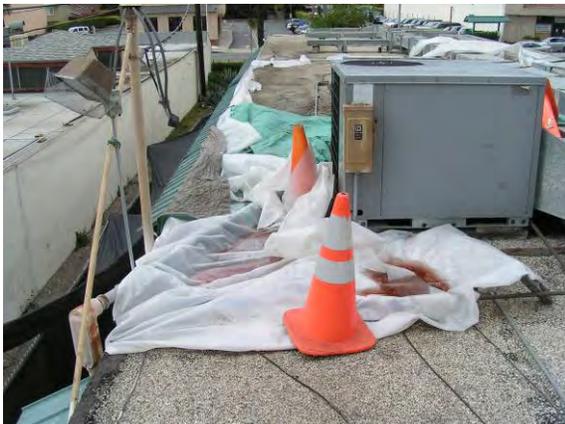
Photo #53: Roof of north pre-fabricated classroom building

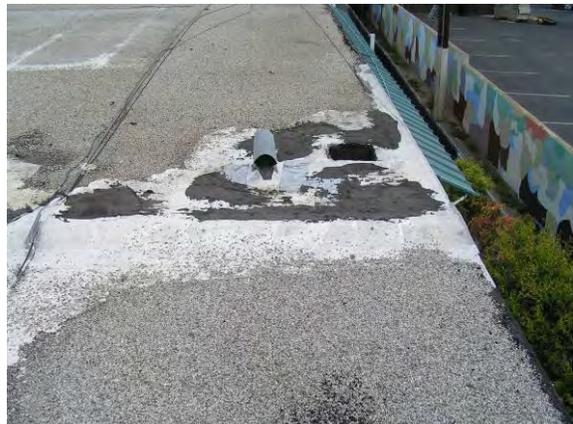
Photo #54: Roof of north fabricated classroom building

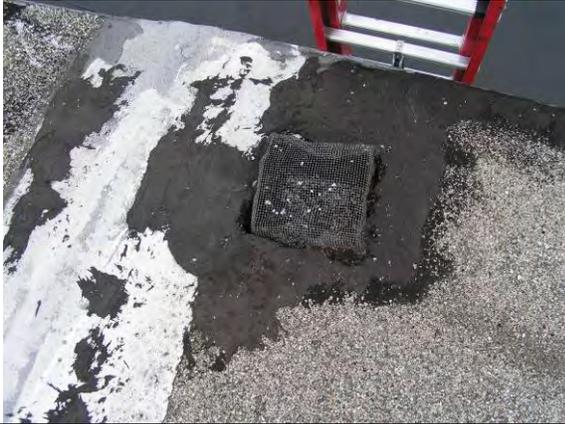
Photo #55:	Roof drain inlet at north pre-fabricated classroom building
------------	---

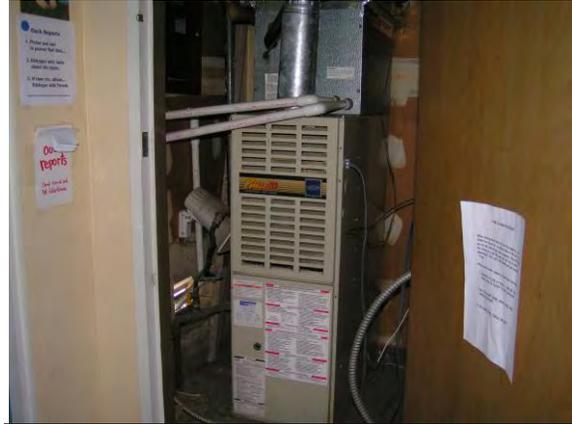
Photo #56:	Furnace at roof of south pre-fabricated classroom building
------------	--
