FACILITY RESERVE STUDY

RANCHO LA PATERA AND STOW HOUSE

EMG Project #: 92184.10R-003.052
Date of Report: September 1, 2010
On-site Date: April 27, 2010

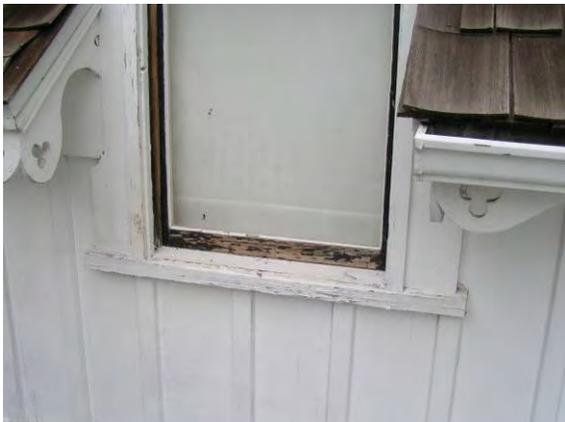
Photo #17: Window sill – Stow House

| Report Section | ID | Cost Description | Lifespan (EUL) | Observed Age (EAge) | Remaining Life (RUL) | Quantity | Unit | Unit Cost | Subtotal | 2011 | 2012 | 2013 | 2014 | 2015 | 2016 | 2017 | 2018 | 2019 | 2020 | 2021 | 2022 | 2023 | 2024 | 2025 | 2026 | 2027 | 2028 | 2029 | 2030 | Deficiency Repair Estimate |
|--|---|---|---|---|---|---|---|---|---|---|---|---|---|---|---|---|---|---|---|---|---|---|---|---|---|---|---|---|---|---|
| 6.6 | 37836 | Historic wood window patch, repair and paint | 15 | 14 | 1 | 52 | Each | \$238.87 | \$12,421 | | \$12,421 | | | | | | | | | | | | | | | \$12,421 | | | | \$24,842 |

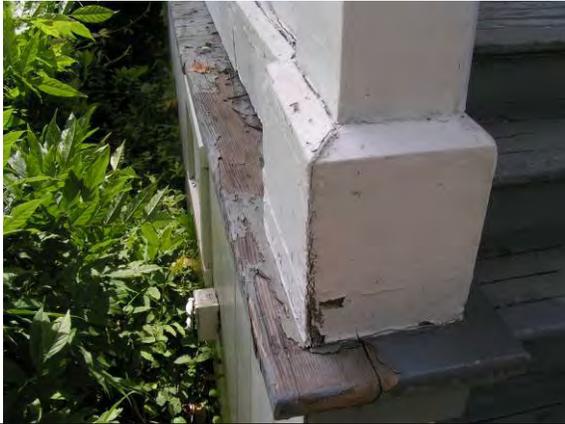
Photo #19: Porch wood condition – Stow House

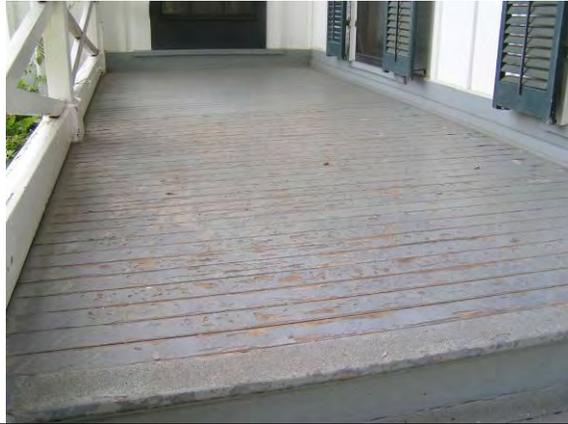
Photo #20: Porch deck condition – Stow House

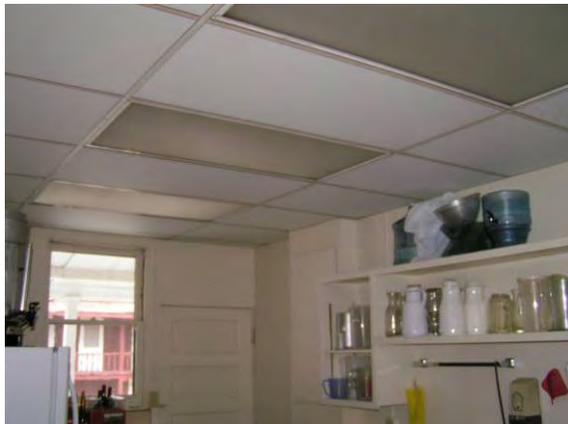
Photo #24: Ceiling at service kitchen – Stow House

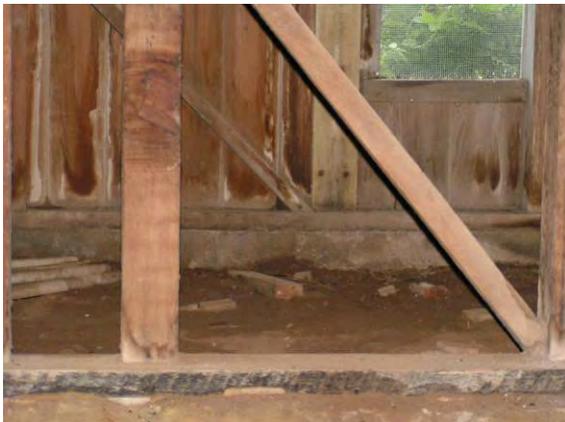
- At the Stow House it appears that framing to foundation connections are inadequate and there is wood to earth contact at the interior cripple walls. Some of the foundation posts have shifted and are not completely bearing on their footings. In addition, according to the staff moisture is evident in the attic of the Stow House. An architect or engineer must be retained to analyze the existing conditions, provide recommendations and, if necessary, estimate the scope and cost of any required repairs. See Sections 6.1 and 6.3 for discussion and costs.
- At the Stow House there is significant evidence of exterior wood trim deterioration due to wood pecker activity at the Stow House. A local, licensed pest control contractor should be retained to treat the property as required to eliminate the threat. See section 6.4 for discussion and costs.

Photo #29: Crawl space wall earth to wood contact at sill plate – Stow House

| Report Section | ID | Cost Description | Lifespan (EUL) | Observed Age (EAge) | Remaining Life (RUL) | Quantity | Unit | Unit Cost | Subtotal | 2011 | 2012 | 2013 | 2014 | 2015 | 2016 | 2017 | 2018 | 2019 | 2020 | 2021 | 2022 | 2023 | 2024 | 2025 | 2026 | 2027 | 2028 | 2029 | 2030 | Deficiency Repair Estimate |
|--|---|---|---|---|---|---|---|---|---|---|---|---|---|---|---|---|---|---|---|---|---|---|---|---|---|---|---|---|---|---|
| 6.1 | 37838 | Correct foundation anchorage | 0 | 0 | 0 | 1 | Each | \$15,000.00 | \$15,000 | \$15,000 | | | | | | | | | | | | | | | | | | | | \$15,000 |

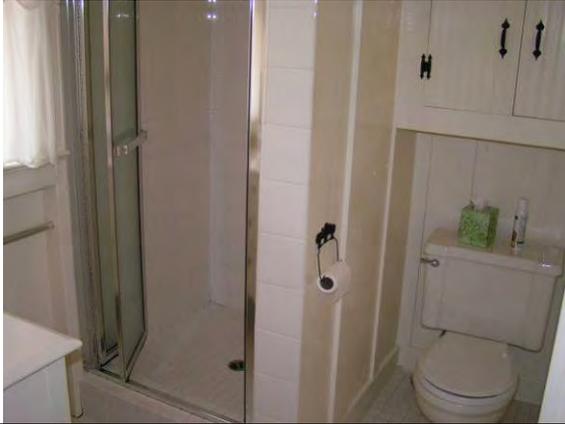
Photo #37: Bathroom – Caretaker’s residence

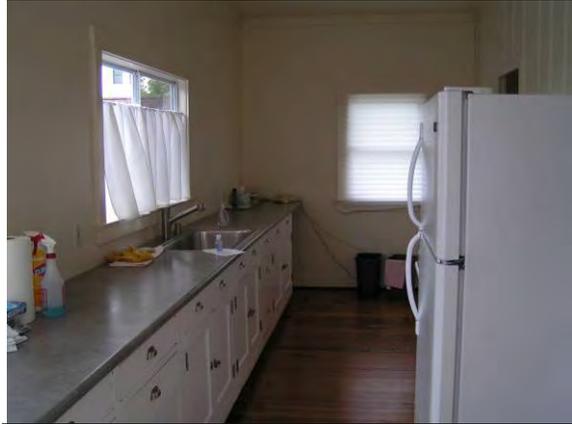
Photo #38: Kitchen – Caretaker’s residence

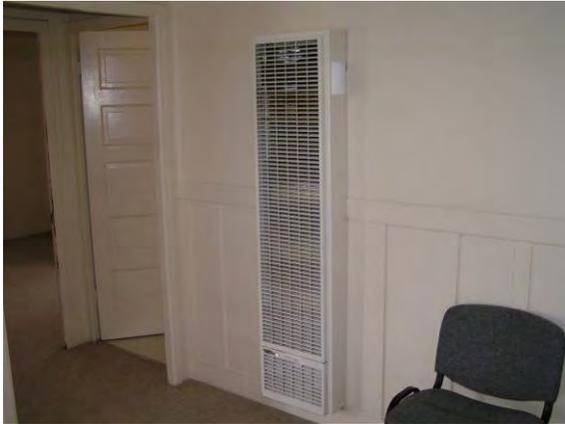
Photo #39: Wall heater – Caretaker’s residence

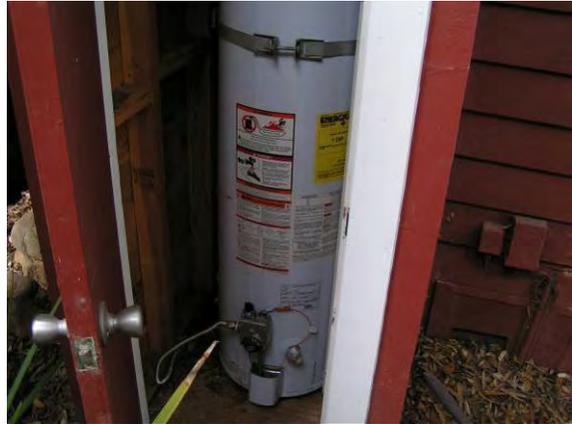
Photo #40: Water heater – Caretaker’s residence

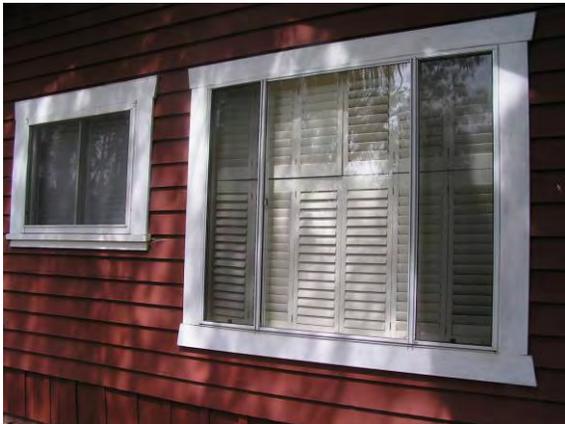
Photo #41: Windows – Caretaker’s residence

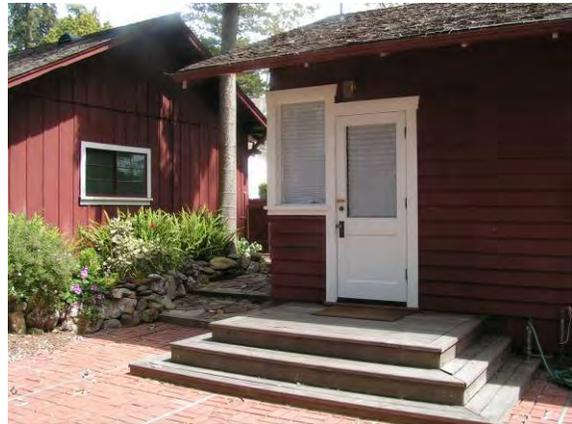
Photo #42: Rear door and stoop – Caretaker’s residence

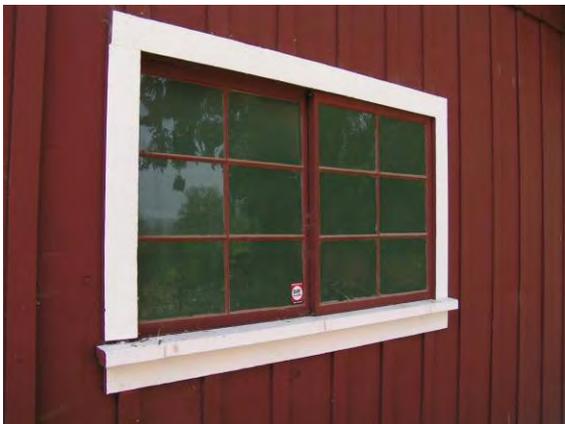
Photo #47: Window – Garage

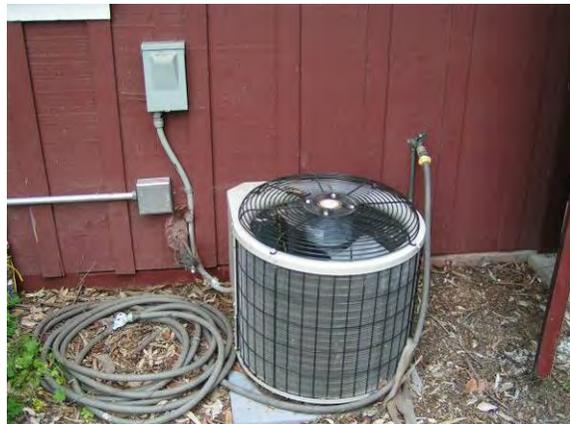
Photo #48: Condensing Unit – Garage

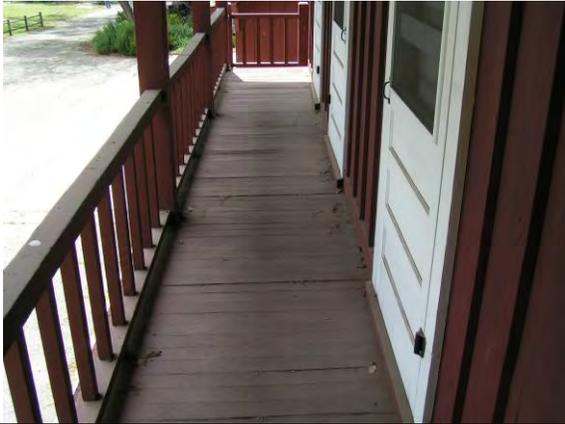
Photo #55: Exit balcony – Bunk House

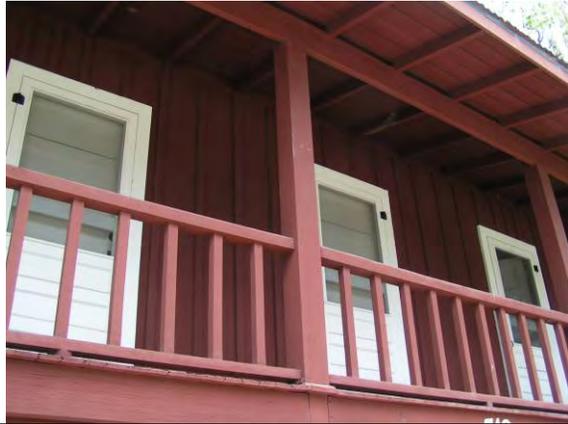
Photo #56: Balcony guardrail and roof overhang – Bunk House

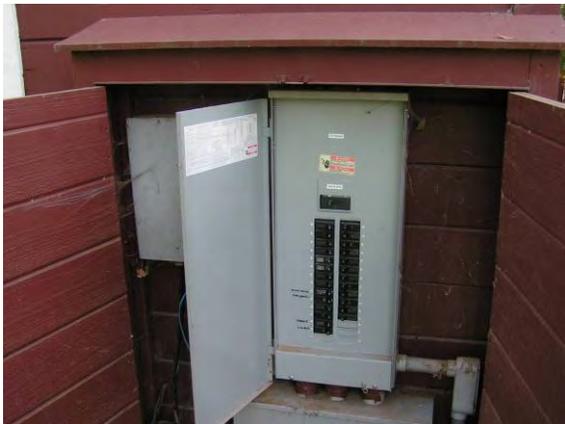
Photo #57: Electrical panel – Bunk House

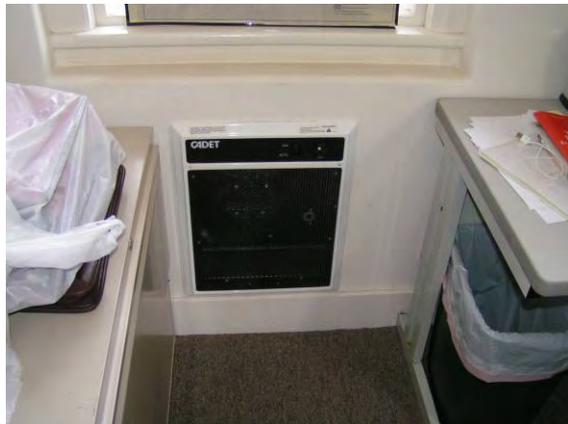
Photo #58: Wall heater – Bunk House

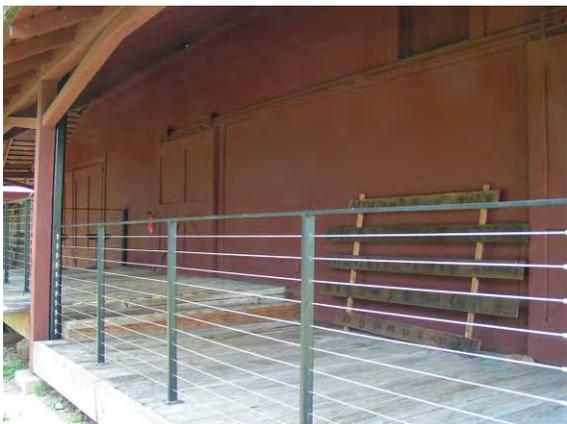
Photo #65: Front porch – Packing shed

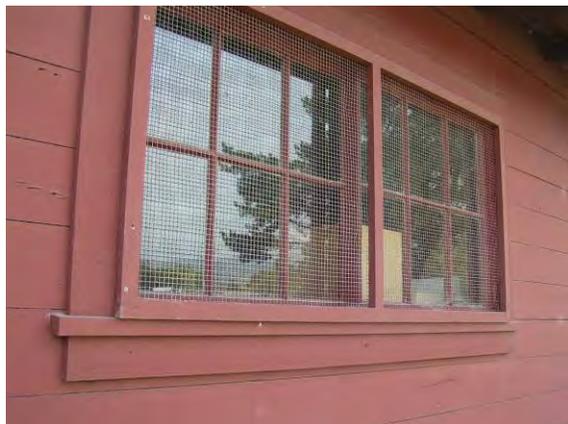
Photo #66: Window – Packing shed

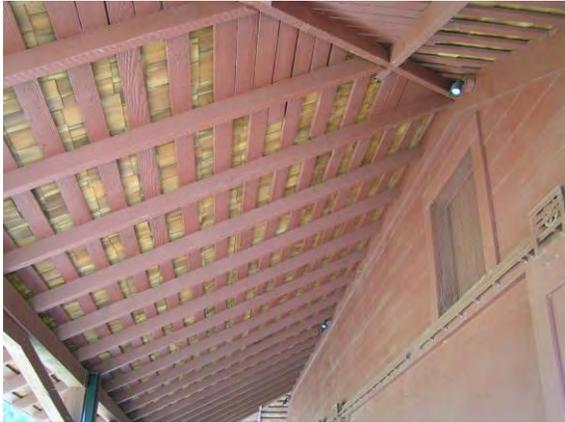
Photo #67: Front porch ceiling – Packing shed

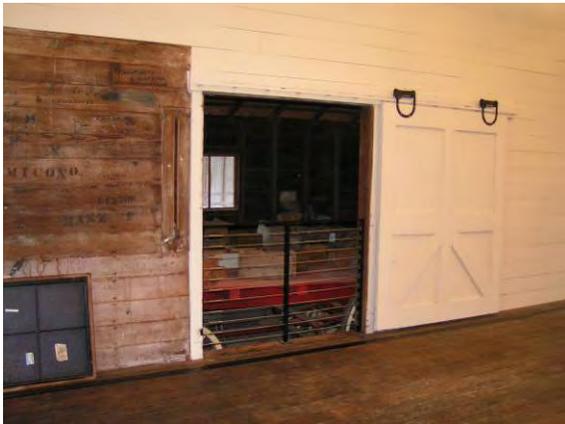
Photo #69: Interior loading door – Packing shed

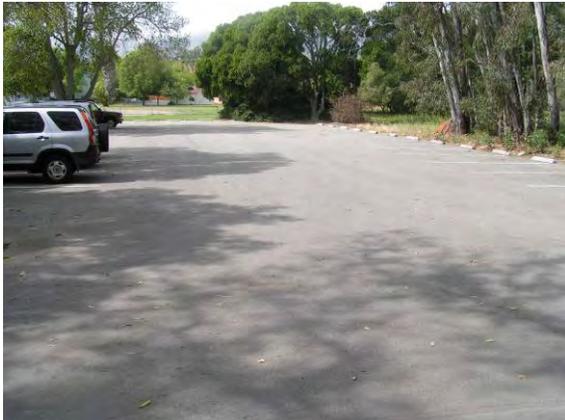
Photo #75: Parking lot

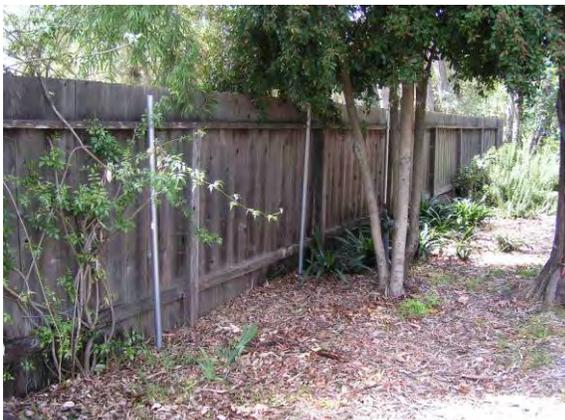
Photo #77: Fence at caretaker's residence

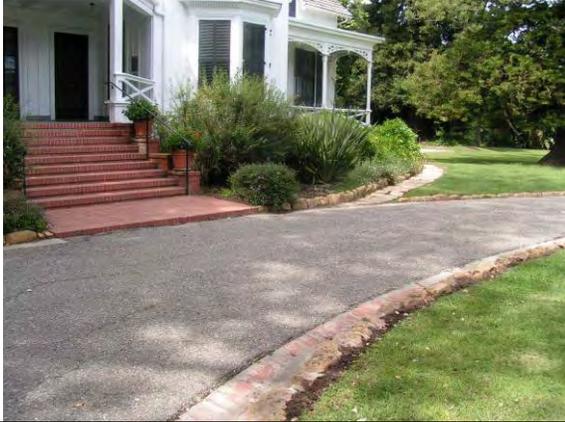
| Photo #79: | Stow House driveway |

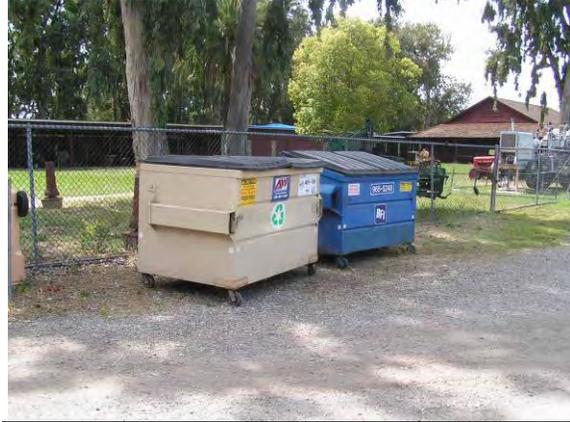
| Photo #80: | Dumpsters |
