Historic Resource Potential Impact Study

POTENTIAL IMPACT STUDY

GOLETA COMMUNITY CENTER GOLETA, CALIFORNIA [16128]

FEBRUARY 2017

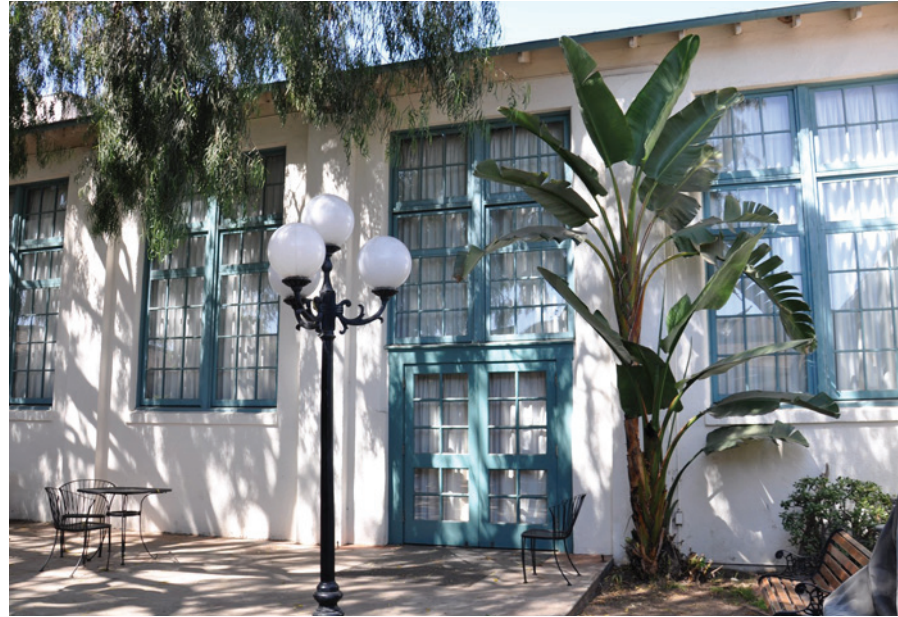
Figure 6. West façade in east patio, looking west at Auditorium.

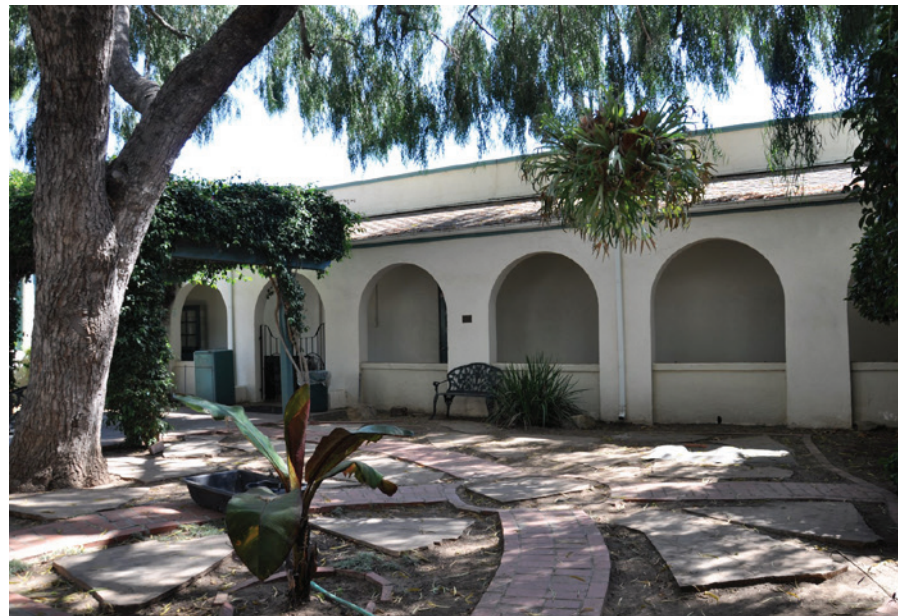
Figure 7. East patio, looking east at arched corridor.
